**Reference: Assessment of Stormwater Discharges on October 28, 2016
Amesbury Heights Project
36 Haverhill Road, Amesbury, MA**

Observations of Stormwater Discharges on October 28, 2016
Relative to Amesbury Heights Project
36 Haverhill Road, Amesbury, MA

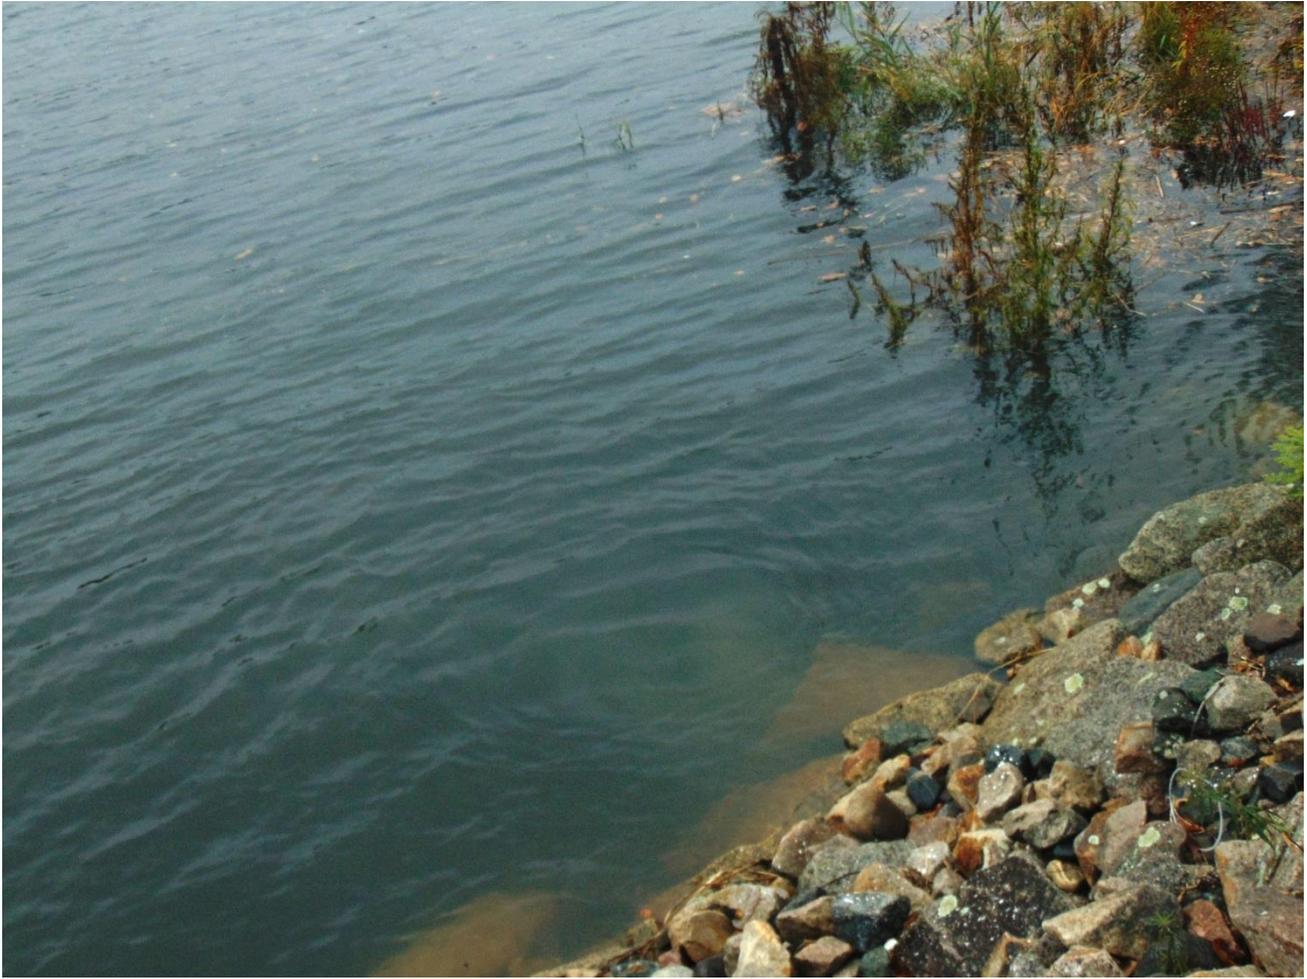
Stantec visited the Hatter's Point project located along the Merrimack River at the outlet pipe location from Bailey's Pond situated just southerly of the Hatter's Point building. At the time of the visit, the tide had risen over the pipe outlet. The outlet pipe was visible below the water and cloudy discharge was observed exiting the pipe into the Merrimack River. (See photos 1 and 2). The outlet pipe into the Merrimack River is connected to the outlet structure at Bailey's Pond.

#1 – Outlet pipe from Baileys Pond that is observed to be below high tide level of Merrimack River taken on 10-28-16. View from Walkway looking southwesterly.

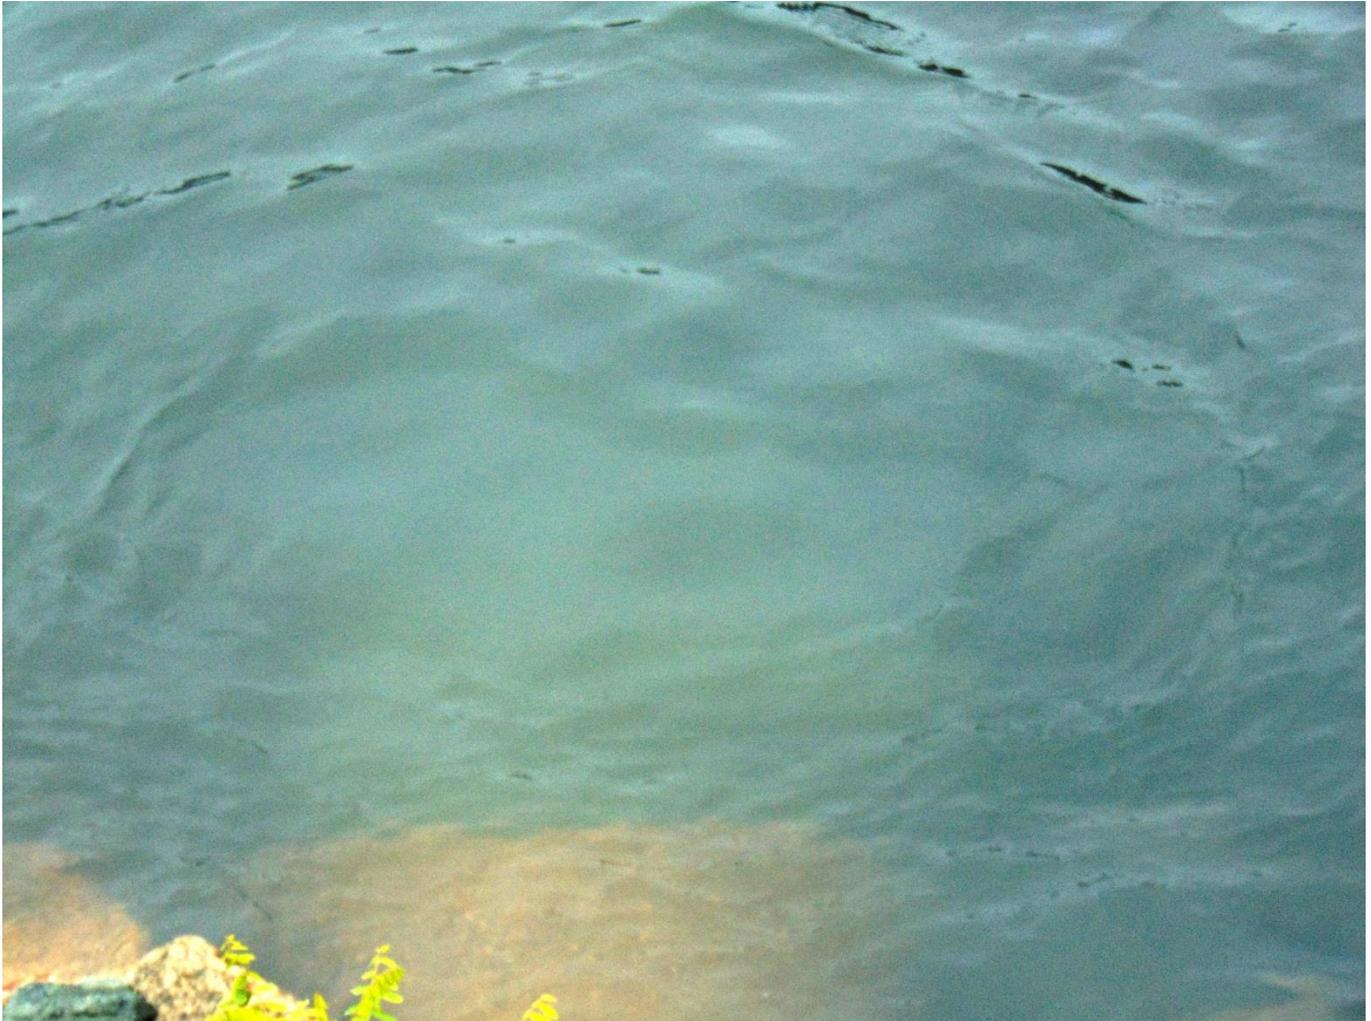
#2 – Enlarged view of Baileys Pond submerged outlet pipe that is observed to be discharging cloudy water into Merrimack River taken 10-28-16

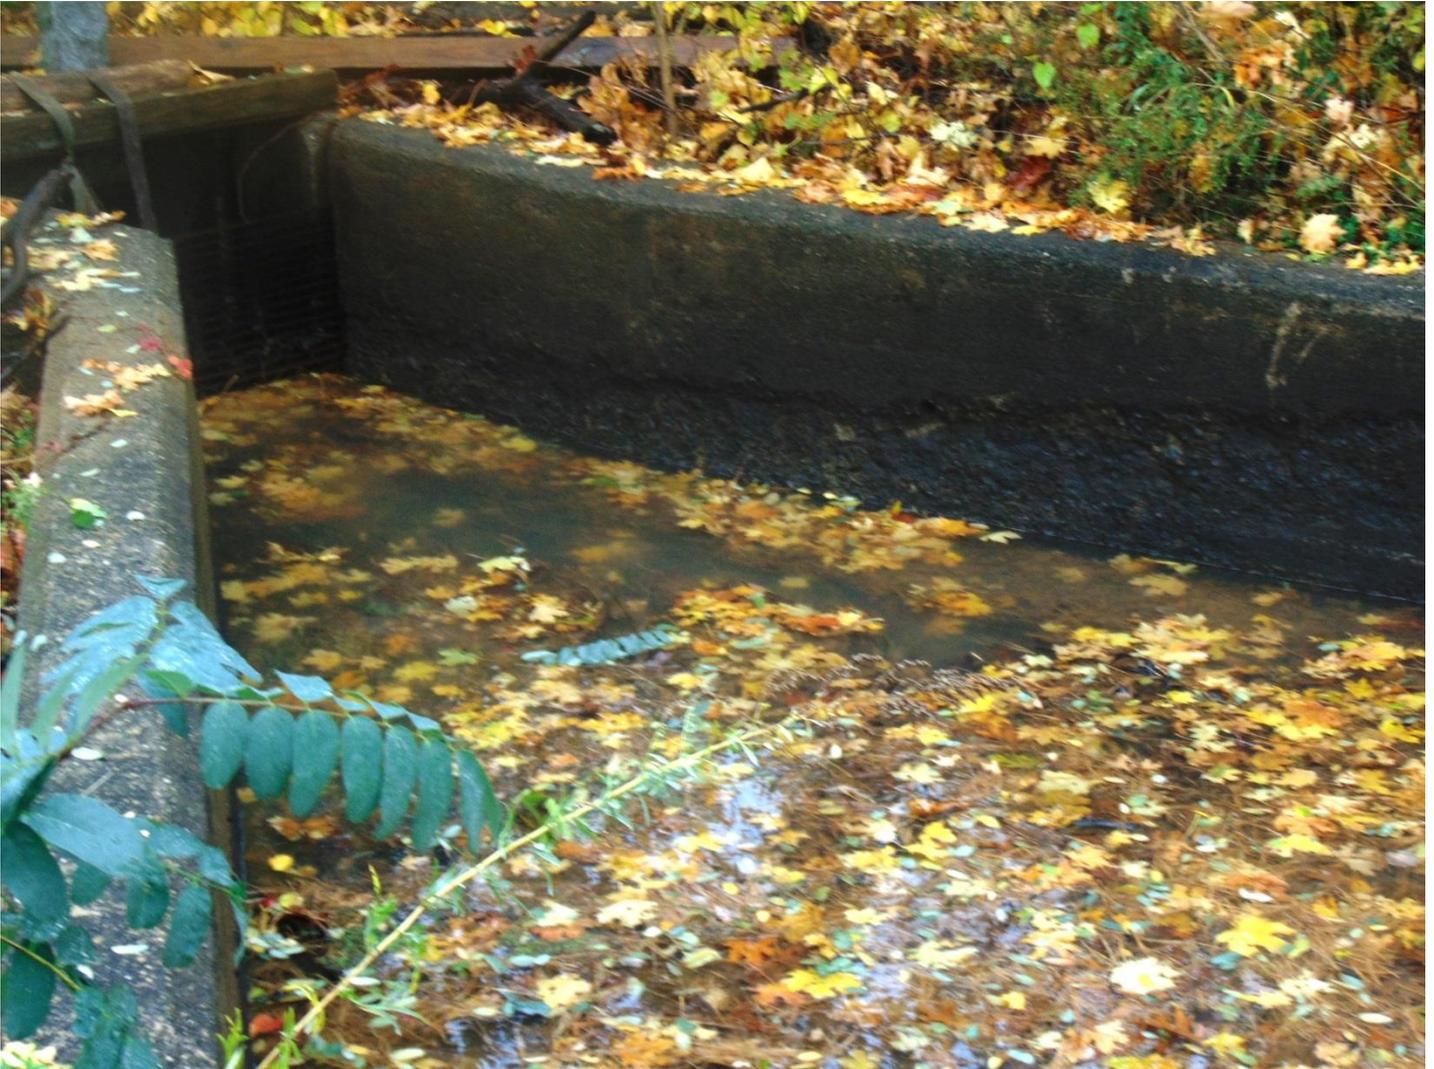
Stantec visited the pipe outlet at Bailey's Pond and observed sediment laden (cloudy) water. The entire pond was cloudy. Photos 3-5 are taken from the easterly shoreline of Bailey's Pond and include a view toward the inlet stream area to the pond. Stantec visited the stream inlet area discharging into Baileys' Pond (see photos 6 and 7) and observed sediment laden stream flow emanating from the culvert under Summit Avenue. Photos 8-10 are along the stream channel toward the culvert under Summit Avenue

#3 – Outlet Structure at Baileys Pond observed with cloudy water flowing towards the Merrimack River.
Taken on 10-28-16

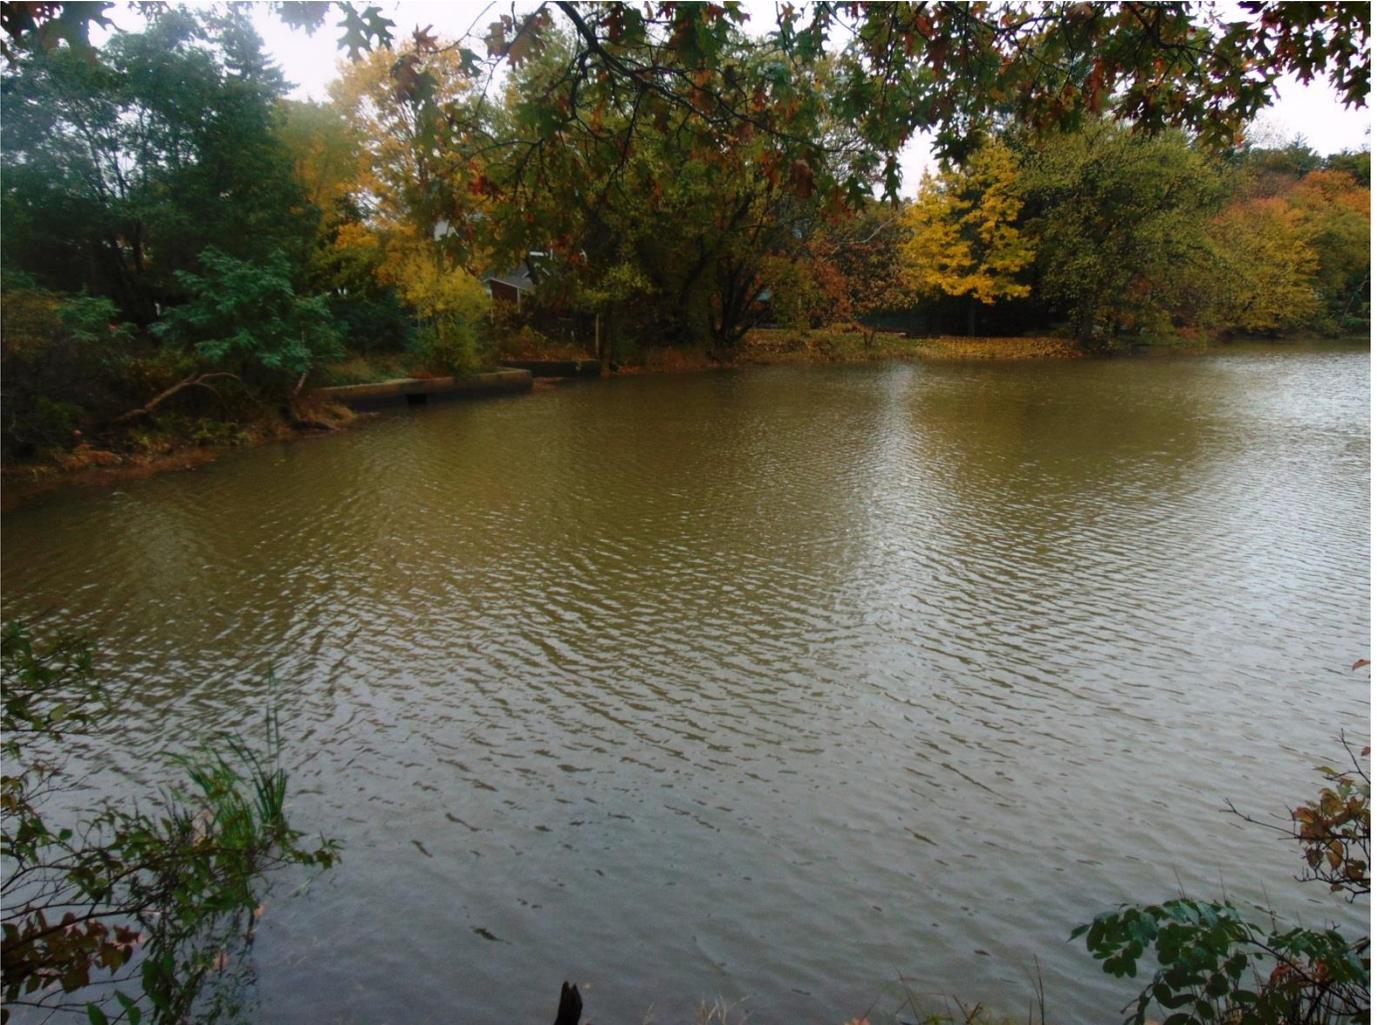
#4 – View along Baileys Pond looking southerly toward Outlet Structure with visible sediment (cloudiness) in the water. Taken on 10-28-16

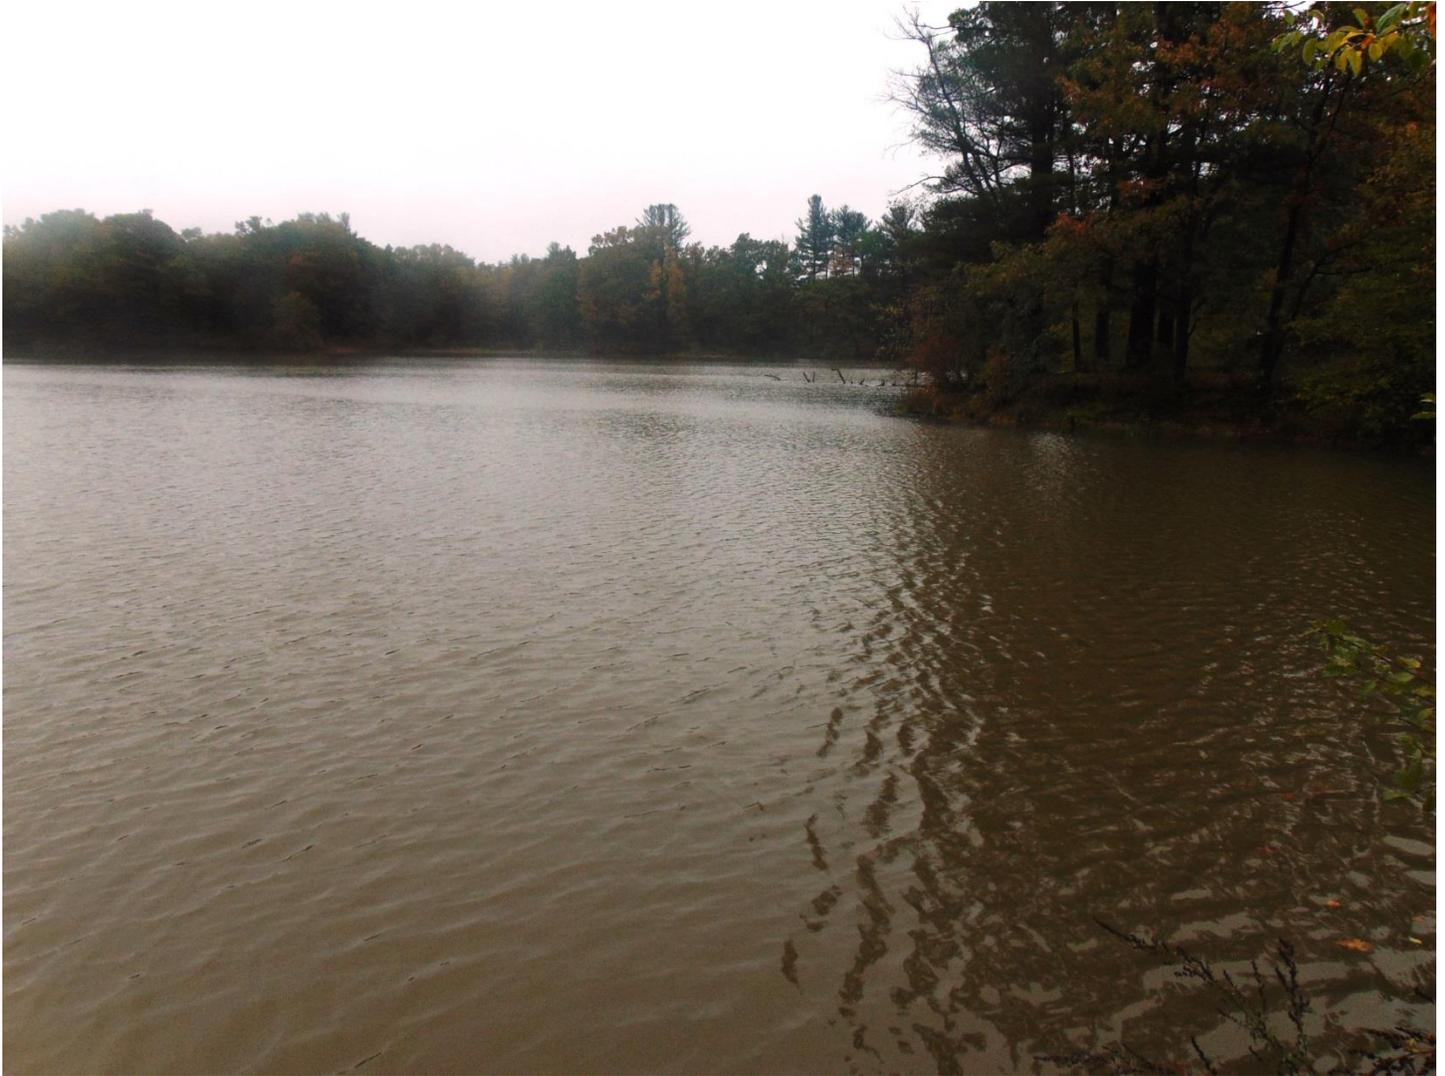
#5 – View from the easterly shoreline of Bailey's Pond looking northwesterly toward stream inlet emanating from the culvert under Summit Avenue. Taken on 10-28-16.

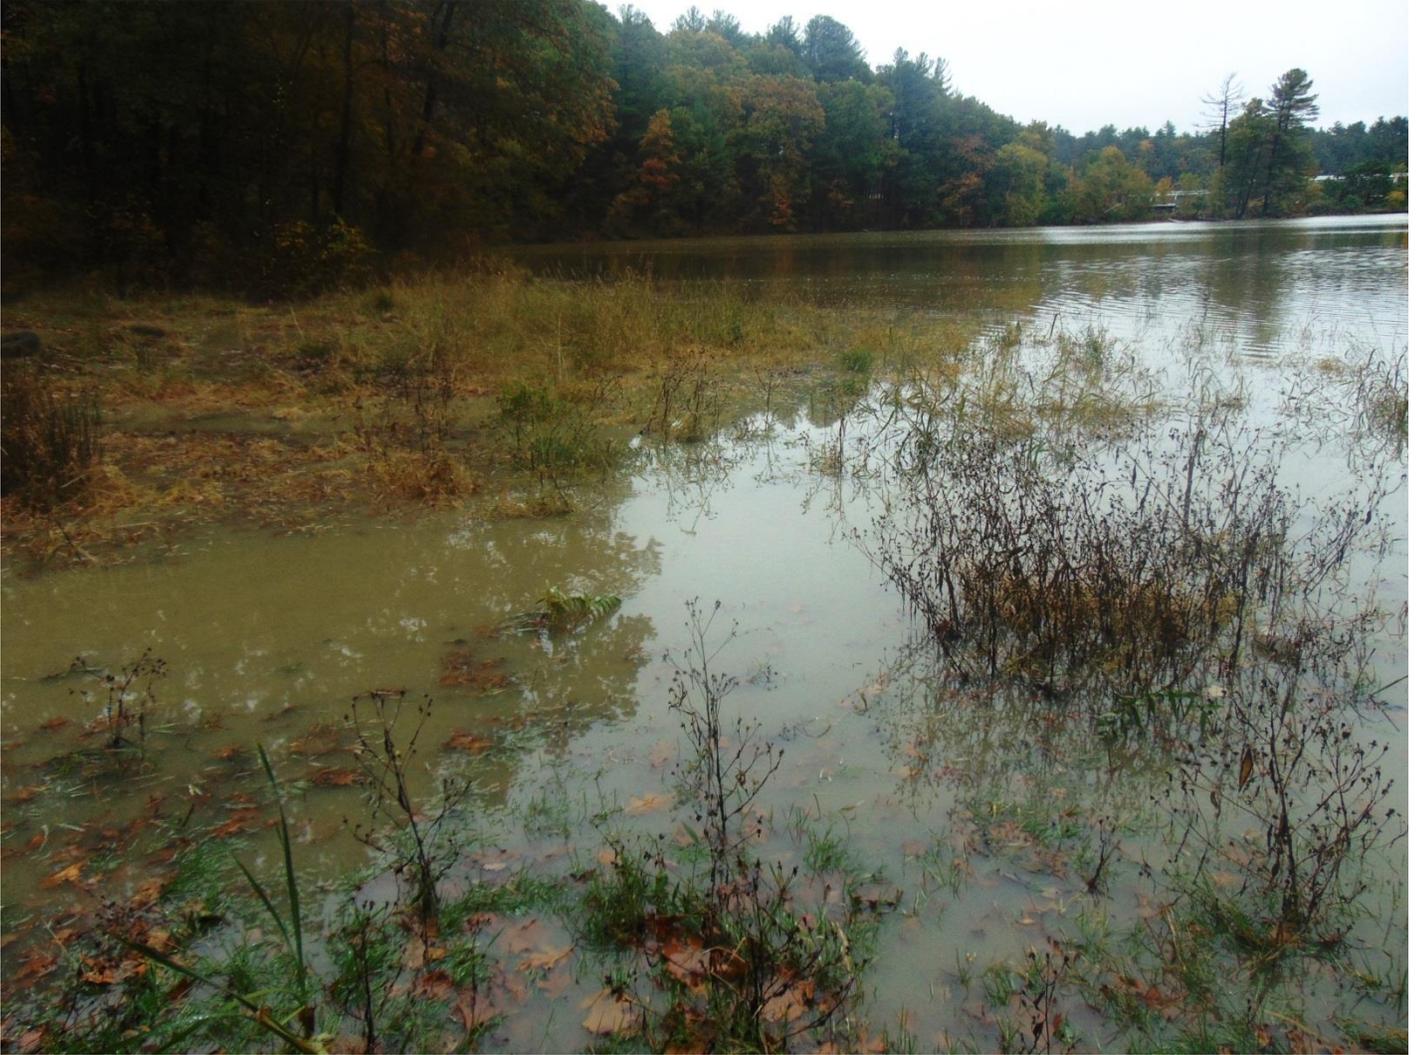
#6 – View from northwesterly Baileys' Pond shoreline at the stream discharge location into Bailey's Pond looking southeasterly. Photo 5 above was taken from the shoreline seen in the upper right corner and looking toward this location on 10-28-16.

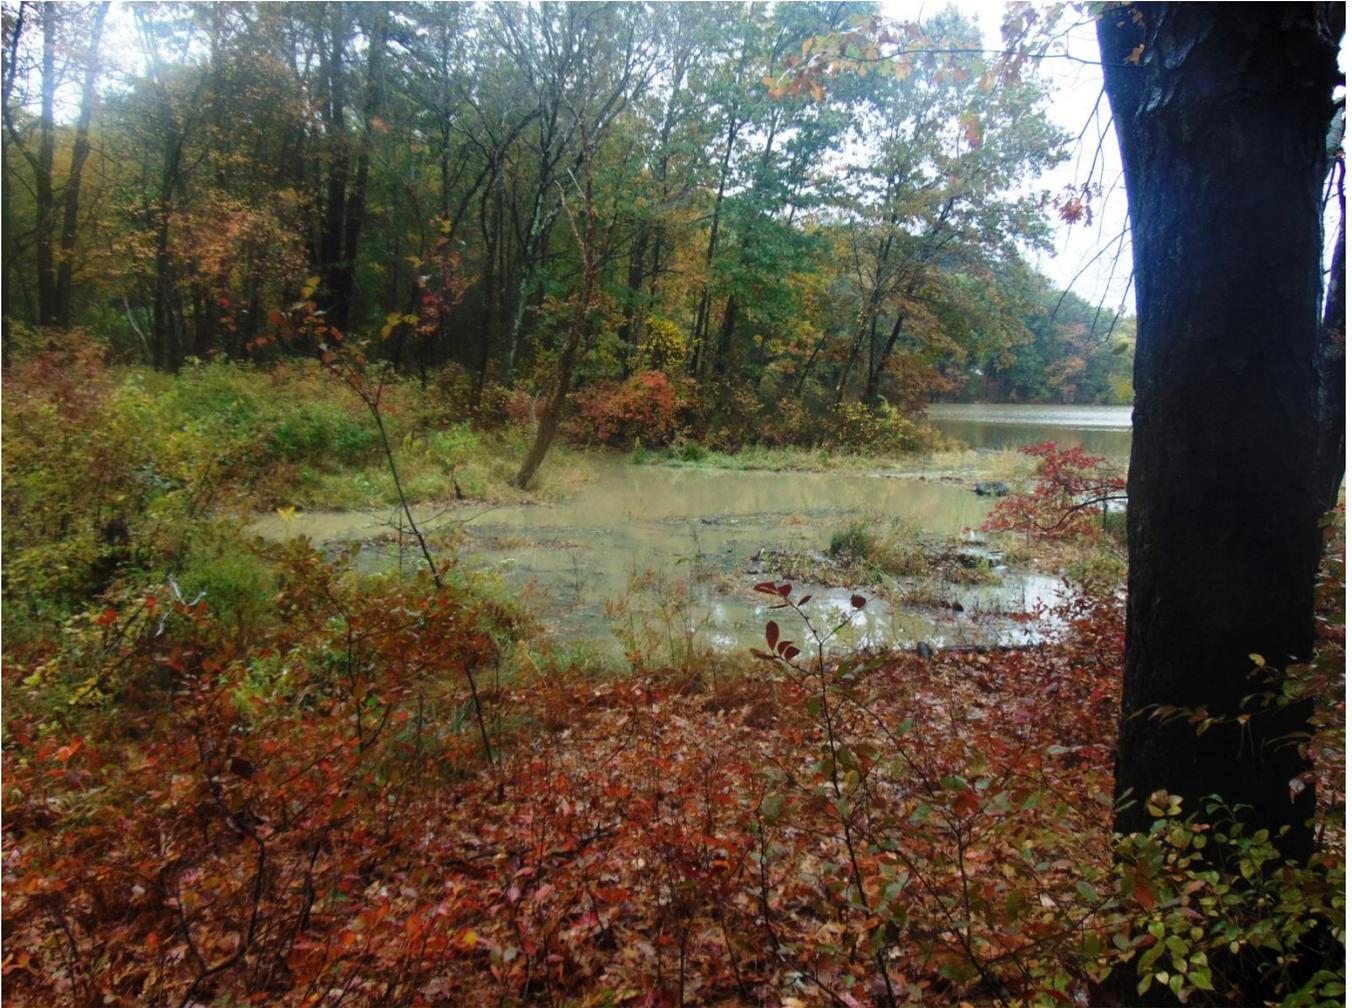
#7 – Observed sediment laden stream flow from Summit Avenue culvert taken near edge Baileys Pond and looking easterly on 10-28-16.

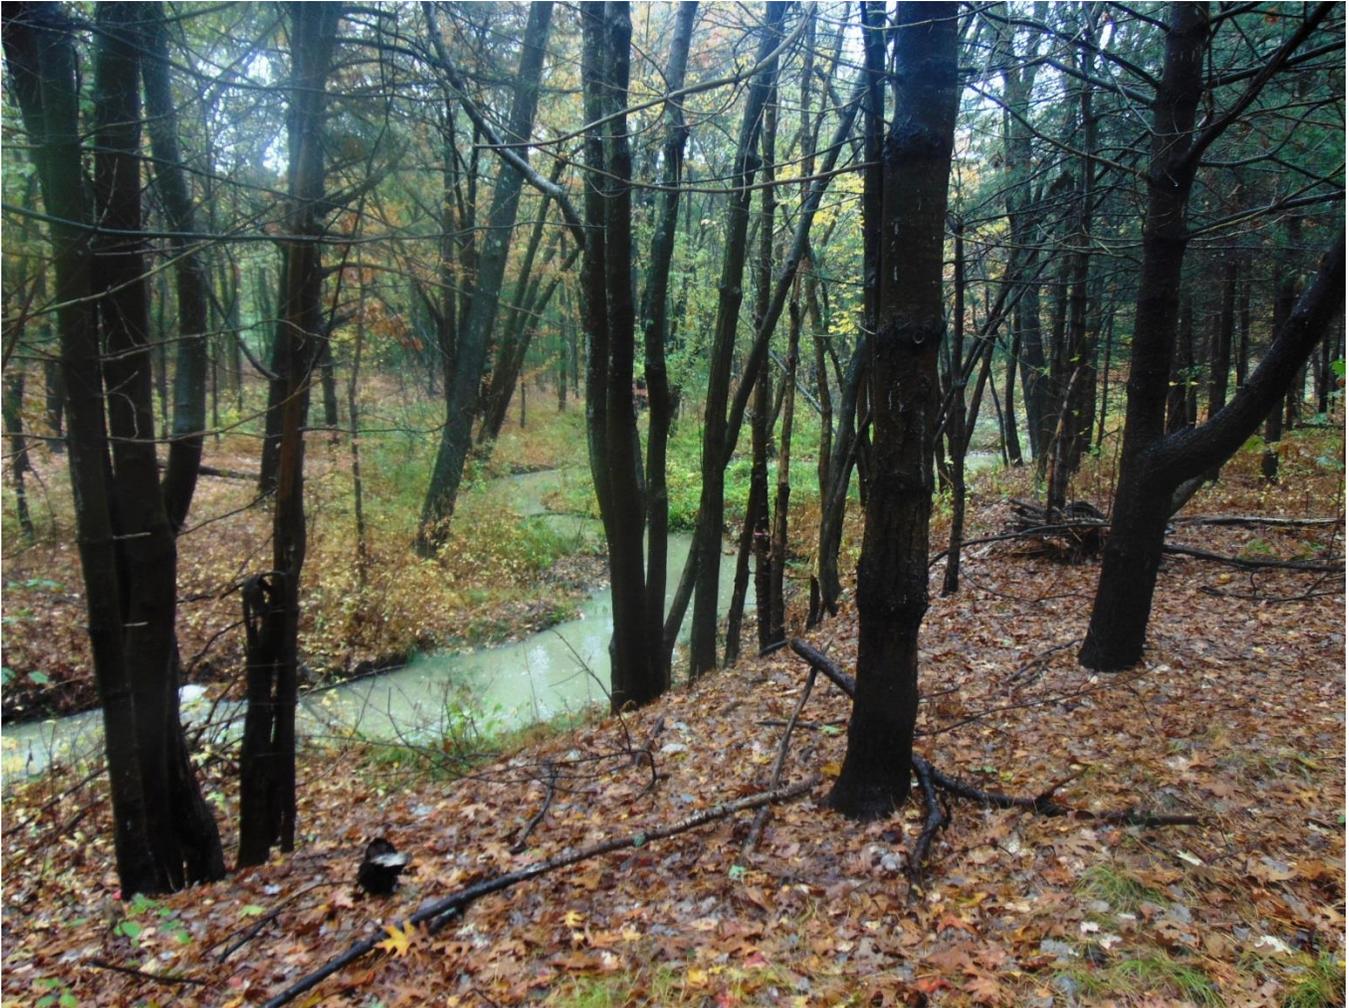
#8 – Observed sediment laden stream discharge from culvert under Summit Avenue flowing downstream towards Bailey's Pond. Taken on 10-28-16 from southerly bank of stream looking southeasterly.

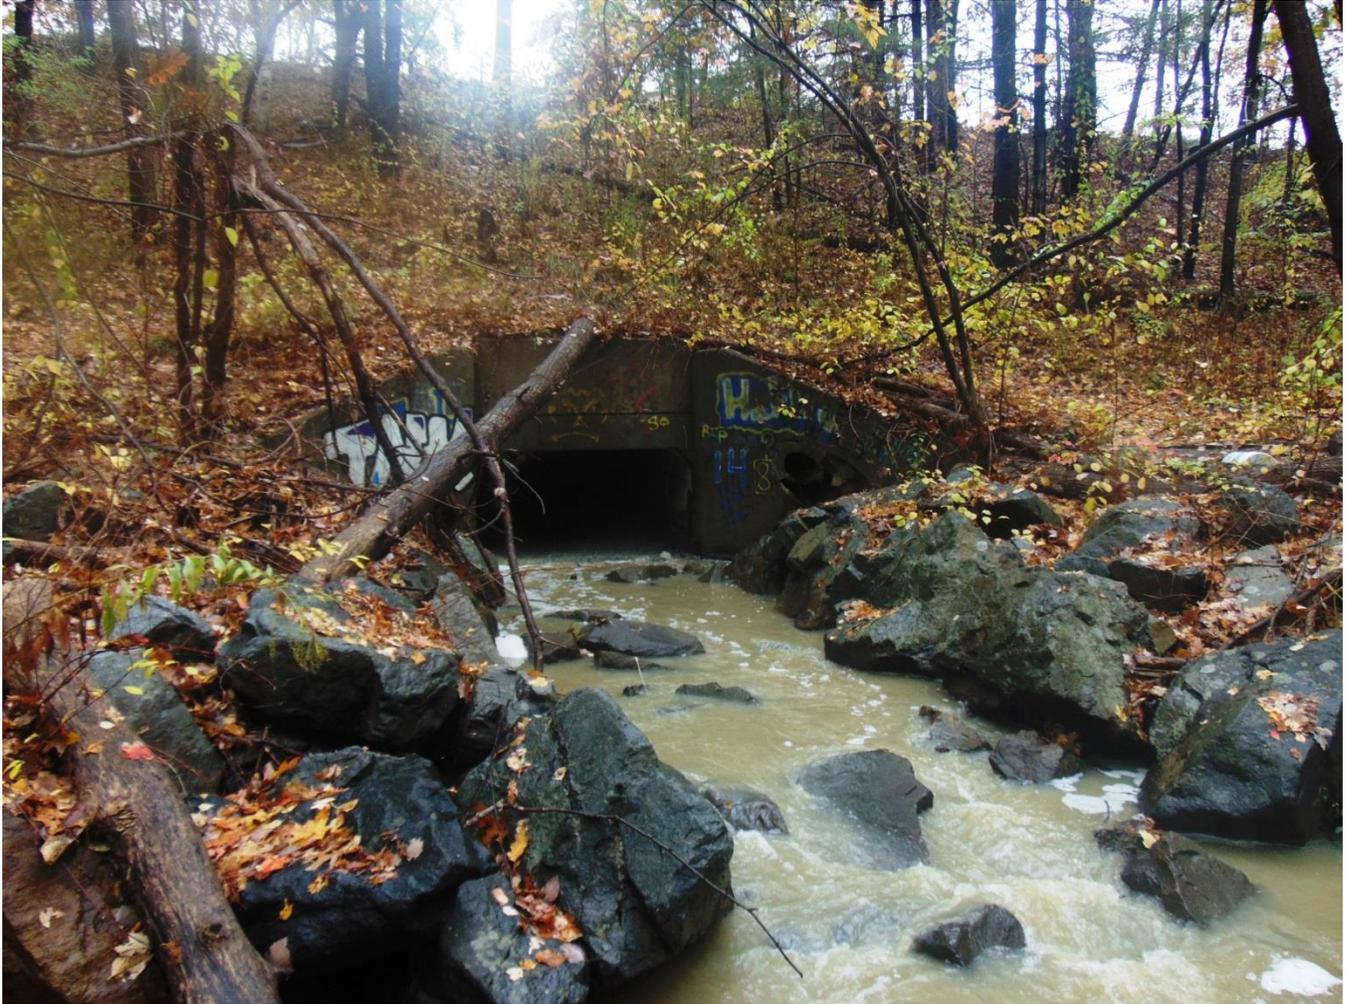
#9 – Standing downstream of culvert under Summit Avenue looking northerly and upstream at the outlet that is observed discharging sediment laden runoff into the stream channel that flows toward Baileys Pond taken on 10-28-16. The culverts associated with the mainline and ramps of Route I-495 are located upstream.

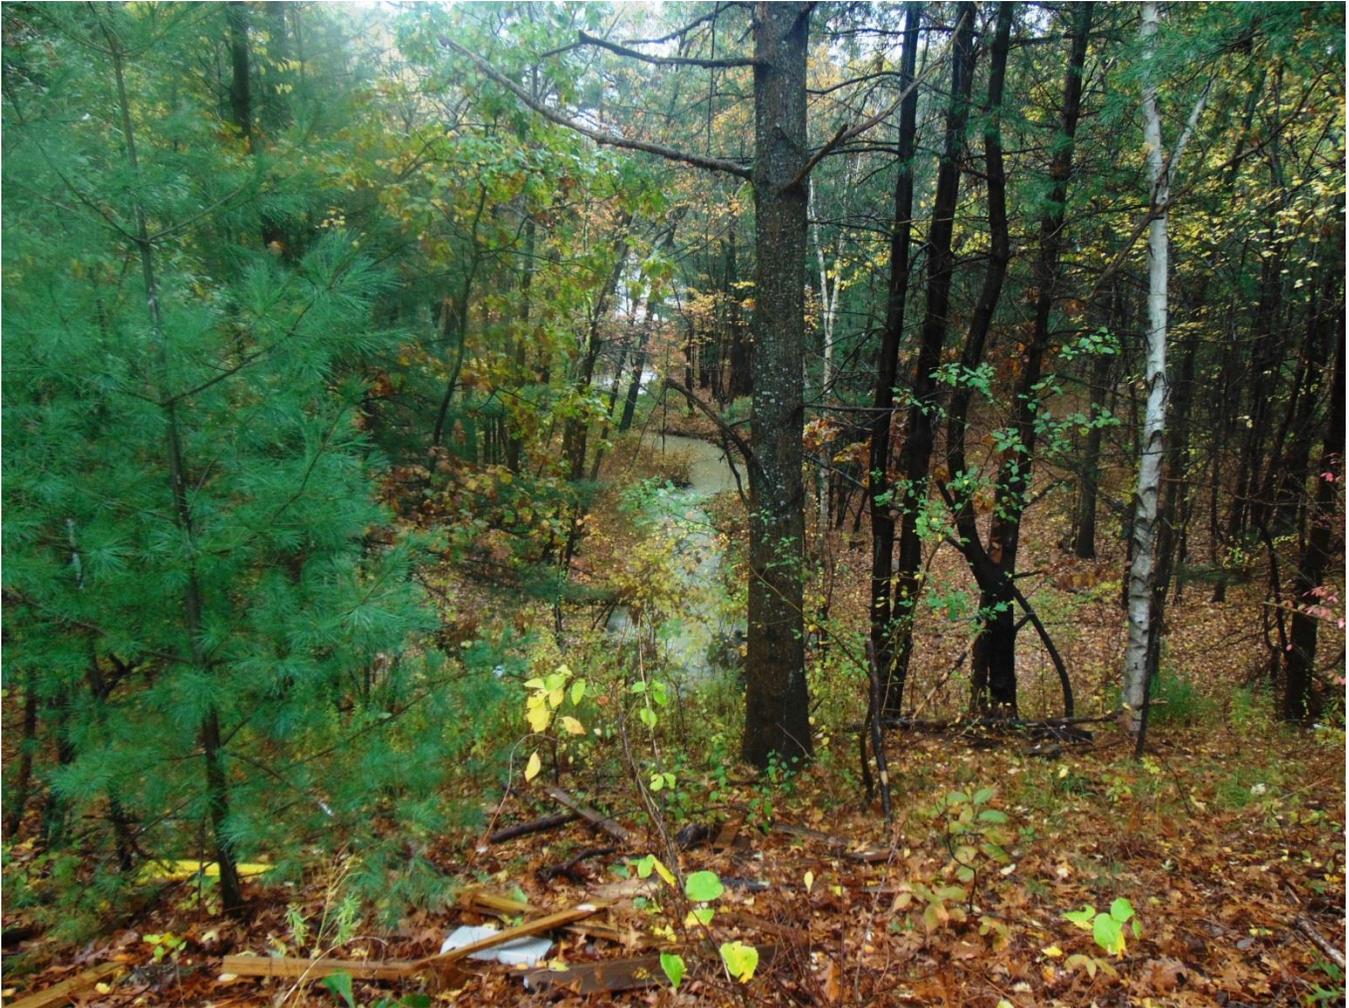
#10 – Standing above the Summit Avenue culvert looking downstream toward Bailey's Pond at the observed sediment laden stream flow from culvert under Summit Avenue taken on 10-28-16.

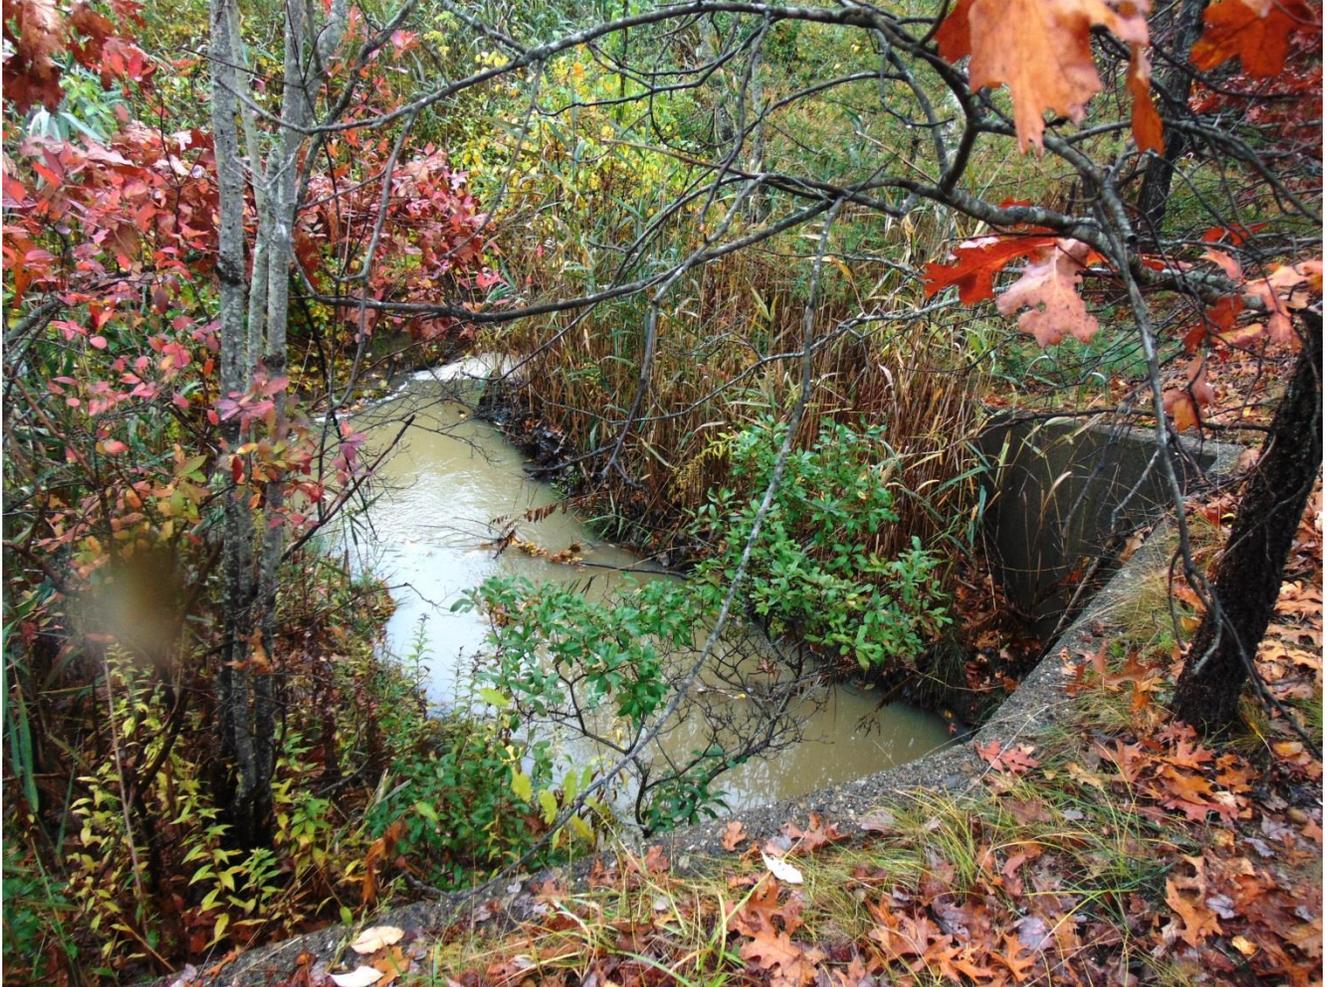
Stantec visited the culvert crossing under Route 150 located upstream of the culverts associated with Route I-495. Photos 11 is of the downstream side of Route 150 and upstream of the mainline and ramps of Route I-495. Photos 12 -15 follow the stream channel upstream along Route 150.

#11 – Standing above the culvert outlet on the easterly side of Route 150 and looking southeasterly at headwall and observed sediment laden stream flowing downstream towards the culverts associated with Route I-495. Taken 10-28-16

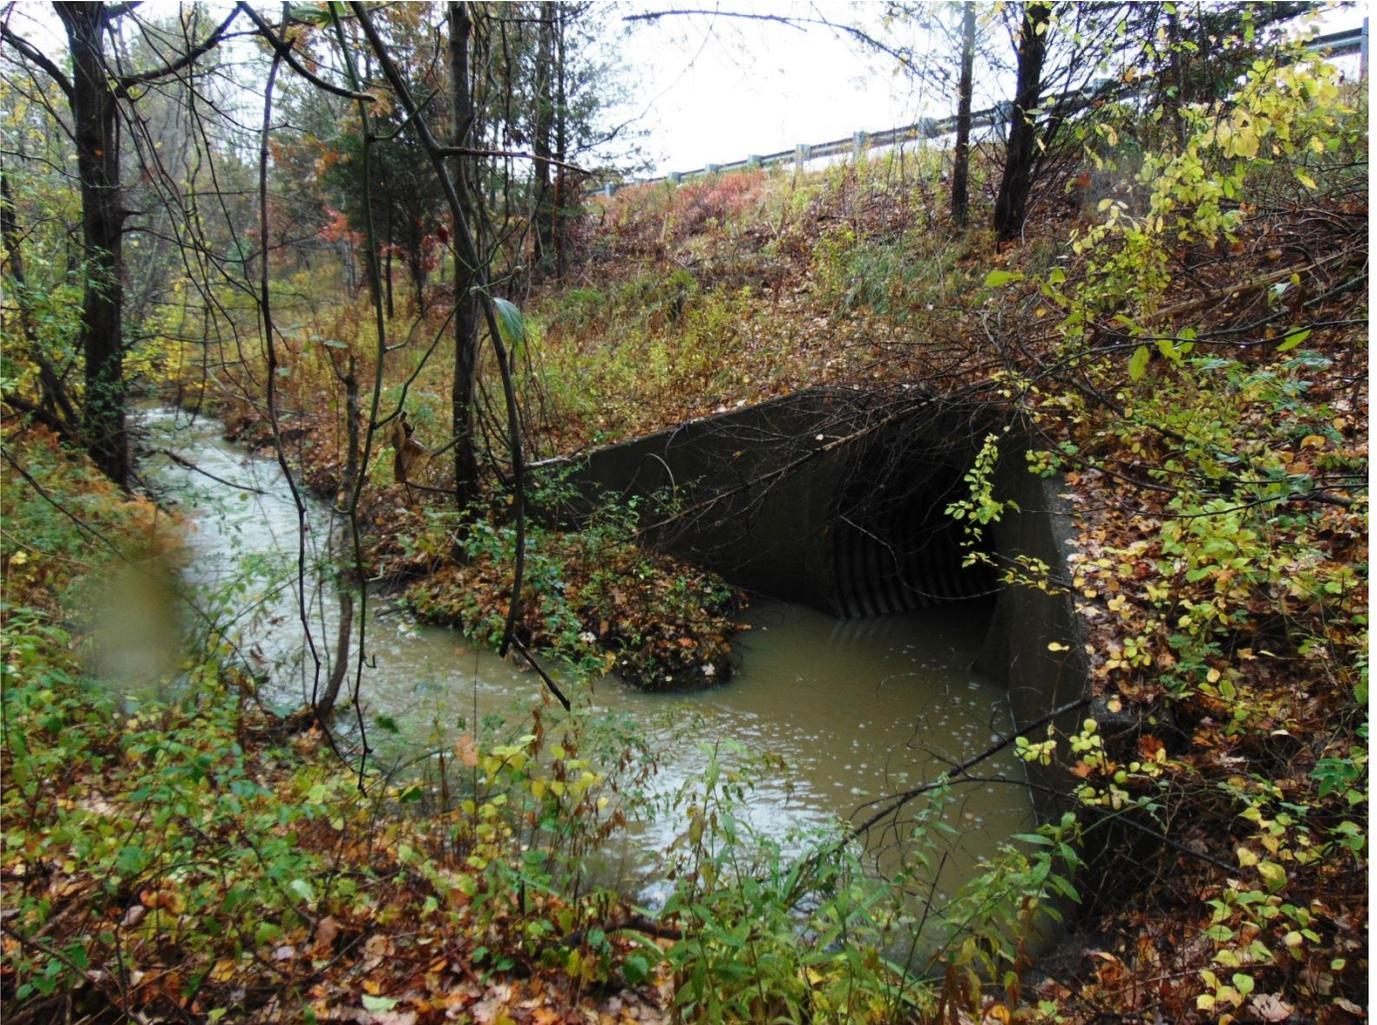
#12 – Standing southwesterly of the culvert inlet under Route 150 and looking northerly at the culvert inlet headwall and upstream flow toward the culvert. Taken on 10-28-16

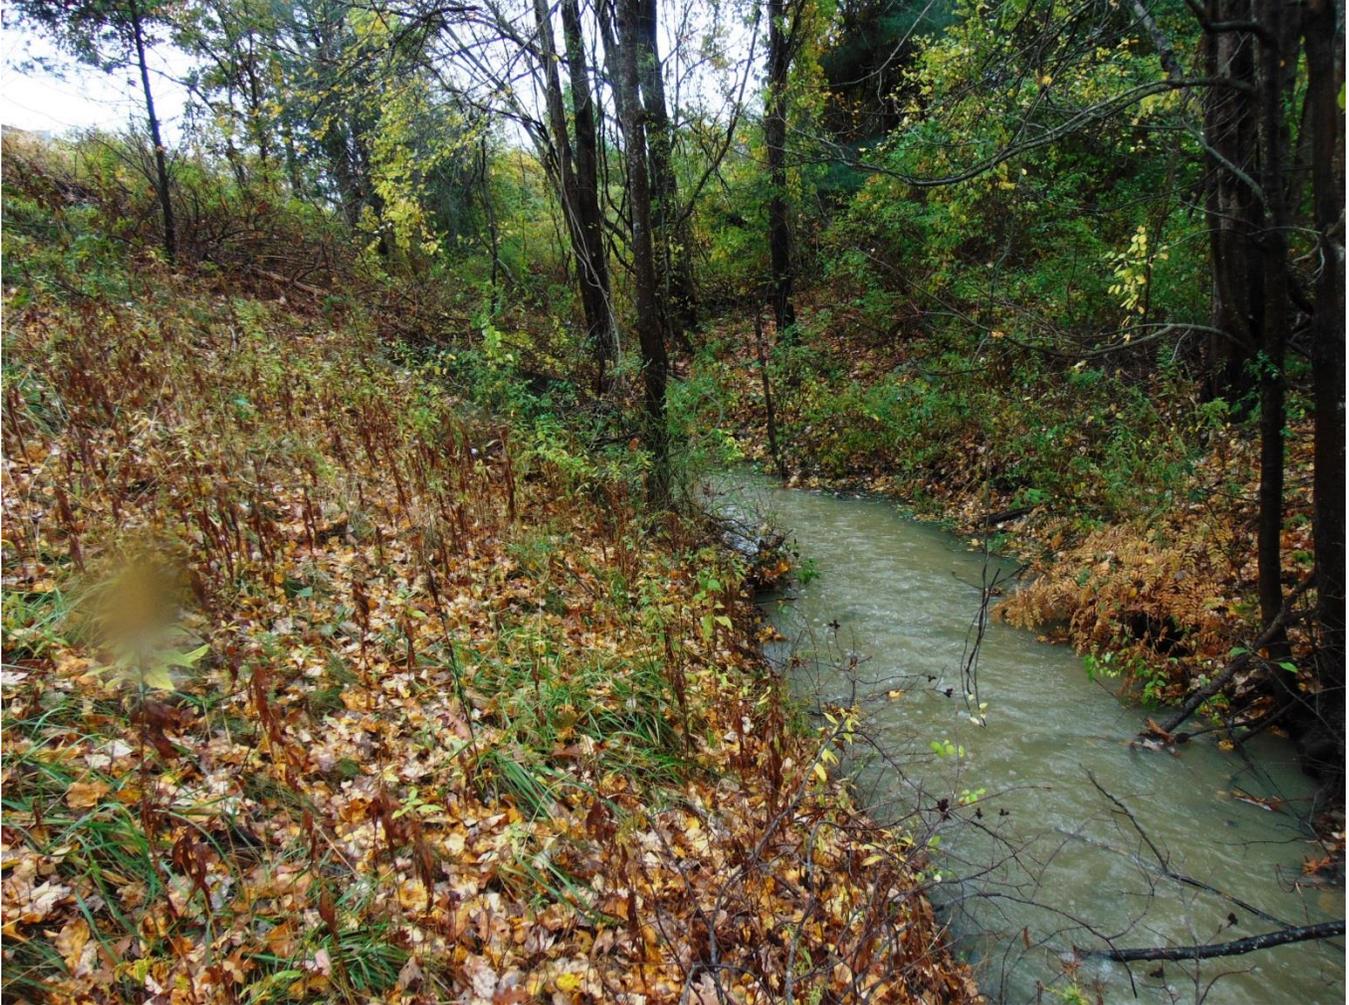
#13 – Standing along the toe of slope on the westerly side of Route 150 at a point upstream of the culvert crossing under Route 150 and looking downstream towards the Route 150 culvert. Taken on 10-28-16

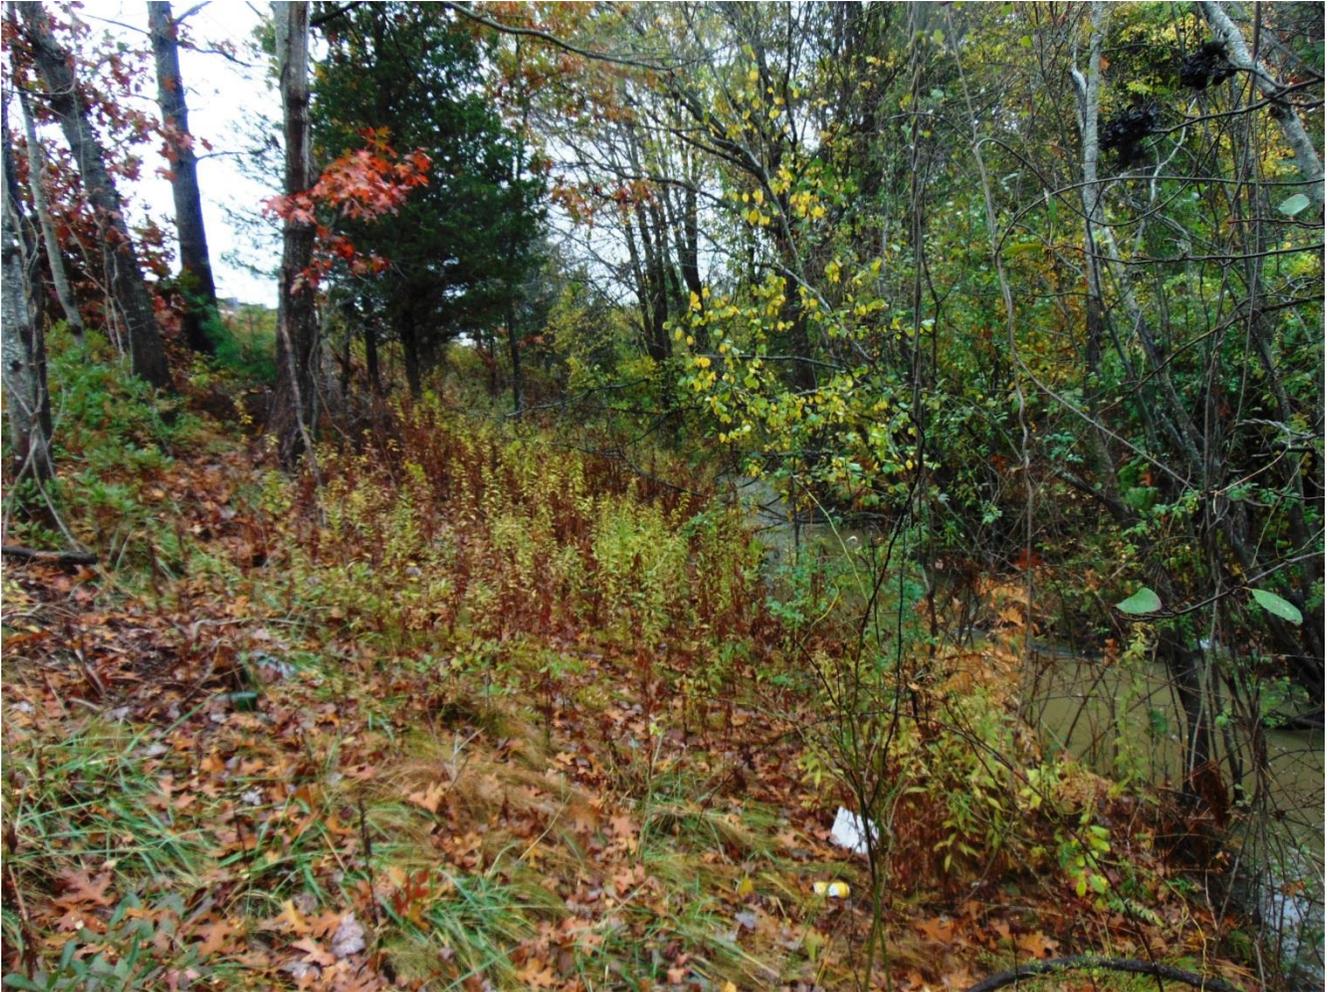
#14– Standing near the toe of slope on the westerly side of Route 150 and upstream of picture 13 and looking downstream toward the Route 150 culvert. Taken on 10-28-16

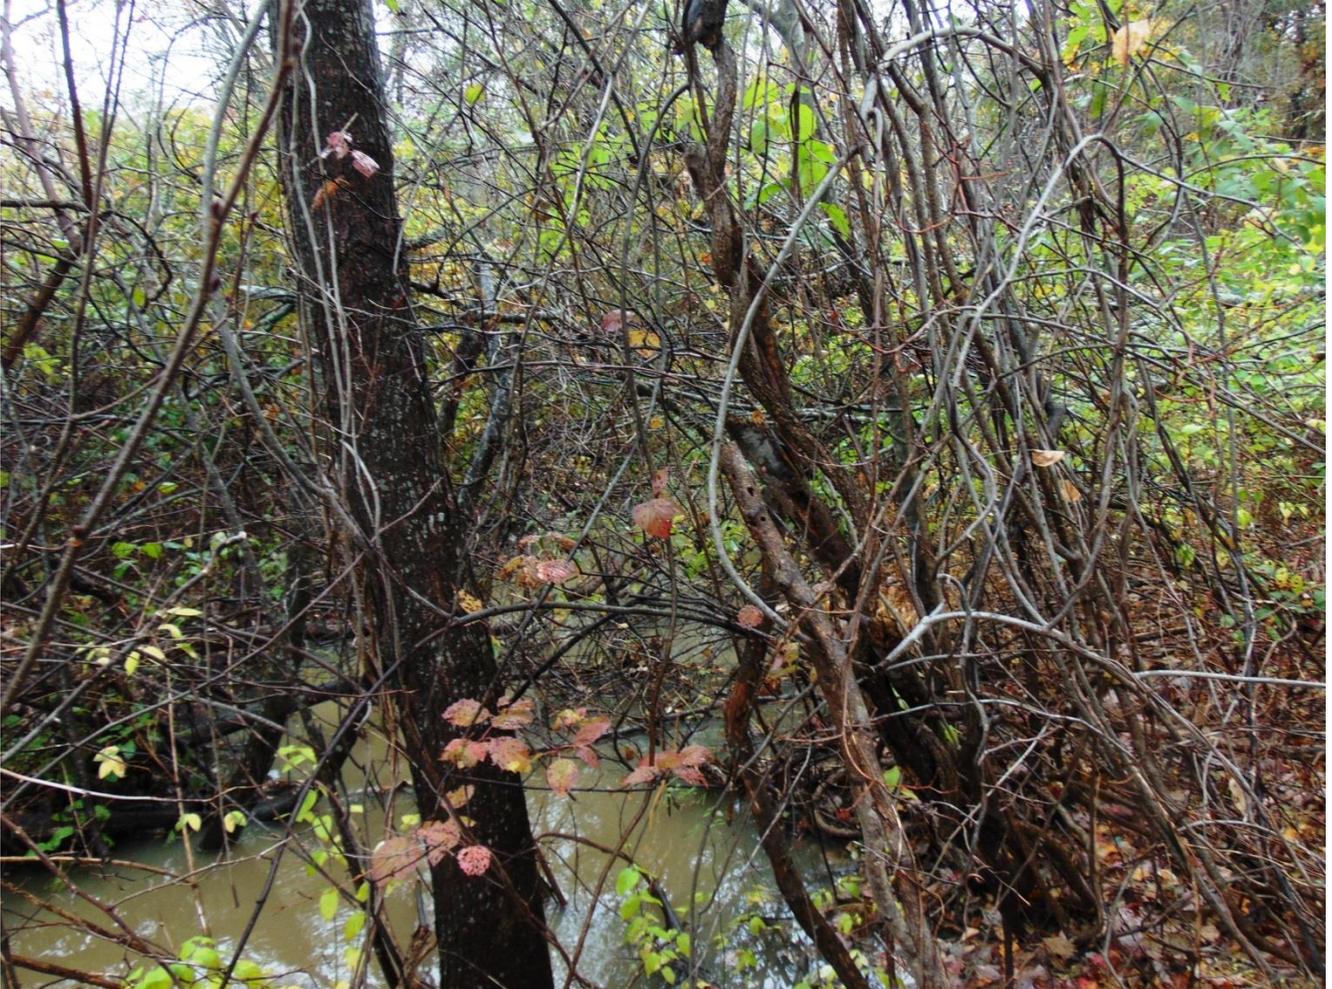
#15 – Standing along the toe of slope on the westerly side of Route 150 at the angle point of the stream channel and looking westerly and upstream along the valley towards the Amesbury Heights project.
Taken on 10-28-16
