**Reference: Assessment of Stormwater Discharges on October 28, 2016
Amesbury Heights Project
36 Haverhill Road, Amesbury, MA**

Observations of Stormwater Discharges on October 28, 2016
Relative to Amesbury Heights Project
36 Haverhill Road, Amesbury, MA

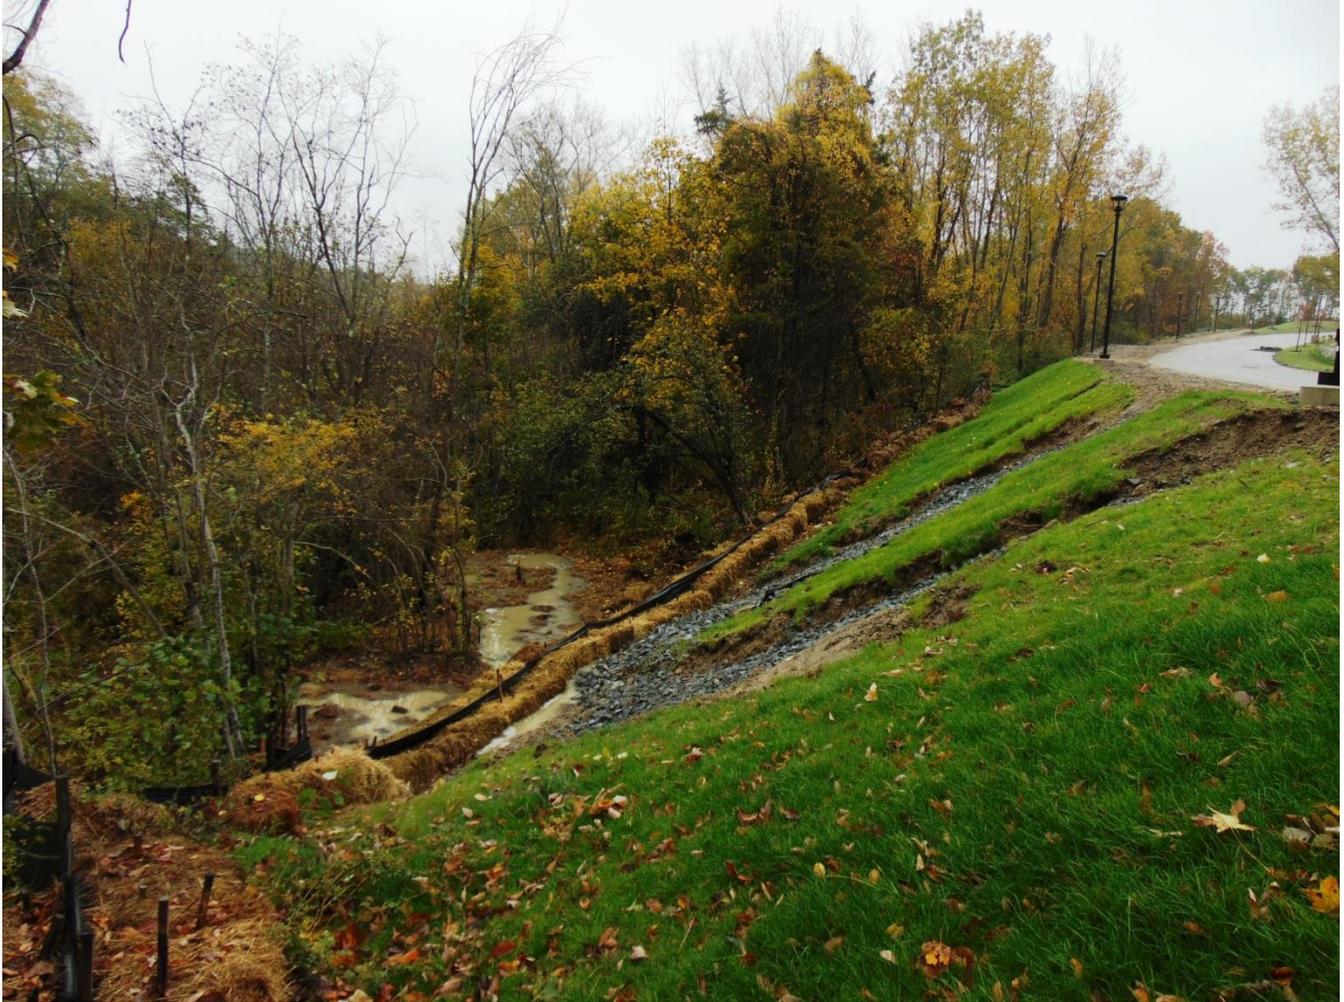
Stantec visited the Amesbury Heights project site and observed two separate locations where sediment laden flows from site culverts were discharging into the wetlands and associated stream located on the abutting property as indicated in photos 16-19.

#16 – Standing along the slope of the easterly side of the Amesbury Heights access driveway and looking easterly and downstream along the valley towards Photo 15 above. Sediment laden runoff discharging from the Amesbury Heights site was observed flowing beyond the erosion control measures towards the wetlands and stream channel located on the abutting property. Taken on 10-28-16.

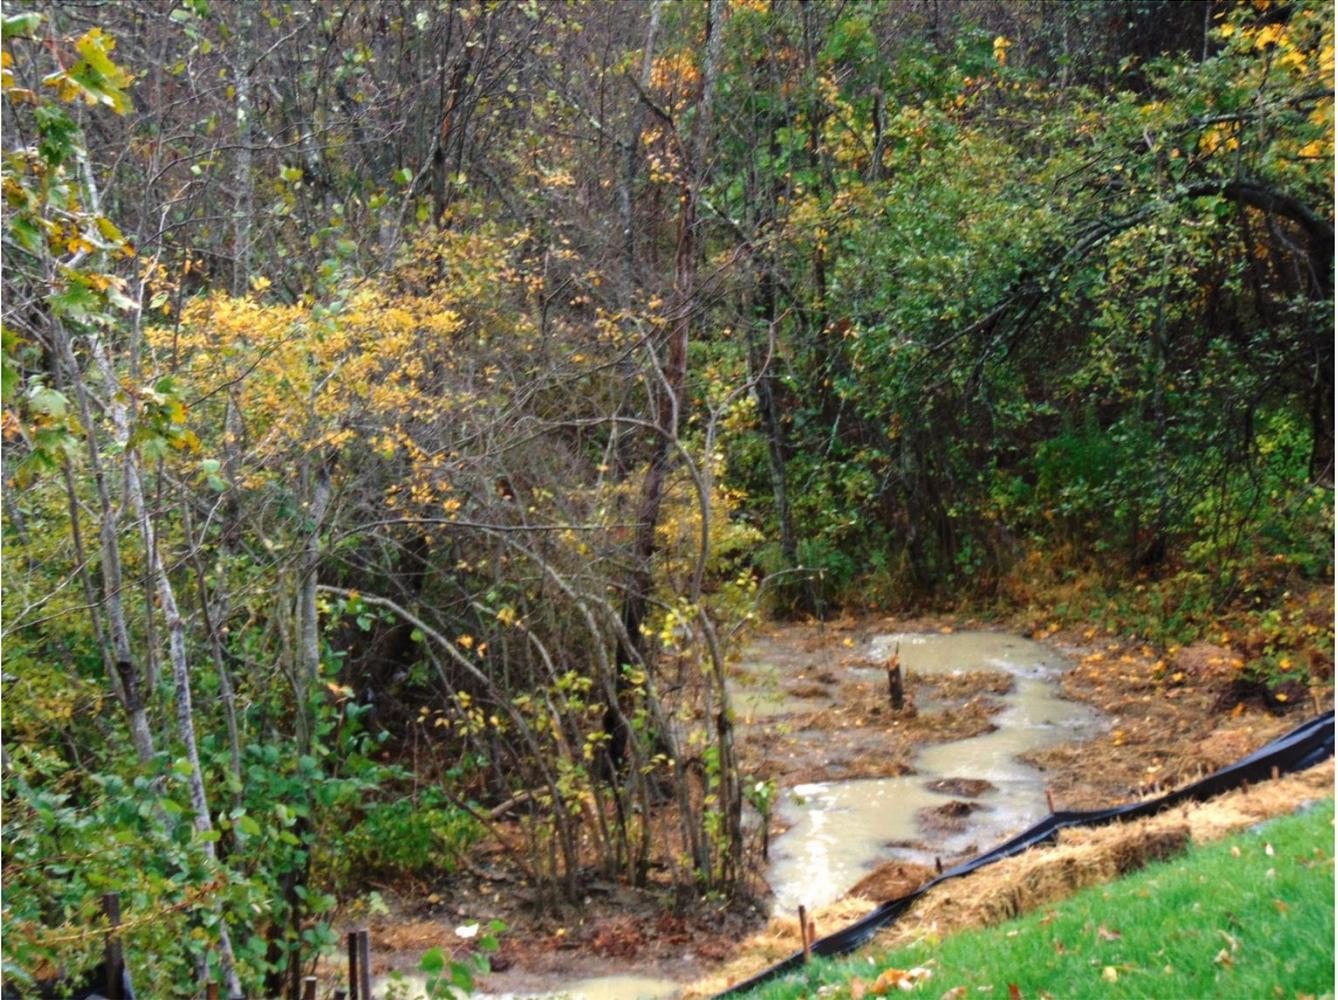
#17 – A closeup view of the observed sediment laden runoff from the Amesbury Heights site at the same location and same view direction as photo 16 above. Taken on 10-28-16.

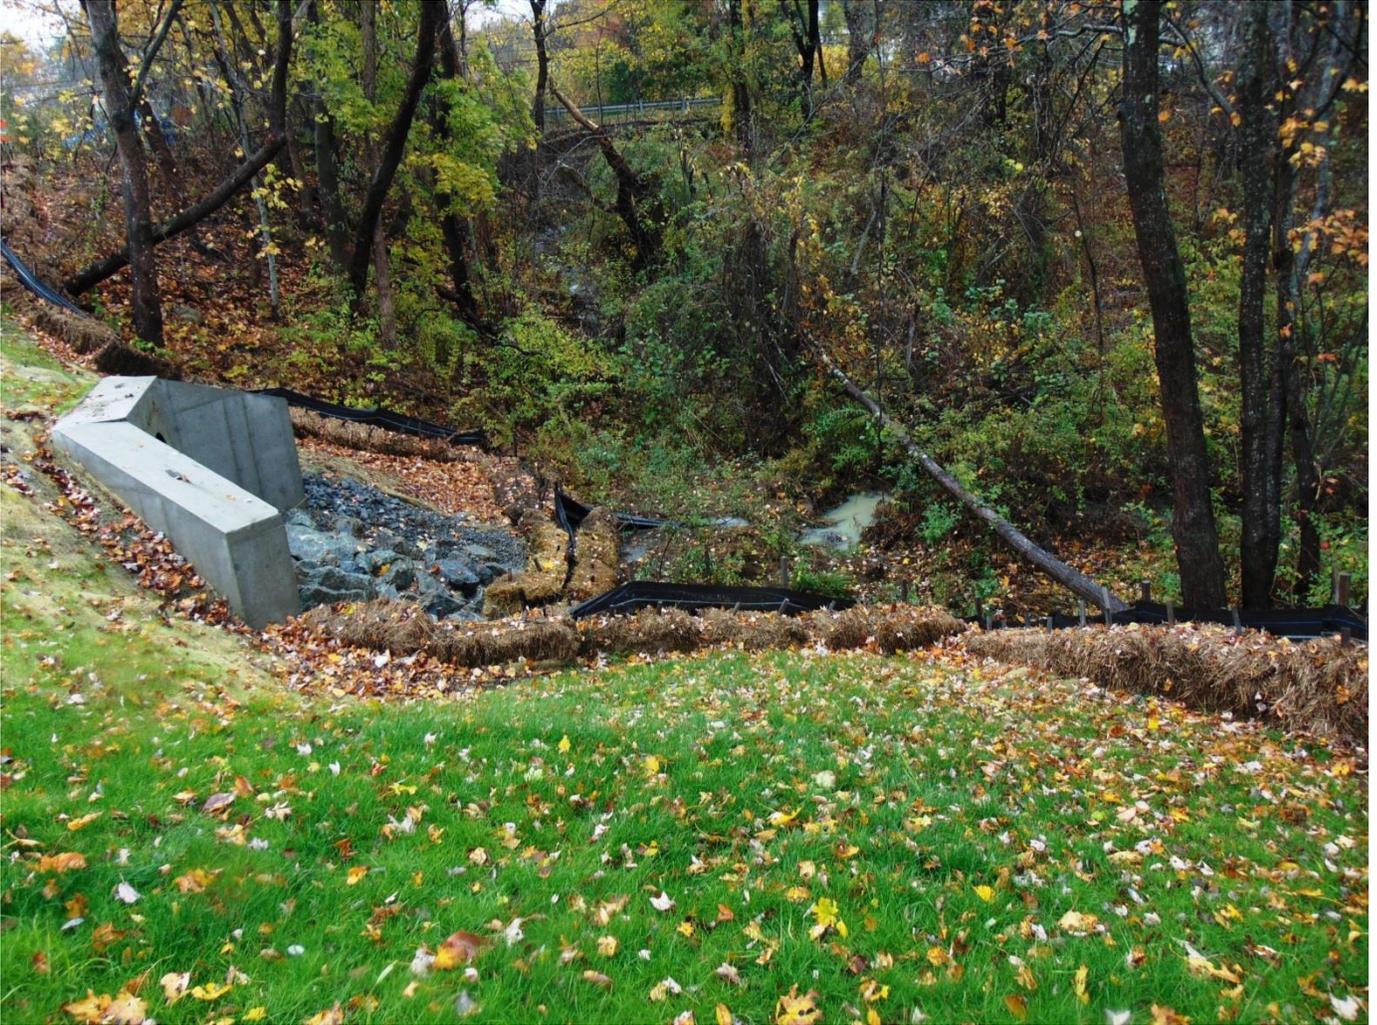
#18 – Standing near the top of slope on the easterly side of the Amesbury Heights access driveway and looking northerly towards Route 110. The guardrail along Route 110 can be seen near the top of the photo. Sediment laden runoff from the Amesbury Heights site is observed to be flowing beyond the erosion control measures toward the wetlands and stream located on the abutting property.

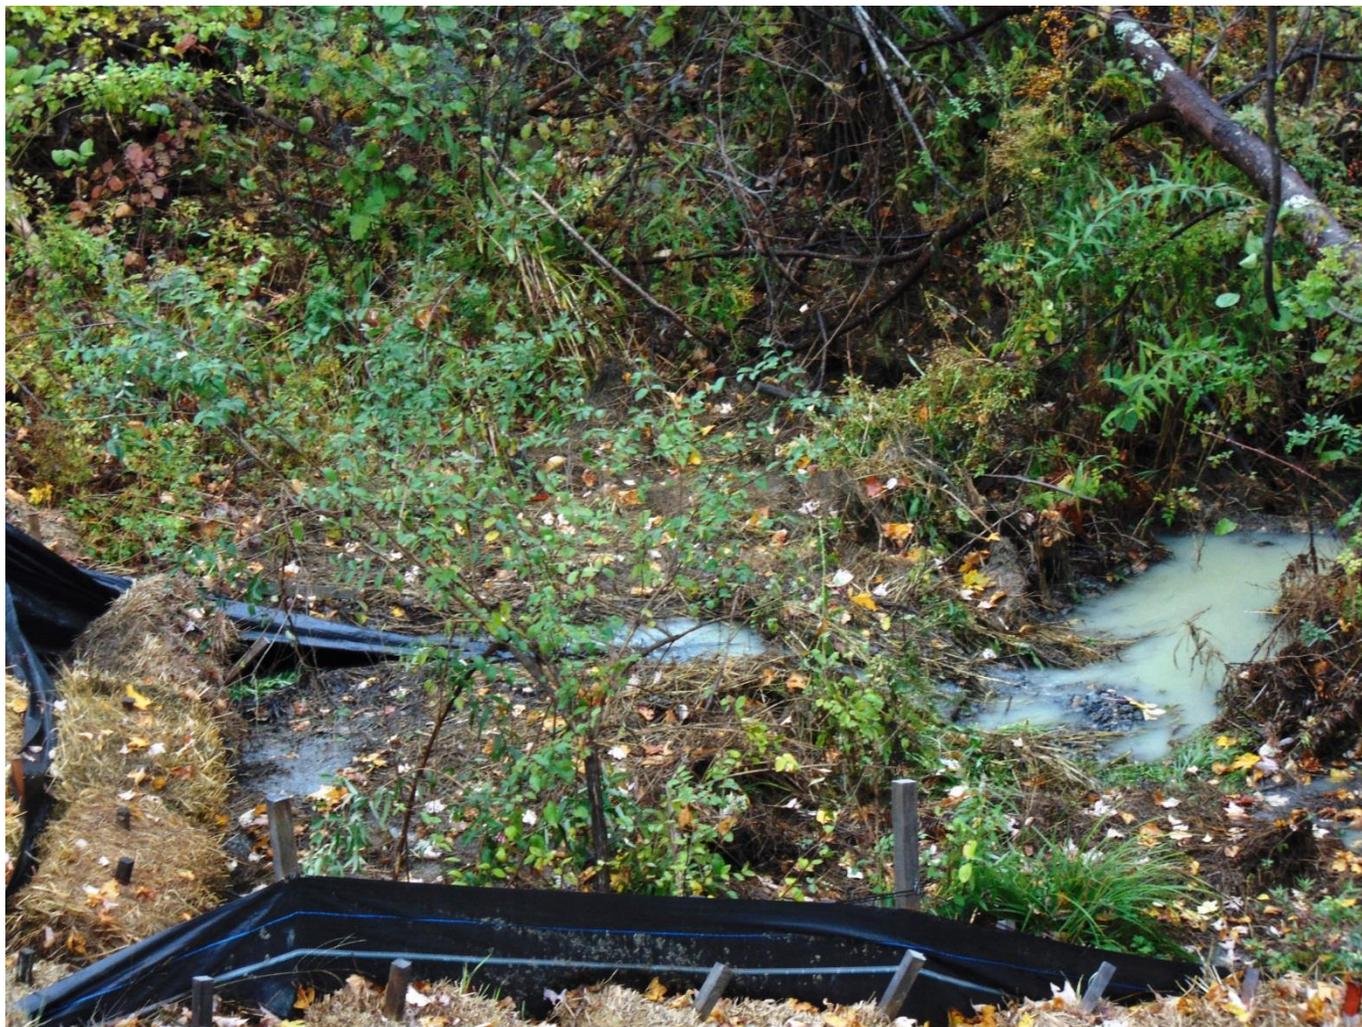
#19 – Standing near the southerly headwall shown in Photo 18 above and looking easterly. This is a closeup photo showing the observed sediment laden site discharge flowing beyond the erosion control measures and into the wetlands and stream channel located beyond the black silt fence. Taken on 10-28-16.

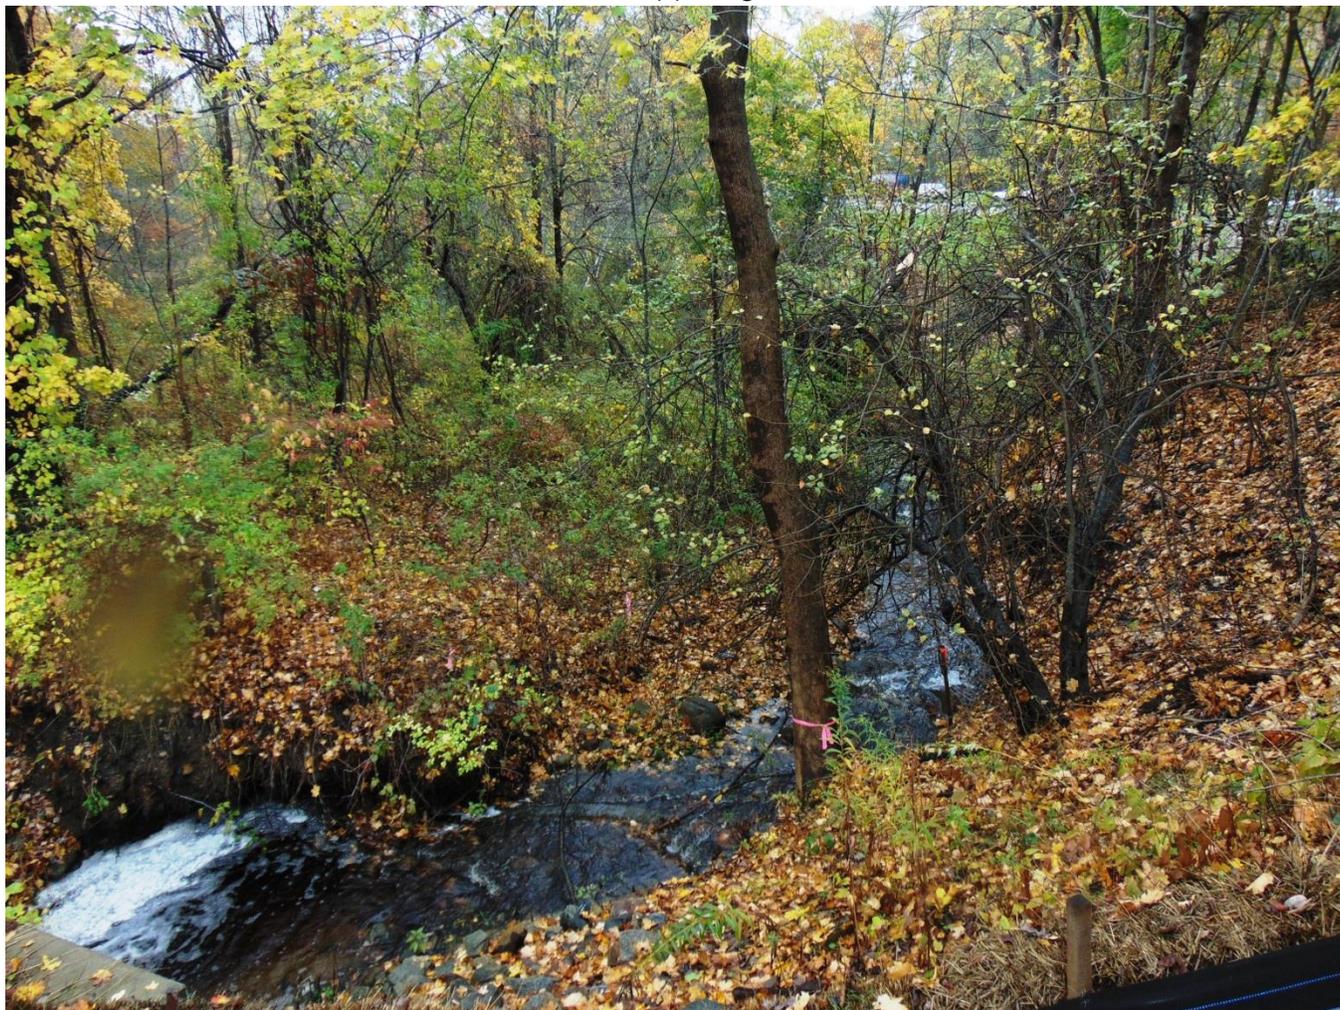
Stantec also visited the stream flowing under Route 110 that is located upstream of the Amesbury Heights project as indicated in photos 20-21. This stream flows adjacent to the Amesbury Heights project towards Route 150 and eventually to Bailey's Pond.

#20 – Standing along the top bank along Route 110 west of the culvert outlet - seen in the lower left corner - and looking downstream towards the Amesbury Heights site and photos 18 and 19 above. Clean water is observed discharging under Route 110. Cars parked along the Amesbury Heights access drive can be seen in the upper right. Taken on 10-28-16.

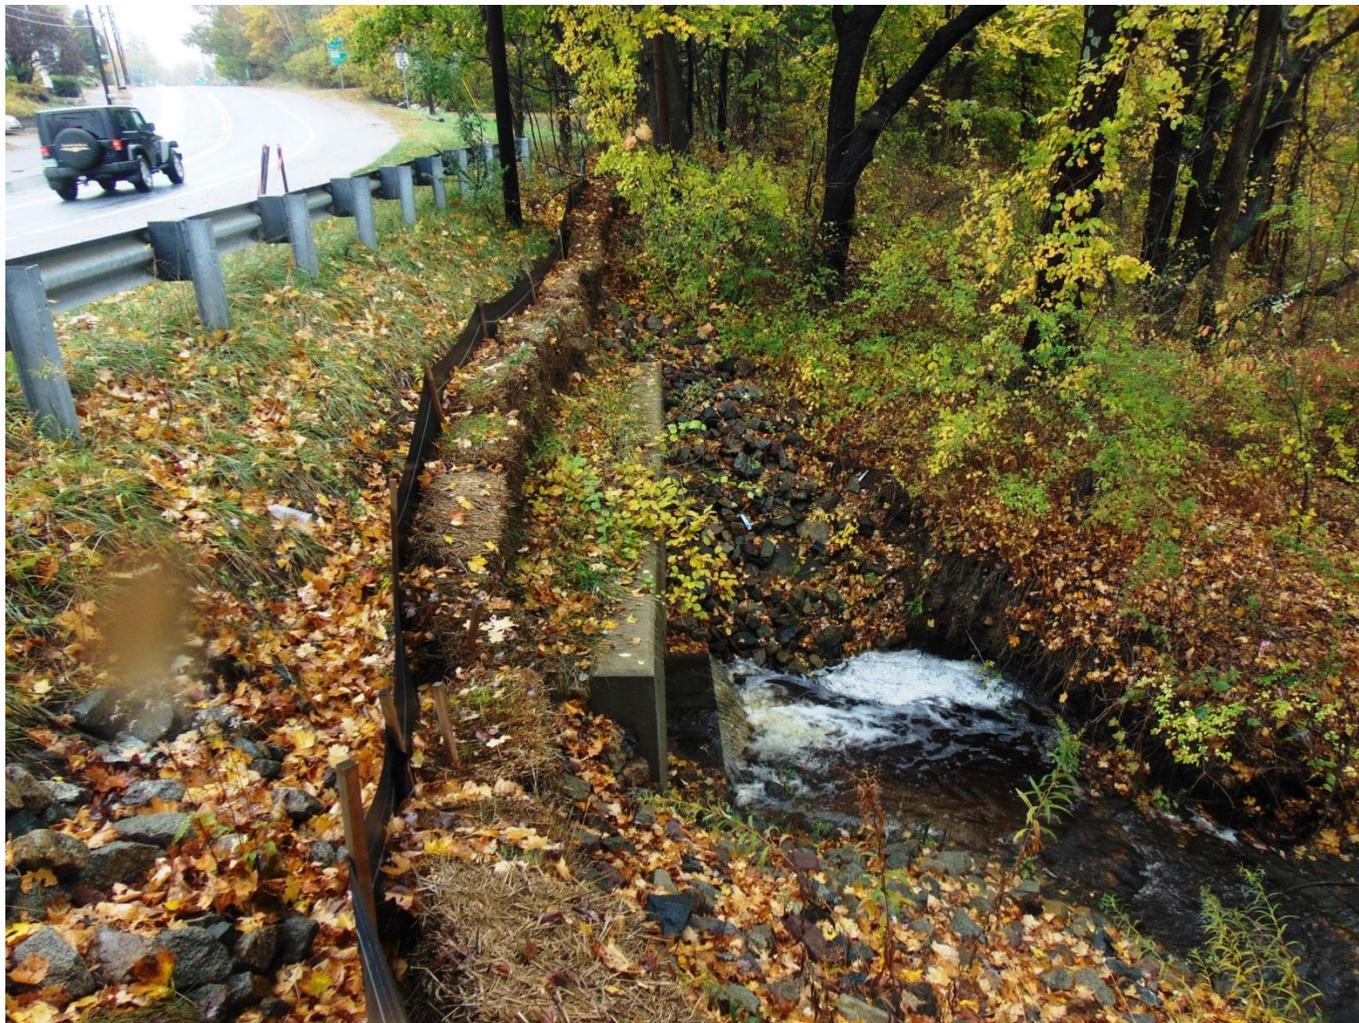
#21 – Standing behind the Route 110 guardrail and westerly of the culvert under Route 110 and looking easterly at the culvert outlet headwall. The culvert and observed clean stream water are upstream of the sediment laden flows shown in photos 16-19. Taken on 10-28-16.
