Massachusetts Department of Environmental Protection
 Bureau of Resource Protection - Wetlands
WPA Form 9 – Enforcement Order
 Massachusetts Wetlands Protection Act M.G.L. c. 131, §40

Amesbury
 Conservation Commission (Issuing Authority)

Issued 9.15.14; Amended 10.6.14;
Amended 3.2.15

This Amended enforcement order authorizes the implementation of the approved restoration plan (Appendix) entitled "Wetlands Impact Assessment, Amesbury Land Associates, Inc. and Event Partners, LLC," and dated December 5, 2014. See Attachment to Enforcement Order for additional information relative to a mandated timeline.

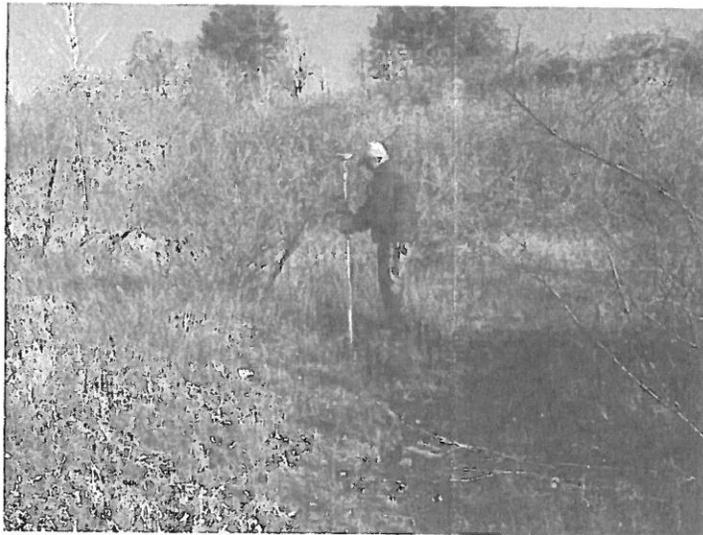
This property is located at the eastern portion of the trail, southeast of the Amesbury Sports Park. The property appears to be a former sand and gravel mining area with mostly early successional growth, especially non-native autumn olive, crabapple and shrub willows. Flags A1-A5 and A6-A10 delineate a section of trail that passes through wetland and buffer zone. Two intermittent stream channels converge near flag A1 and this combined channel flows south within the trail where it then begins to pond in a low area near flags A6-A10. There is some erosion within the trail, but little or no siltation of adjacent wetlands. It is difficult to determine if this is due to race activities or if this was a previously existing condition.

Photo 1 – Near flag A1, confluence of 2 intermittent streams

Recommendations for Margaret Rice Park: No restoration is recommended for the Margaret Rice Park area. Any damage to vegetation appears to have been temporary and the area is likely to be fully restored on its own within one more growing season and the elimination of heavy use from past racing activities. The City should consider measures to eliminate access to the site by ATVs to provide further protection to the trail and adjacent wetlands.

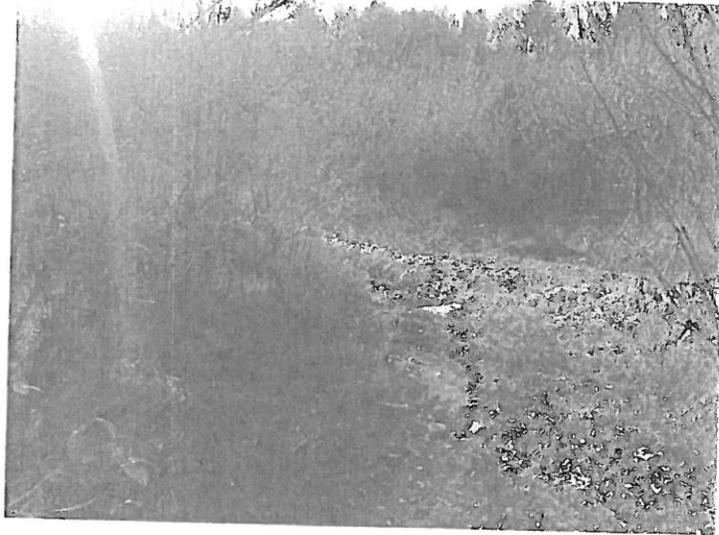
Photo 2: Stream flowing in trail toward wetland at flag A6

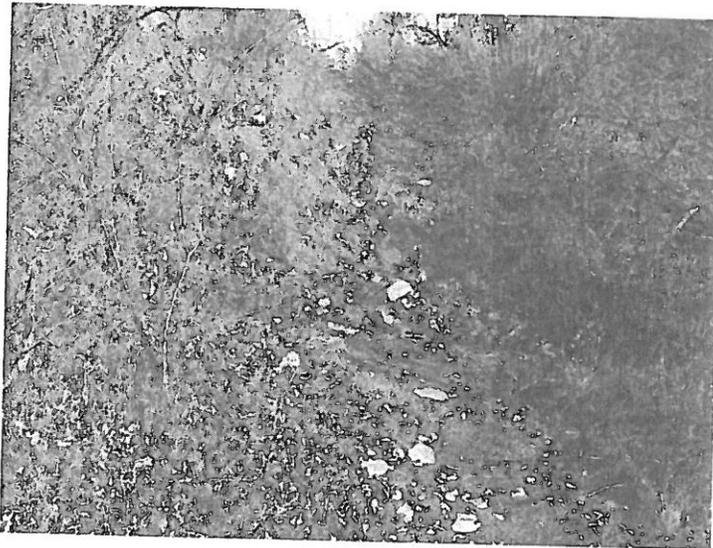
There is a second area where the trail (shown in Photo 3 below) crosses a stream channel in this property at flags B1-B2, and B3-B4. This is a small swale that likely also conveys intermittent flow. It is not more than 2-3-feet wide. There does not appear to have been significant impact in this area.

Photo 3: Swale/Intermittent stream crossing trail at flags B1-B4

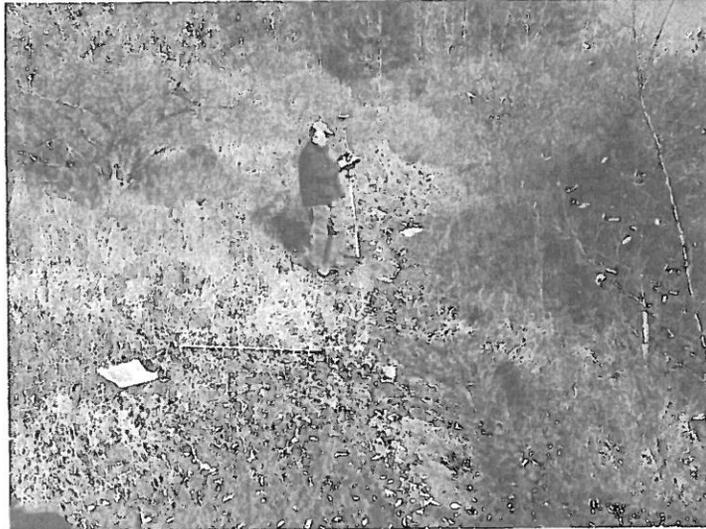
This property is located west of Margaret Rice Park. An approximately 250 foot section of the easternmost portion of the trail contains some gully erosion where runoff is channeled east toward the A-series wetland described above.

Photo 4: Near property boundary between Margaret Rice Park and Goodwin's Creek Homeowner's Trust

Recommendations for Goodwin's Creek Homeowner's Trust: No restoration is recommended for the Goodwin's Creek Homeowners Trust parcel. Any damage to vegetation appears to have been temporary and the area is likely to be fully restored on its own within one more growing season and the elimination of heavy use from past racing activities. The homeowner's trust should consider measures to eliminate access to the site by ATVs to provide further protection to the trail and adjacent wetlands.

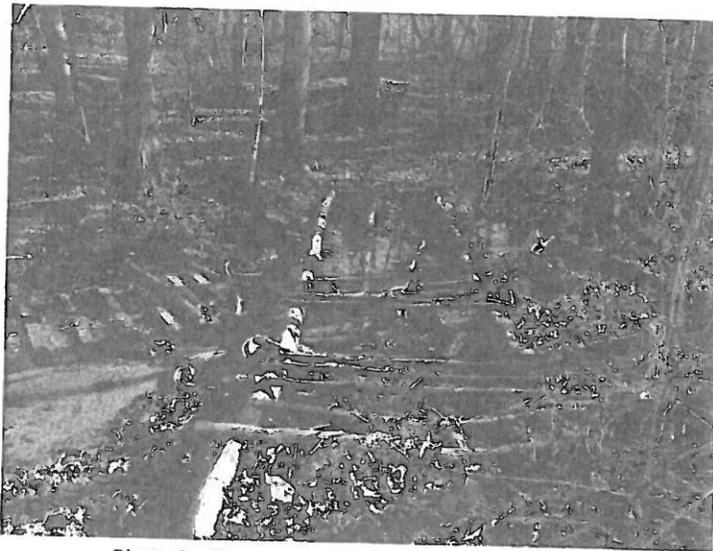
In addition to the pits there is a stream crossing at the western end of the trail near the border with the Merrimac Landing Conservation Area, delineated by flags C1-C2 and C3-C5. This stream contained remnants of a wooden footbridge supported by tires, a wooden pallet and other debris. Approximately 25 feet of the trail at the steep decline approaching the west bank contains some gully erosion. Approximately 20 feet from the east bank the trail has been widened by ATV use and probably pedestrian use. REC estimated that there were 460 square feet of impact to Bordering Vegetated Wetland (BVW) at this location and 32 linear feet of intermittent stream bank.

Photo 5: Stream crossing near flag C1, view east

- Installation of straw wattle erosion control barrier on both sides of the stream crossing as a temporary erosion control measure
- Minor re-grading of the wetland and buffer zone within 50 feet of the east side of the stream using a small track machine to minimize further rutting of the trail.
- Removal of the remains of the bridge, pallets, tires and any other debris within the stream bed by hand.
- Re-grading and installation of 1-inch gravel fill to repair gully erosion on the slope approaching the west bank. No fill is to be placed in wetlands.
- Install approximately 4 highbush blueberry (*Vaccinium corymbosum*) and 4 Northern arrow-wood (*Viburnum recognitum*) to re-establish minimum trail width of 5 feet in the wetland area on the east side of the stream.
- Overseeding with New England Wetmix any disturbed soil areas on the bank or wetland.

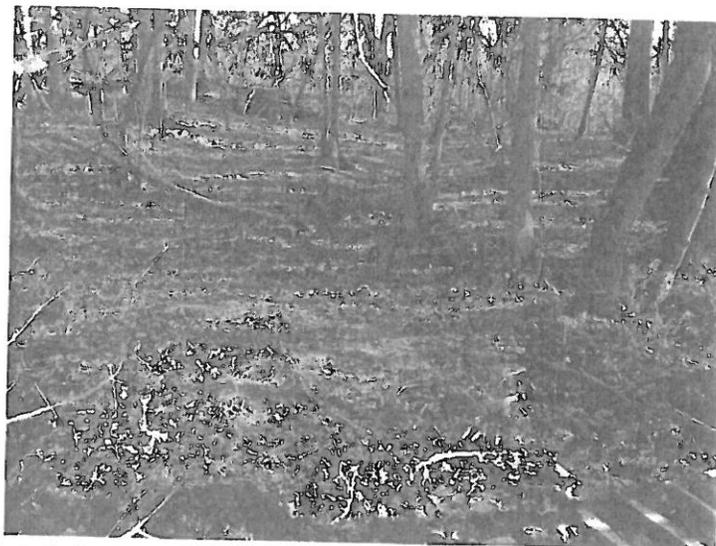
Photo 6: Trail erosion and trail widening beyond stream crossing, view east

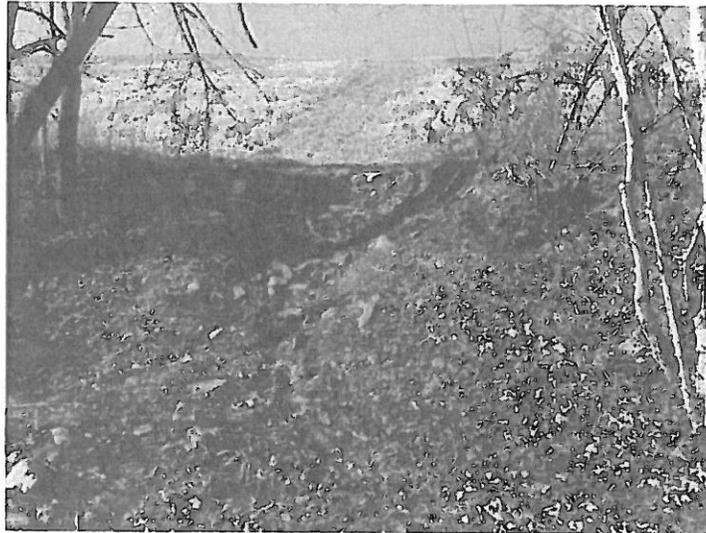
Photo 7: Gully erosion on the trail leading to stream, view west

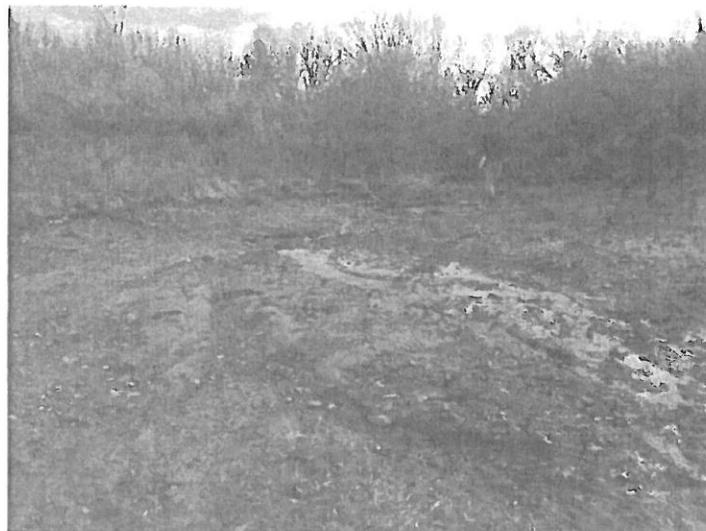
The area on the Waste Management site that was used for the tire pull by the Spartan Race is relatively flat, open cleared area mostly devoid of vegetation. Soil has been bermed up along much of the southern edge of this clearing. The clearing is more than 100 feet from wetland resources. However, stormwater runoff from the drainage area upgradient of the clearing which includes the grassy hillside to the east (Spartan stations 14-18) is directed along existing gravel roads to a single point in the northeast corner of the clearing. There is some erosion here that has created a small channel which flows out of the clearing and down the steep hillside to the south. By the time this flow reaches the Merrimack Landing Conservation Area the channel has excised a very steep gully (see Merrimack Landing photos in the following section 4(h)).

Photo 8: Cleared area showing discharge to the south

Restoration of the on-going erosion within the clearing area is recommended as follows:

- Install erosion controls consisting of straw wattles across the discharge location.
- Extend a portion of the existing berm on the southern side of the cleared area across the discharge location to direct flow away from the gully.
- Re-grade approximately 200 feet of the gravel road upgradient of the cleared area to minimize rutting and channelization of flow.
- Remove the remaining portions of the berm on the south side of the clearing and replace this material within the clearing, grading to prevent discharge to the gully.
- Overseed clearing with a conservation seed mix to improve vegetative cover and soil retention.

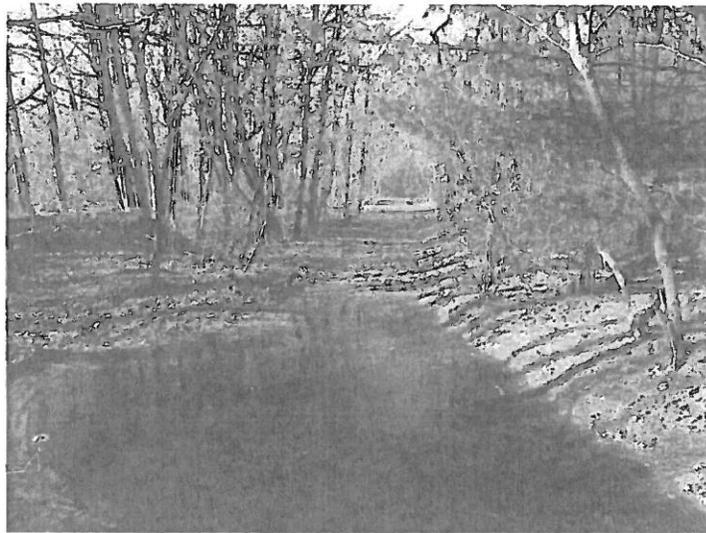
- a) Flags D1-D3 and D4-D6 delineate an approximately 90 foot long mucky section of trail that appears to have been slightly widened at some point recently. There were a few cuts of shrubs and small saplings noted on the edges of the trail. There was some ponding in the eastern portion near D5-D6 approximately 6-inches deep. Some sand and silt was eroding along the trail near D1 where runoff from the steeper section of the trail to the west was beginning to settle out. Soil stockpiles nearby, shown on left of photo 9, suggest that this area had been excavated at one time.

Photo 9: Near flag D7

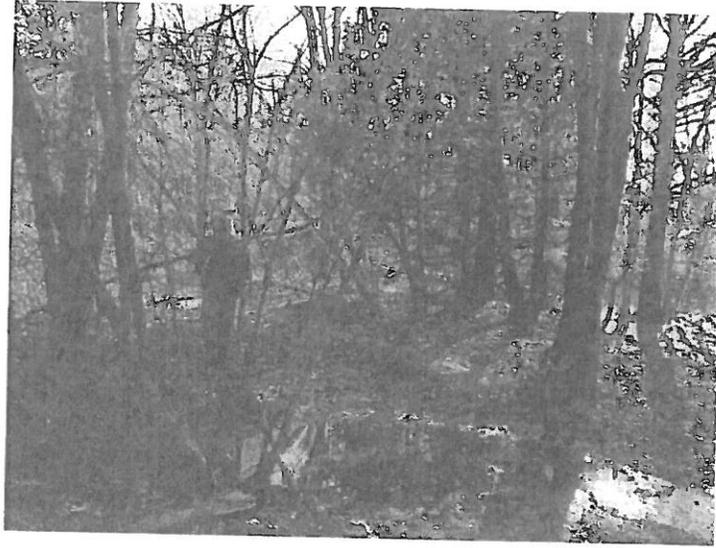
- b) Flags E1-E2 and E3-E5 delineate the banks of a narrow stream crossing. The stream makes a bend at this location and the banks have been disturbed to allow for passage by ATV use and pedestrian use. A small cut in the south bank has been made to make a more gradual slope. The material excavated appears to be stockpiled close to the bank.

Photo 10: Stream crossing at E4, view south

- 4b) Repair/rebuild the north and south banks of area E using staked coir logs and backfill on the upland side to restored grades using existing soil stockpiled nearby in the buffer zone. Install 4 highbush blueberry (*Vaccinium corymbosum*) on south bank to re-establish maximum 5-foot trail width.

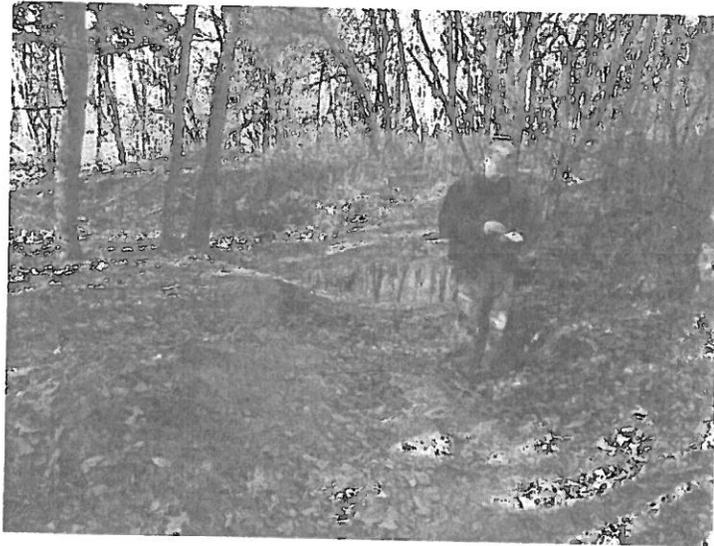
**Photo 11: Stream Crossing above cut to south bank (view north)
Stockpiled material on left of photo**

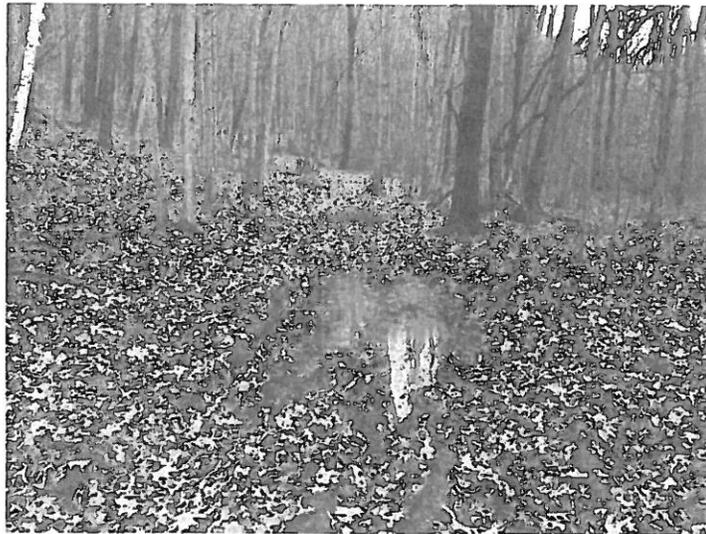
- c) **Flags 1-8 delineate an approximately 200 foot section of trail that passes through wetland and buffer zone. The portion of trail that passes through flags 1-5 is part of the wetland and is muddy and contained vehicle ruts. The section that passes by flag 5-8 is in the buffer zone. This section of trail contained some gully erosion.**

Photo 12: muddy section of trail through wetland with vehicle tracks near flag 3

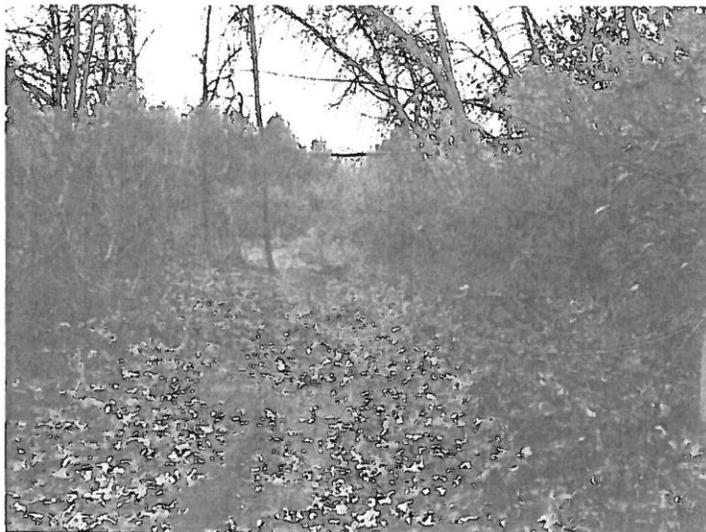
- d) An intermittent stream channel that exits the Waste Management site near the pits that were created flows downhill toward a trail intersection just west of flags 1-8 on Detail Sheet 5. This stream channel was flagged by LEC as part of its review of the Tough Mudders impacts. The 1-foot wide intermittent stream channel appears to have originally crossed over the trail just east of the trail intersection. With the trail ruts created by ATV and possibly some trail widening in this area it appears that the channel is now directed to the west along the trail instead of into its original channel across the trail.

Photo13: Intermittent stream channel re-directed to side of trail

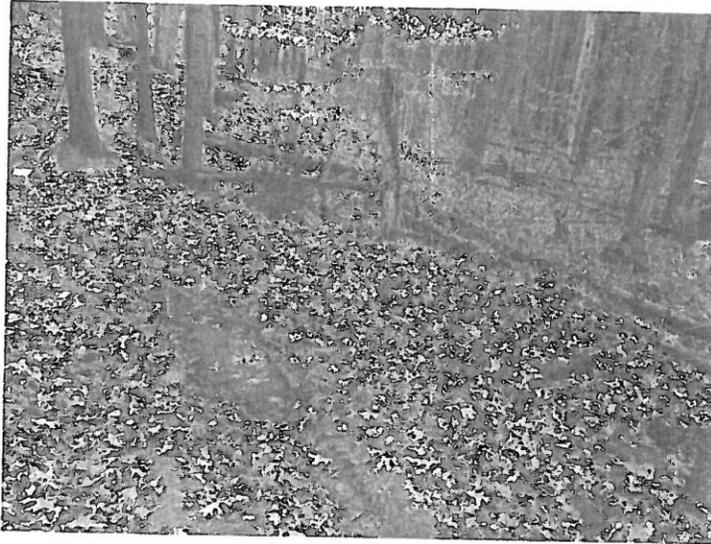
- e) Flags 9-11 and 12-15 on Detail Sheet 4 delineate an approximately 200 foot section of trail along the base of the hill that follows along the upslope side of a wooded swamp. A small section of approximately 70 feet intersects the wetland. Again, vehicle ruts were noted here but no other impacts were observed.

Photo 14: Near flag 9 Trail passes through buffer zone.

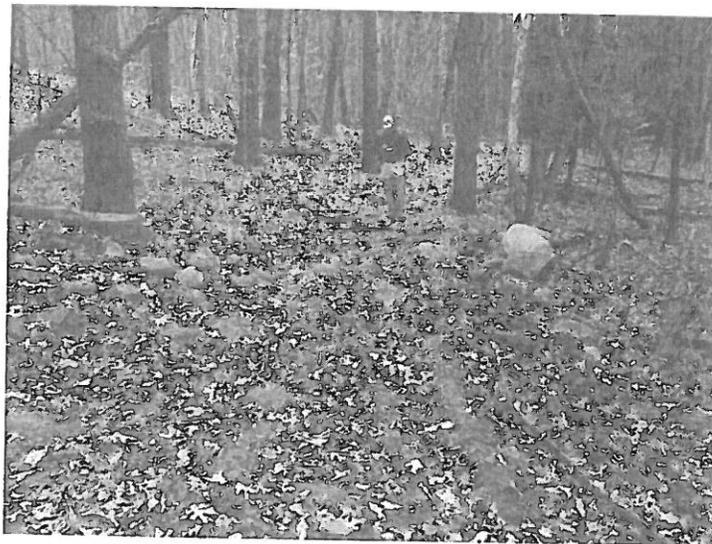
Photo 15: rutted trail near flag 12 where trail passes through wetland

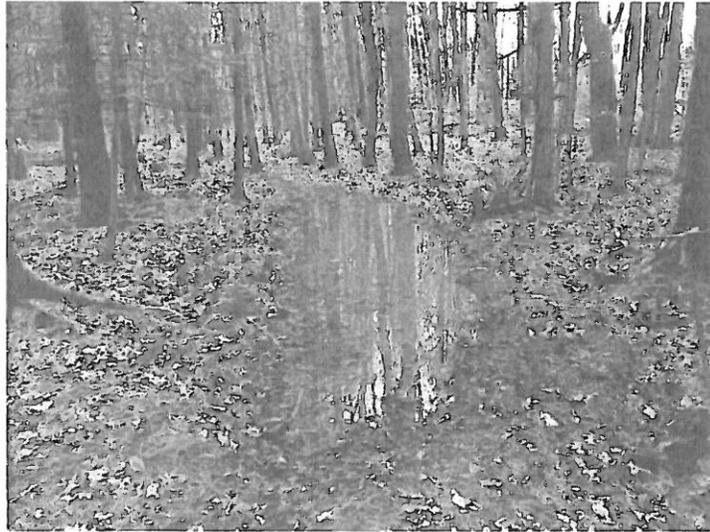
- f) Again, the trail passes through a muddy section of mostly buffer zone at flags 16-19 (see Detail Sheet 4). This is an approximately 50 foot section of trail with a large puddle and several muddy sections, but with only 20 feet or so within wetland. The area is relatively flag and despite some rutting, no sedimentation of adjacent wetlands was observed.

Photo 16: Near flag 17

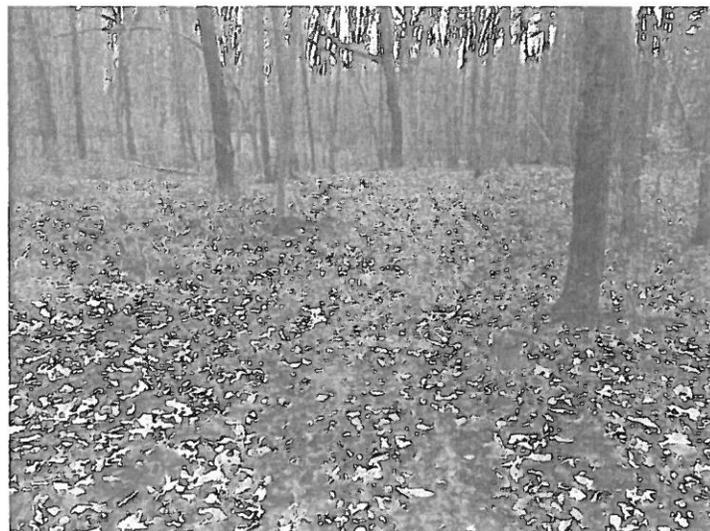
- g) Flags 20-24 and 25-27 on Detail Sheet 3 delineate the location of a swale/intermittent stream channel crossing the trail conveying flow to the east. There is wooded wetland on both sides of the trail at this location. Again only vehicle ruts were noted and no other direct wetland impacts were observed.

Photo17: Near flag 22

- 4g) No change proposed here.
- 4h) Since the erosion associated with the impacts to wetlands down gradient of this location appears to pre-date the activities addressed in the present Enforcement Order, REC is not recommending remediation of the sedimentation to wetlands that have occurred as a result of the extensive gully erosion. The Conservation Commission may wish to address the restoration of this wetland under a separate enforcement action. However, since the activities associated with the Spartan Race may have contributed to on-going erosion of the gully by maintaining the tire pull area in a non-vegetated condition that makes it more susceptible to erosion and they may be responsible for construction of the earthen berm along the south side of this cleared area, measures are recommended under Section 3 of this report under Waste Management Disposal Services of Massachusetts to minimize the conditions contributing to this on-going erosion.

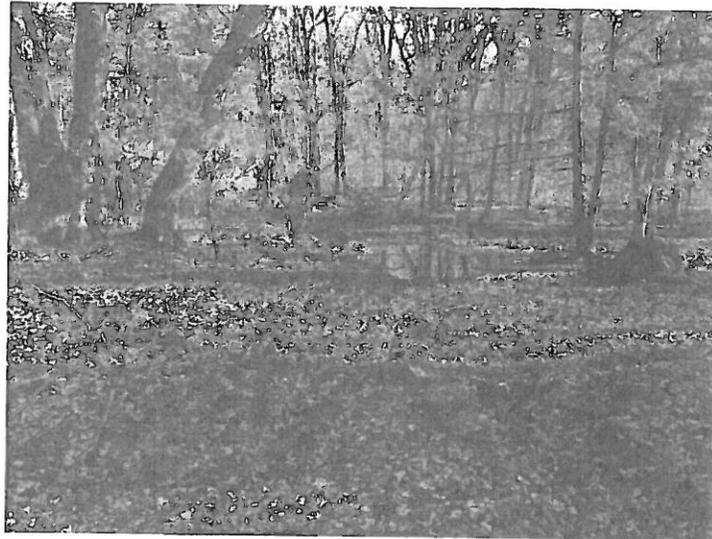
Starting approximately 50 feet west of the northernmost portion of the Bartlett's Reach Condominium Trust property within the Merrimack Landing Conservation Area and extending approximately 300 feet into the Bartlett's Reach property is a large wooded swamp. This swamp contains a stream that crosses the trail from northwest to southeast. Because the soils are very mucky in this area, there was considerable soil disturbance from the heavy foot traffic during the races that occurred through here, as evidenced by the numerous shoes and socks still strewn through the area. The trail has been significantly widened and it appears some understory has been cleared. The stream banks have been altered by trampling and there is a small earth dam across the channel that has caused re-routing of a portion of the channel. An approximately 20 x 20 foot pit has been constructed in the portion of the trail that includes the wetland. REC estimates approximately 4,900 square feet of Bordering Vegetated Wetland was impacted and 54 linear feet of intermittent stream bank.

Photo 20: Approach to stream crossing. Constructed pit in background

- This work is to be conducted as much as possible during winter months with frozen ground conditions or during summer low flow conditions.
- Install temporary erosion controls consisting of straw wattle along the east and west sides of the stream and across the downstream end of the stream channel.
- Temporarily divert flow away from the restoration area using a temporary coffer dam and pump to discharge downstream around the restoration area. The intake is to be

- Install and stake 12-inch coir fiber logs to restore damaged section of stream banks
- Backfill against the upgradient side of the fiber logs using existing soil material, including material taken from earthen dam within the stream bed.
- Replant disturbed area with the following plantings:

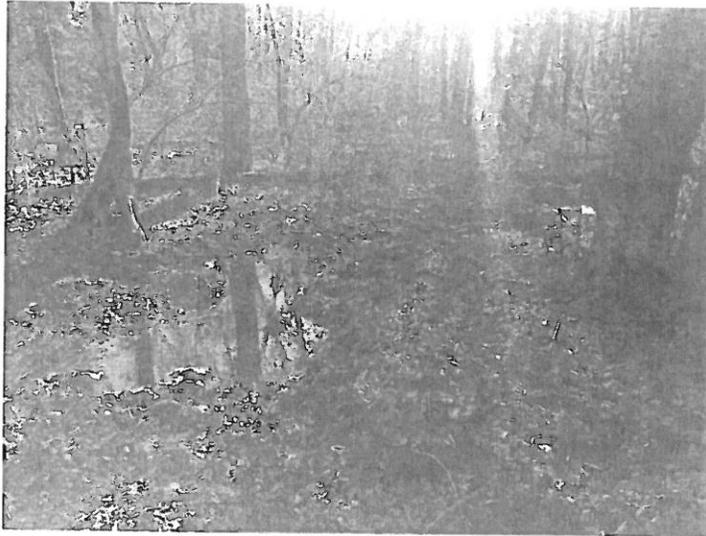
Photo21: Earthen dam across stream channel

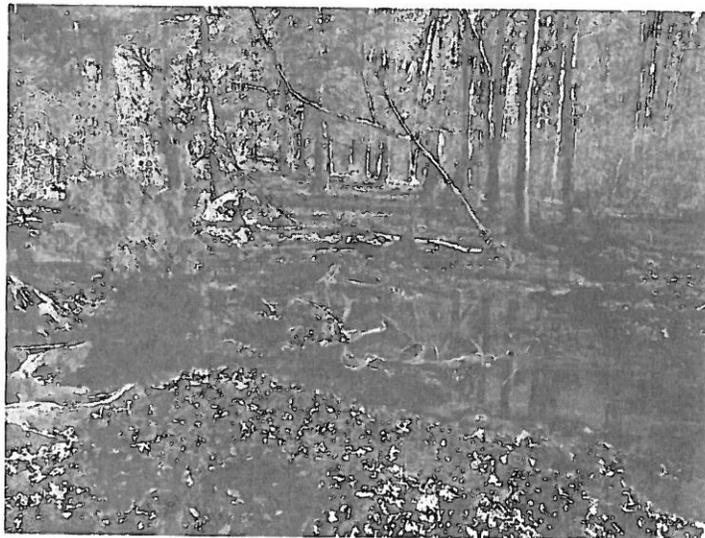
Photo 22: Disturbed stream channel

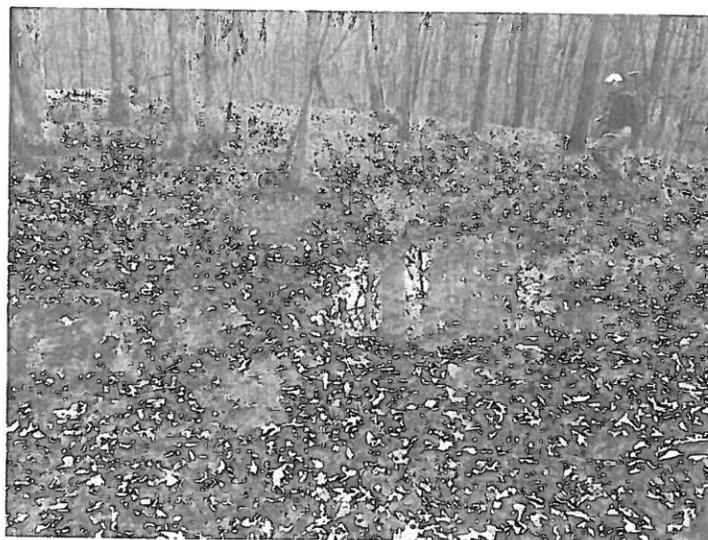
Flags 28-31 and 32-35 delineate another ponded area of trail with wetland on the north side and an intermittent channel on the south side. The trail has been constructed wider than necessary at this location in order to avoid a large puddle.

Photo 23: Flag 30, trail widened to avoid puddle

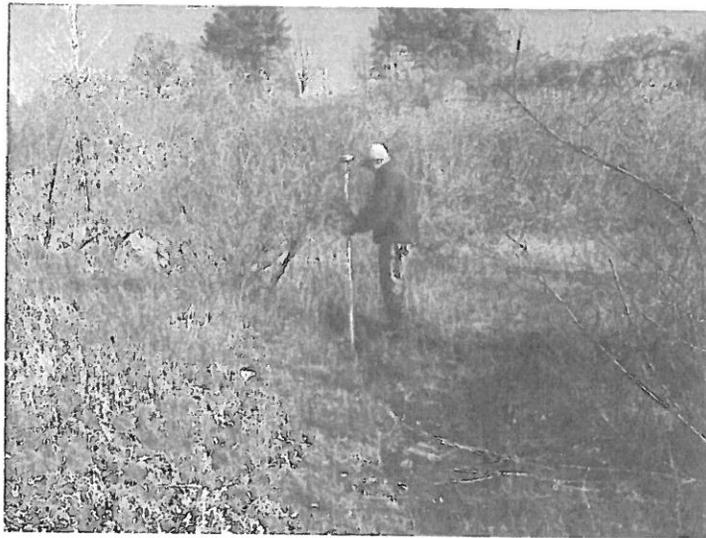
This property is located at the eastern portion of the trail, southeast of the Amesbury Sports Park. The property appears to be a former sand and gravel mining area with mostly early successional growth, especially non-native autumn olive, crabapple and shrub willows. Flags A1-A5 and A6-A10 delineate a section of trail that passes through wetland and buffer zone. Two intermittent stream channels converge near flag A1 and this combined channel flows south within the trail where it then begins to pond in a low area near flags A6-A10. There is some erosion within the trail, but little or no siltation of adjacent wetlands. It is difficult to determine if this is due to race activities or if this was a previously existing condition.

Photo 1 – Near flag A1, confluence of 2 intermittent streams

Recommendations for Margaret Rice Park: No restoration is recommended for the Margaret Rice Park area. Any damage to vegetation appears to have been temporary and the area is likely to be fully restored on its own within one more growing season and the elimination of heavy use from past racing activities. The City should consider measures to eliminate access to the site by ATVs to provide further protection to the trail and adjacent wetlands.

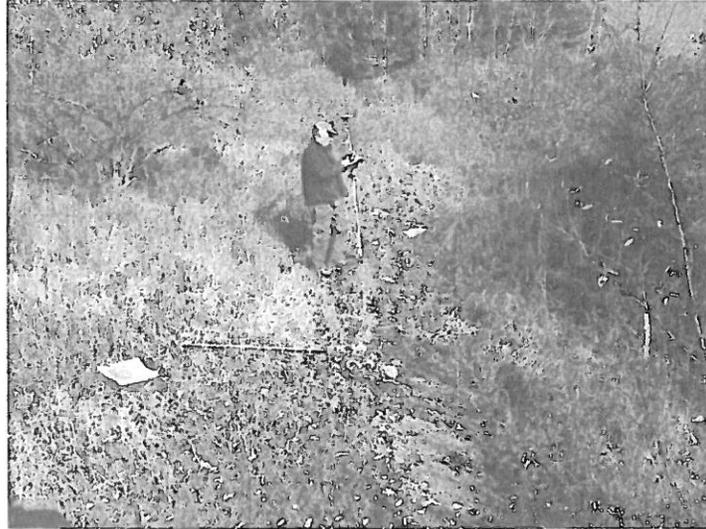
This property is located west of Margaret Rice Park. An approximately 250 foot section of the easternmost portion of the trail contains some gully erosion where runoff is channeled east toward the A-series wetland described above.

Photo 4: Near property boundary between Margaret Rice Park and Goodwin's Creek Homeowner's Trust

Recommendations for Goodwin's Creek Homeowner's Trust: No restoration is recommended for the Goodwin's Creek Homeowners Trust parcel. Any damage to vegetation appears to have been temporary and the area is likely to be fully restored on its own within one more growing season and the elimination of heavy use from past racing activities. The homeowner's trust should consider measures to eliminate access to the site by ATVs to provide further protection to the trail and adjacent wetlands.

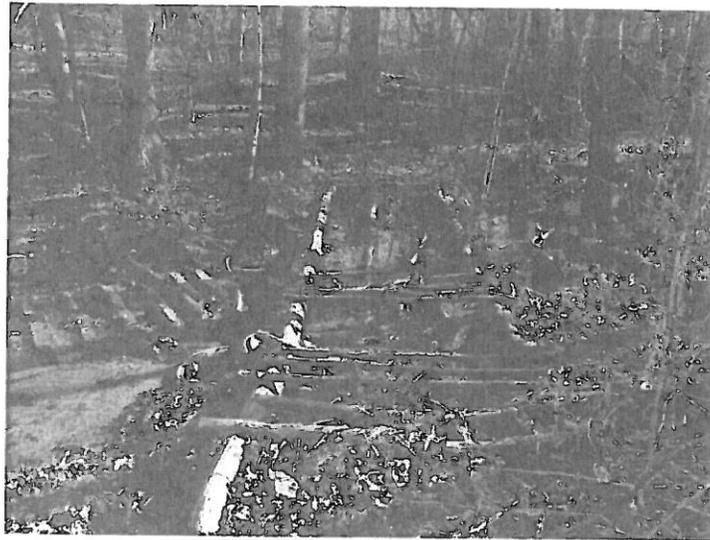
In addition to the pits there is a stream crossing at the western end of the trail near the border with the Merrimac Landing Conservation Area, delineated by flags C1-C2 and C3-C5. This stream contained remnants of a wooden footbridge supported by tires, a wooden pallet and other debris. Approximately 25 feet of the trail at the steep decline approaching the west bank contains some gully erosion. Approximately 20 feet from the east bank the trail has been widened by ATV use and probably pedestrian use. REC estimated that there were 460 square feet of impact to Bordering Vegetated Wetland (BVW) at this location and 32 linear feet of intermittent stream bank.

Photo 5: Stream crossing near flag C1, view east

- Installation of straw wattle erosion control barrier on both sides of the stream crossing as a temporary erosion control measure
- Minor re-grading of the wetland and buffer zone within 50 feet of the east side of the stream using a small track machine to minimize further rutting of the trail.
- Removal of the remains of the bridge, pallets, tires and any other debris within the stream bed by hand.
- Re-grading and installation of 1-inch gravel fill to repair gully erosion on the slope approaching the west bank. No fill is to be placed in wetlands.
- Install approximately 4 highbush blueberry (*Vaccinium corymbosum*) and 4 Northern arrow-wood (*Viburnum recognitum*) to re-establish minimum trail width of 5 feet in the wetland area on the east side of the stream.
- Overseeding with New England Wetmix any disturbed soil areas on the bank or wetland.

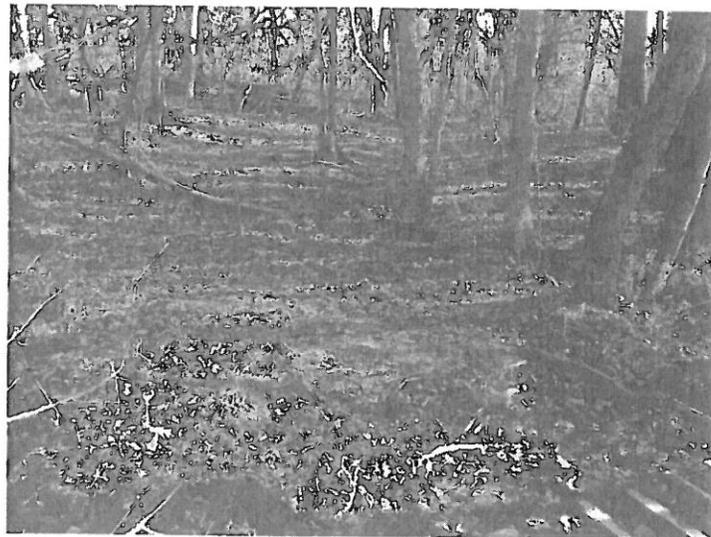
Photo 6: Trail erosion and trail widening beyond stream crossing, view east

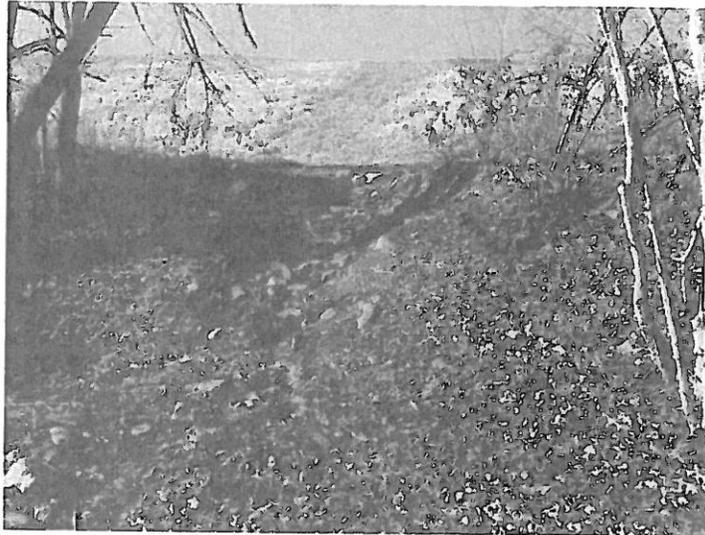
Photo 7: Gully erosion on the trail leading to stream, view west

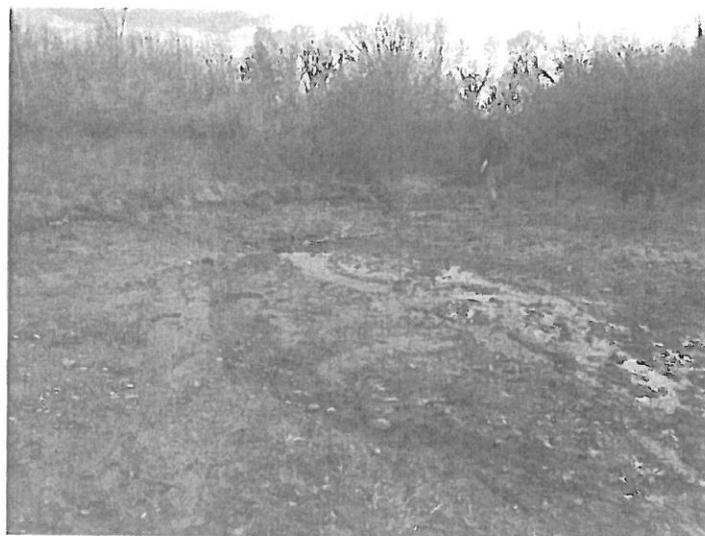
The area on the Waste Management site that was used for the tire pull by the Spartan Race is relatively flat, open cleared area mostly devoid of vegetation. Soil has been bermed up along much of the southern edge of this clearing. The clearing is more than 100 feet from wetland resources. However, stormwater runoff from the drainage area upgradient of the clearing which includes the grassy hillside to the east (Spartan stations 14-18) is directed along existing gravel roads to a single point in the northeast corner of the clearing. There is some erosion here that has created a small channel which flows out of the clearing and down the steep hillside to the south. By the time this flow reaches the Merrimack Landing Conservation Area the channel has excised a very steep gully (see Merrimack Landing photos in the following section 4(h)).

Photo 8: Cleared area showing discharge to the south

Eventually the flow discharges to a down gradient wetland where the slope flattens out. Considerable sediment has accumulated in this wetland.

Restoration of the on-going erosion within the clearing area is recommended as follows:

- Install erosion controls consisting of straw wattles across the discharge location.
- Extend a portion of the existing berm on the southern side of the cleared area across the discharge location to direct flow away from the gully.
- Re-grade approximately 200 feet of the gravel road upgradient of the cleared area to minimize rutting and channelization of flow.
- Remove the remaining portions of the berm on the south side of the clearing and replace this material within the clearing, grading to prevent discharge to the gully.
- Overseed clearing with a conservation seed mix to improve vegetative cover and soil retention.

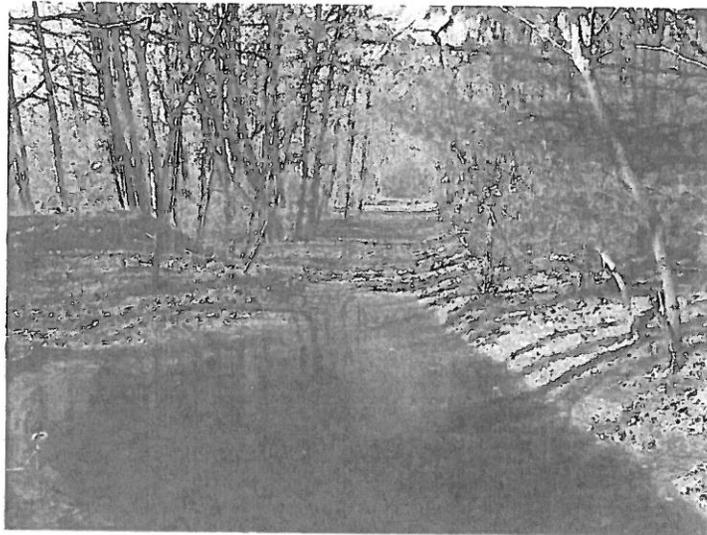
- a) Flags D1-D3 and D4-D6 delineate an approximately 90 foot long mucky section of trail that appears to have been slightly widened at some point recently. There were a few cuts of shrubs and small saplings noted on the edges of the trail. There was some ponding in the eastern portion near D5-D6 approximately 6-inches deep. Some sand and silt was eroding along the trail near D1 where runoff from the steeper section of the trail to the west was beginning to settle out. Soil stockpiles nearby, shown on left of photo 9, suggest that this area had been excavated at one time.

Photo 9: Near flag D7

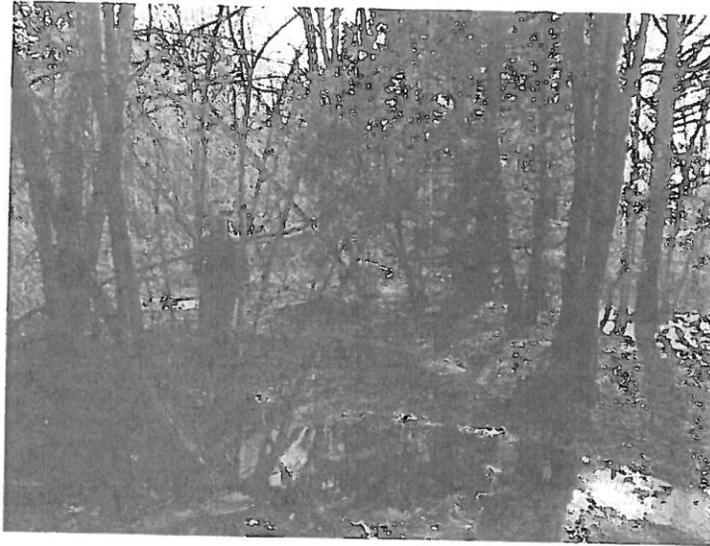
- b) Flags E1-E2 and E3-E5 delineate the banks of a narrow stream crossing. The stream makes a bend at this location and the banks have been disturbed to allow for passage by ATV use and pedestrian use. A small cut in the south bank has been made to make a more gradual slope. The material excavated appears to be stockpiled close to the bank.

Photo 10: Stream crossing at E4, view south

4b) Repair/rebuild the north and south banks of area E using staked coir logs and backfill on the upland side to restored grades using existing soil stockpiled nearby in the buffer zone. Install 4 highbush blueberry (*Vaccinium corymbosum*) on south bank to re-establish maximum 5-foot trail width.

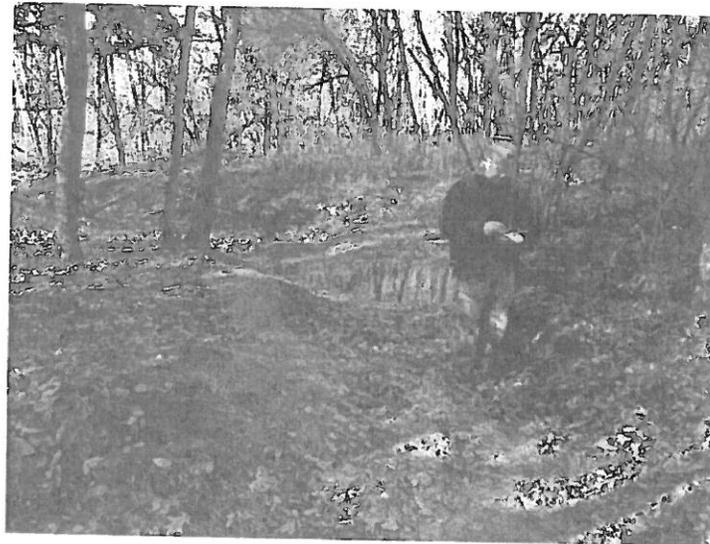
**Photo 11: Stream Crossing above cut to south bank (view north)
Stockpiled material on left of photo**

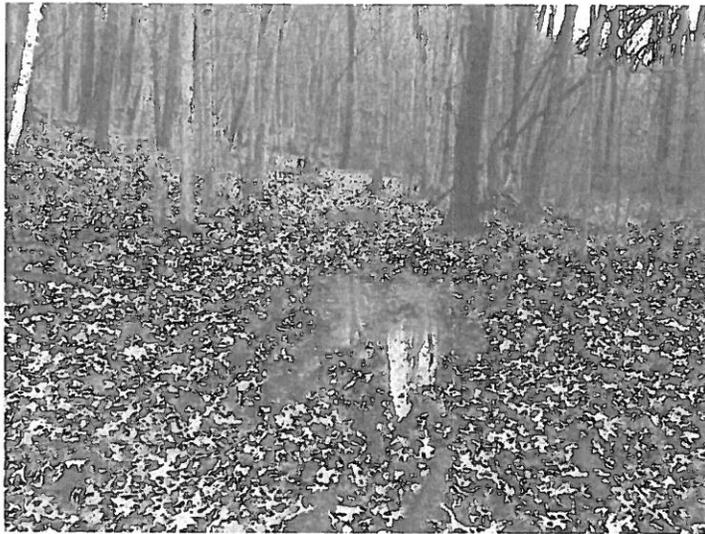
- c) Flags 1-8 delineate an approximately 200 foot section of trail that passes through wetland and buffer zone. The portion of trail that passes through flags 1-5 is part of the wetland and is muddy and contained vehicle ruts. The section that passes by flag 5-8 is in the buffer zone. This section of trail contained some gully erosion.

Photo 12: muddy section of trail through wetland with vehicle tracks near flag 3

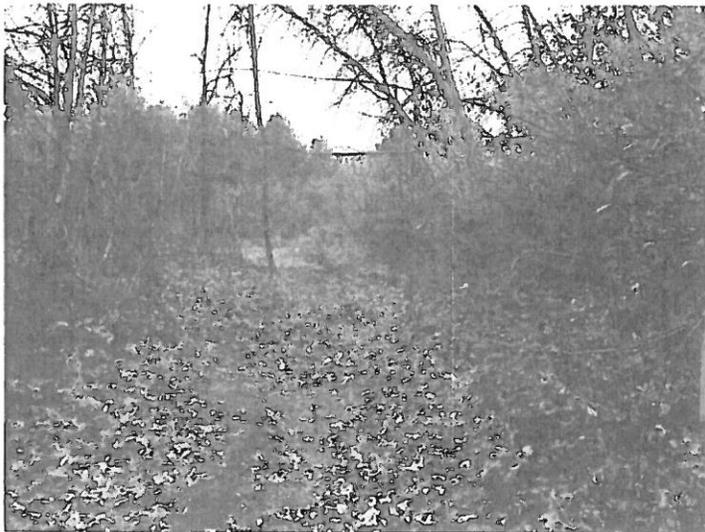
- d) An intermittent stream channel that exits the Waste Management site near the pits that were created flows downhill toward a trail intersection just west of flags 1-8 on Detail Sheet 5. This stream channel was flagged by LEC as part of its review of the Tough Mudders impacts. The 1-foot wide intermittent stream channel appears to have originally crossed over the trail just east of the trail intersection. With the trail ruts created by ATV and possibly some trail widening in this area it appears that the channel is now directed to the west along the trail instead of into its original channel across the trail.

Photo13: Intermittent stream channel re-directed to side of trail

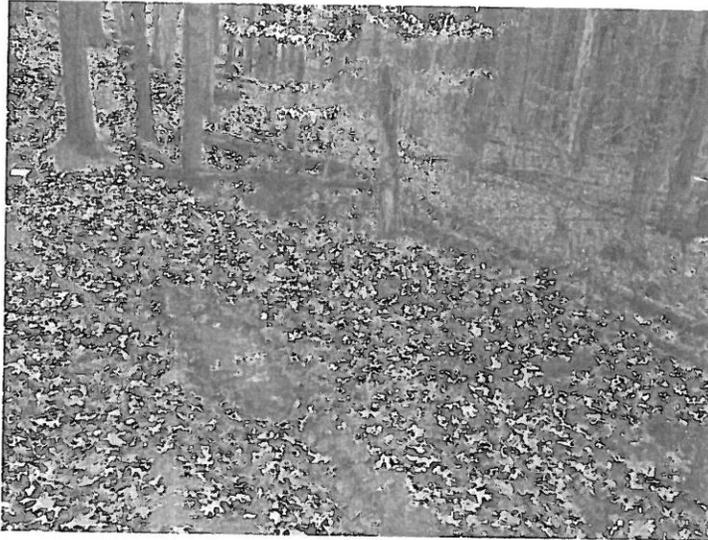
- e) Flags 9-11 and 12-15 on Detail Sheet 4 delineate an approximately 200 foot section of trail along the base of the hill that follows along the upslope side of a wooded swamp. A small section of approximately 70 feet intersects the wetland. Again, vehicle ruts were noted here but no other impacts were observed.

Photo 14: Near flag 9 Trail passes through buffer zone.

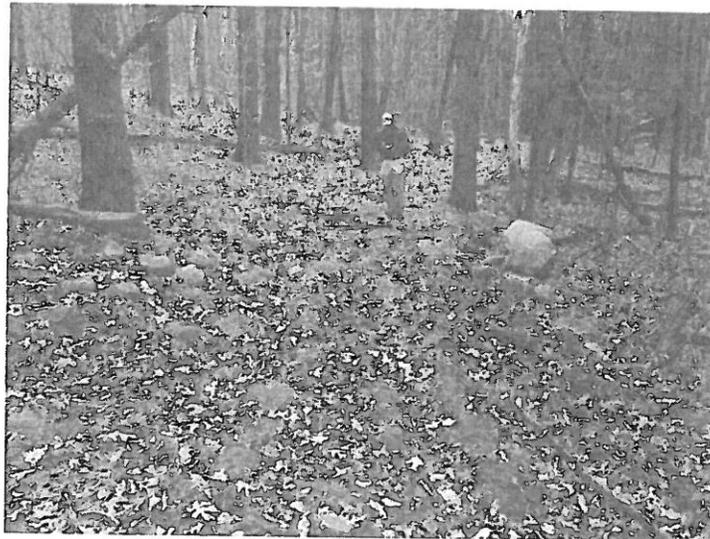
Photo 15: rutted trail near flag 12 where trail passes through wetland

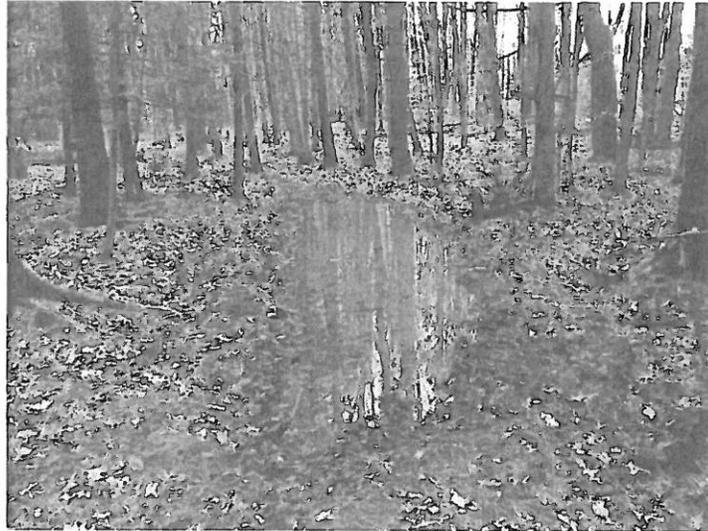
- f) Again, the trail passes through a muddy section of mostly buffer zone at flags 16-19 (see Detail Sheet 4). This is an approximately 50 foot section of trail with a large puddle and several muddy sections, but with only 20 feet or so within wetland. The area is relatively flag and despite some rutting, no sedimentation of adjacent wetlands was observed.

Photo 16: Near flag 17

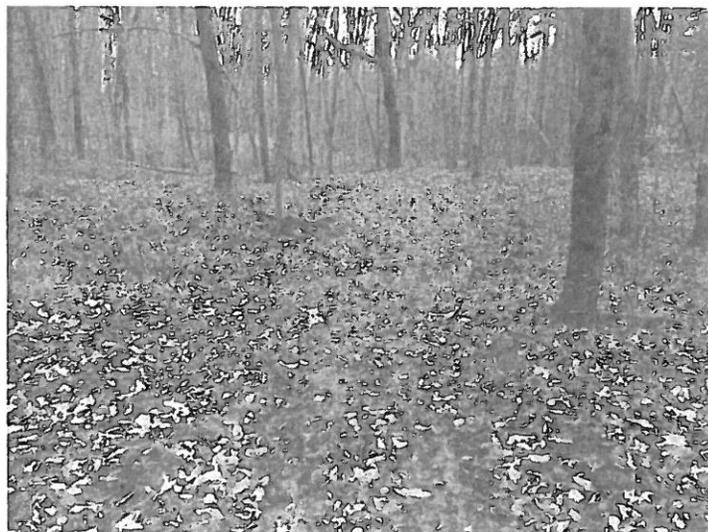
- g) Flags 20-24 and 25-27 on Detail Sheet 3 delineate the location of a swale/intermittent stream channel crossing the trail conveying flow to the east. There is wooded wetland on both sides of the trail at this location. Again only vehicle ruts were noted and no other direct wetland impacts were observed.

Photo17: Near flag 22

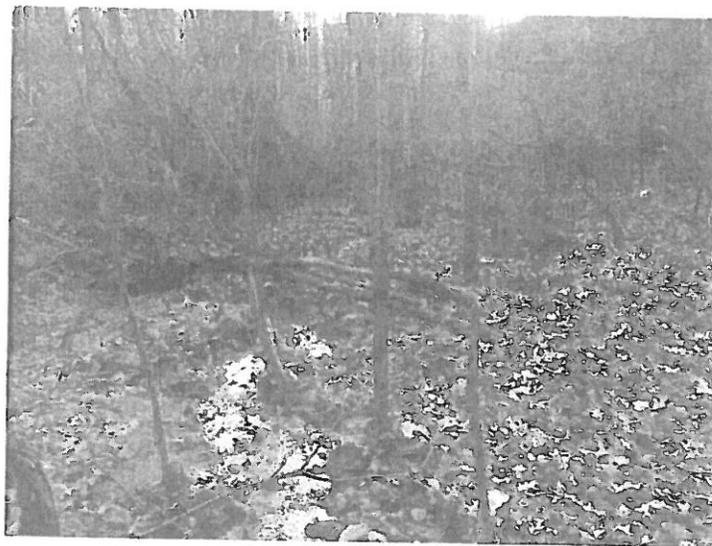
- h) Just west of wetland flags 9-11 is the location where the trail crosses the gully described above under the Waste Management section of this report. The gully starts in the clearing of the Waste Management site where the tire pull activity was held by the Spartan Race and continues through the Merrimack Landing Conservation Area. The gully is not a resource area under the Wetlands Protection Act, since it does not flow out of another wetland. However, the erosion of the gully is causing continuing deposition of sediment into the downgradient wetland.

Photo 19: Sedimentation of down gradient wetland

4h) Since the erosion associated with the impacts to wetlands down gradient of this location appears to pre-date the activities addressed in the present Enforcement Order, REC is not recommending remediation of the sedimentation to wetlands that have occurred as a result of the extensive gully erosion. The Conservation Commission may wish to address the restoration of this wetland under a separate enforcement action. However, since the activities associated with the Spartan Race may have contributed to on-going erosion of the gully by maintaining the tire pull area in a non-vegetated condition that makes it more susceptible to erosion and they may be responsible for construction of the earthen berm along the south side of this cleared area, measures are recommended under Section 3 of this report under Waste Management Disposal Services of Massachusetts to minimize the conditions contributing to this on-going erosion.

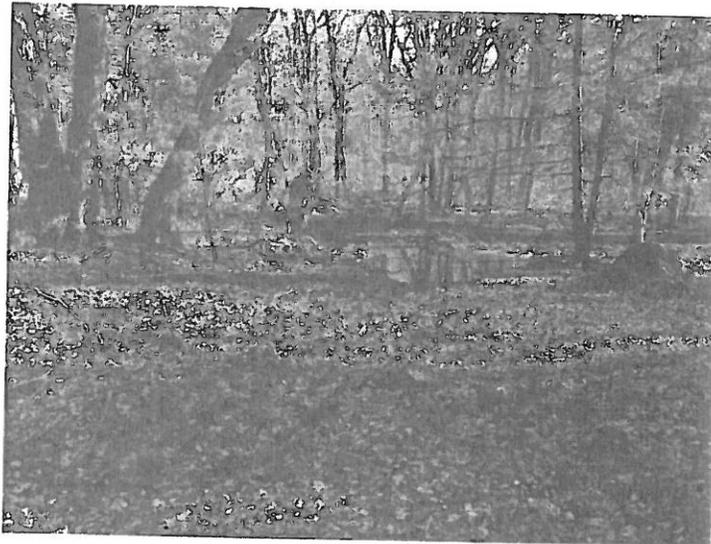
Starting approximately 50 feet west of the northernmost portion of the Bartlett's Reach Condominium Trust property within the Merrimack Landing Conservation Area and extending approximately 300 feet into the Bartlett's Reach property is a large wooded swamp. This swamp contains a stream that crosses the trail from northwest to southeast. Because the soils are very mucky in this area, there was considerable soil disturbance from the heavy foot traffic during the races that occurred through here, as evidenced by the numerous shoes and socks still strewn through the area. The trail has been significantly widened and it appears some understory has been cleared. The stream banks have been altered by trampling and there is a small earth dam across the channel that has caused re-routing of a portion of the channel. An approximately 20 x 20 foot pit has been constructed in the portion of the trail that includes the wetland. REC estimates approximately 4,900 square feet of Bordering Vegetated Wetland was impacted and 54 linear feet of intermittent stream bank.

Photo 20: Approach to stream crossing. Constructed pit in background

- This work is to be conducted as much as possible during winter months with frozen ground conditions or during summer low flow conditions.
- Install temporary erosion controls consisting of straw wattle along the east and west sides of the stream and across the downstream end of the stream channel.
- Temporarily divert flow away from the restoration area using a temporary coffer dam and pump to discharge downstream around the restoration area. The intake is to be

- Install and stake 12-inch coir fiber logs to restore damaged section of stream banks
- Backfill against the upgradient side of the fiber logs using existing soil material, including material taken from earthen dam within the stream bed.
- Replant disturbed area with the following plantings:
