Massachusetts Department of Environmental Protection
 Bureau of Resource Protection - Wetlands
WPA Form 9 – Enforcement Order
 Massachusetts Wetlands Protection Act M.G.L. c. 131, §40

Amesbury
 Conservation Commission (Issuing Authority)

Issued 9.15.14; Amended 10.6.14;
Amended 3.2.15

This Amended enforcement order authorizes the implementation of the approved restoration plan (Appendix) entitled "Wetlands Impact Assessment, Amesbury Land Associates, Inc. and Event Partners, LLC," and dated December 5, 2014. See Attachment to Enforcement Order for additional information relative to a mandated timeline.

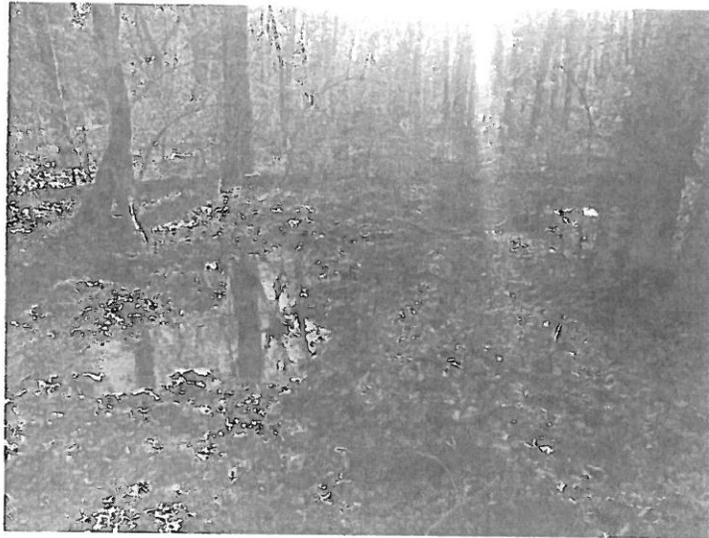
Starting approximately 50 feet west of the northernmost portion of the Bartlett's Reach Condominium Trust property within the Merrimack Landing Conservation Area and extending approximately 300 feet into the Bartlett's Reach property is a large wooded swamp. This swamp contains a stream that crosses the trail from northwest to southeast. Because the soils are very mucky in this area, there was considerable soil disturbance from the heavy foot traffic during the races that occurred through here, as evidenced by the numerous shoes and socks still strewn through the area. The trail has been significantly widened and it appears some understory has been cleared. The stream banks have been altered by trampling and there is a small earth dam across the channel that has caused re-routing of a portion of the channel. An approximately 20 x 20 foot pit has been constructed in the portion of the trail that includes the wetland. REC estimates approximately 4,900 square feet of Bordering Vegetated Wetland was impacted and 54 linear feet of intermittent stream bank.

Photo21: Earthen dam across stream channel

- This work is to be conducted as much as possible during winter months with frozen ground conditions or during summer low flow conditions.
- Install temporary erosion controls consisting of straw wattle along the east and west sides of the stream and across the downstream end of the stream channel.
- Temporarily divert flow away from the restoration area using a temporary coffer dam and pump to discharge downstream around the restoration area. The intake is to be

- Install and stake 12-inch coir fiber logs to restore damaged section of stream banks
- Backfill against the upgradient side of the fiber logs using existing soil material, including material taken from earthen dam within the stream bed.
- Replant disturbed area with the following plantings:

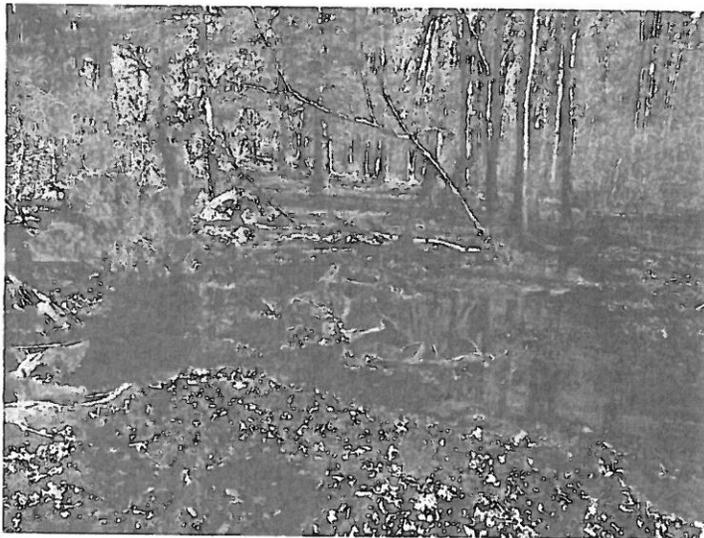
Photo 22: Disturbed stream channel

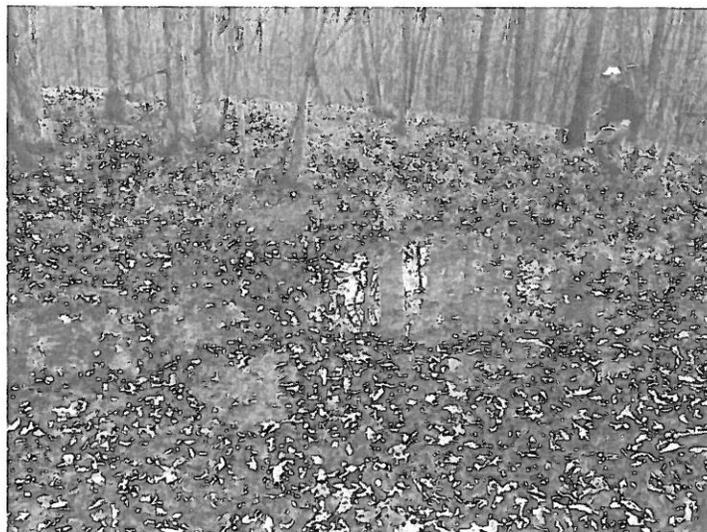
Flags 28-31 and 32-35 delineate another ponded area of trail with wetland on the north side and an intermittent channel on the south side. The trail has been constructed wider than necessary at this location in order to avoid a large puddle.

Photo 23: Flag 30, trail widened to avoid puddle
