Lake Gardner Bacteriological Study

Section 604b Project # 2009-09/ARRA 604

May 2011

Town of Amesbury, Massachusetts

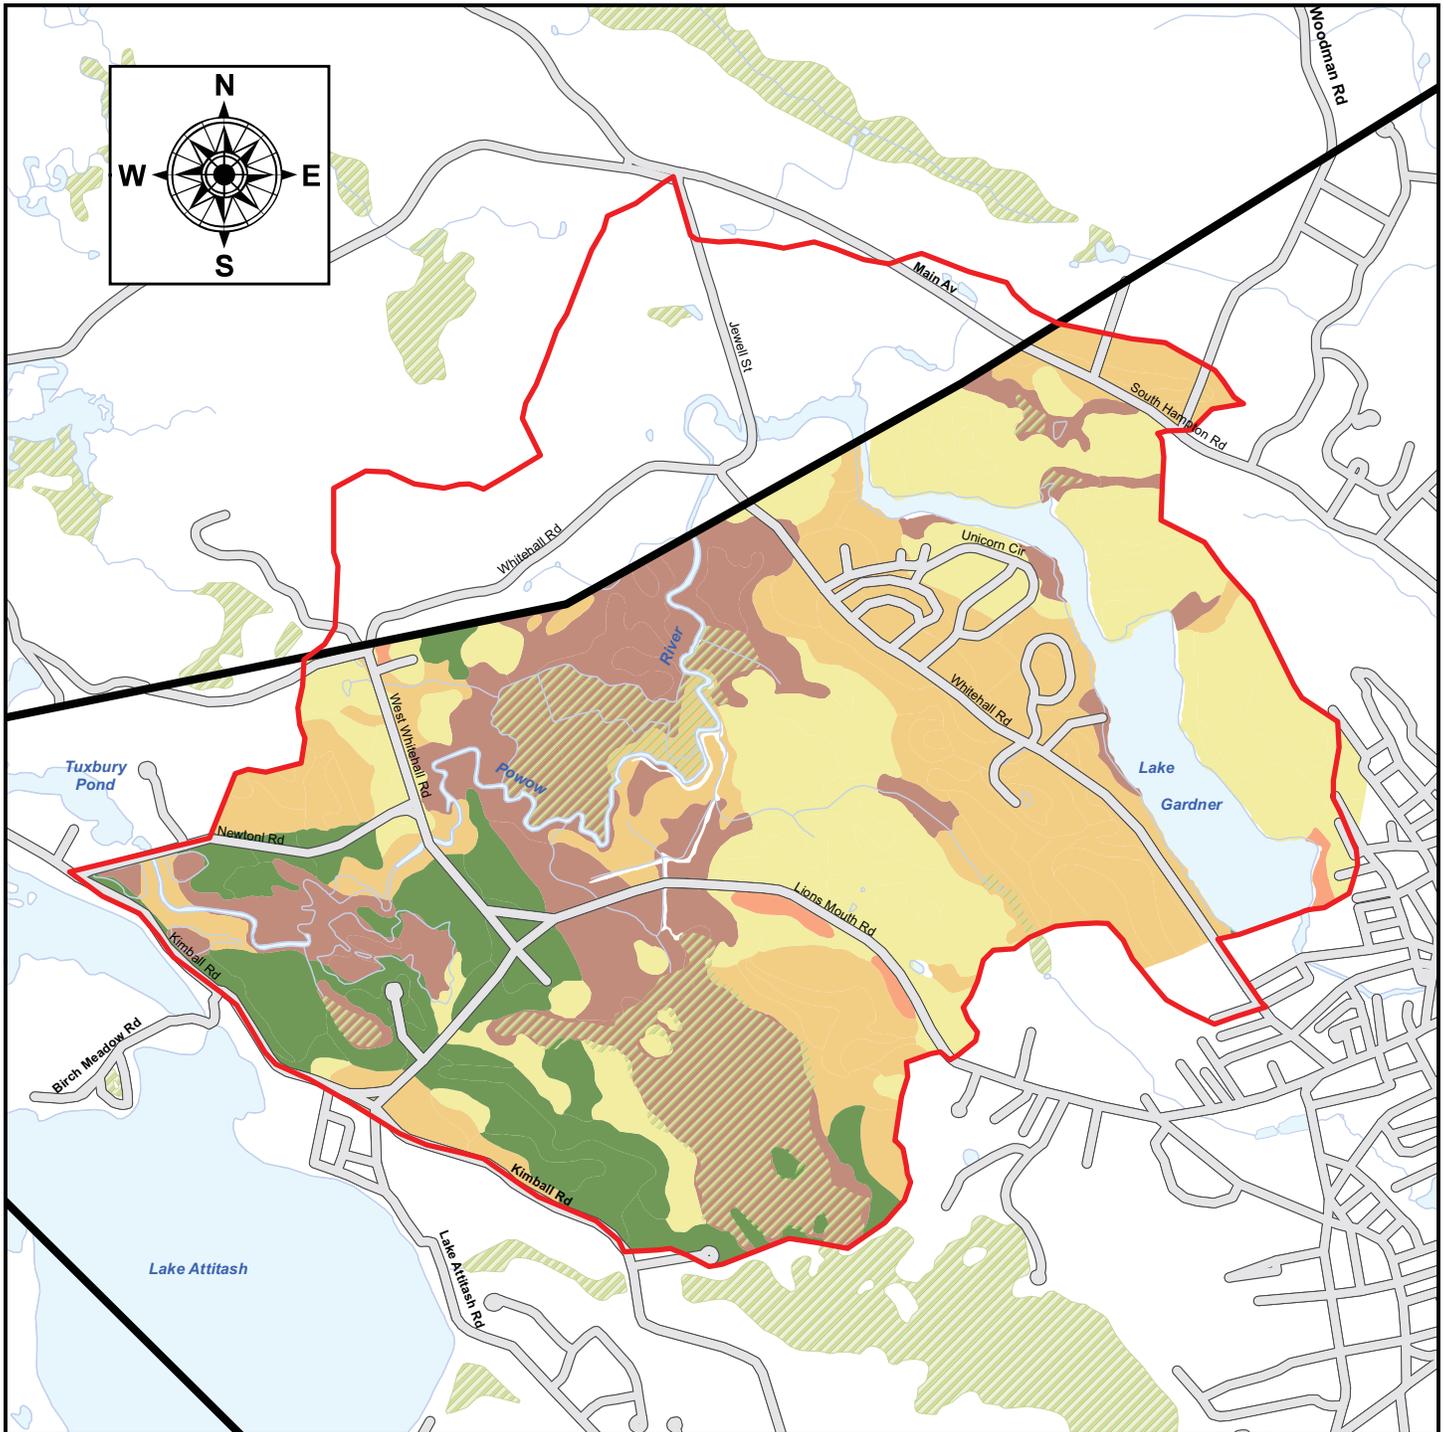
Soils - Hydrologic Group

The hydrologic group classification indicates the ability of a soil to infiltrate stormwater and is used to estimate runoff from rainfall. Soils are placed into four hydrologic groups A, B, C, and D, which are described in **Table 5-1**. **Figure 5-1**, illustrates the hydrologic group for soils found in the Lake Gardner watershed. GIS soils data was not available for the watershed area within New Hampshire. Copies of the USDA soils maps that cover New Hampshire are provided in **Appendix B**.

The Lake Gardner watershed is split into four areas with distinct porosity characteristics. Sandy loam soils found on east side of the lake have moderate infiltration rates while soils on the west side of the lake tend to have slow infiltrating soils. These slow infiltrating soils follow the ridgeline along Whitehall Road. A small pocket of moderate infiltrating soils is located in the area of Unicorn Circle. Very slow infiltration rates are characteristic of soils located along the Powow River corridor where silty loam is predominate. These soils are also found in the large wetland areas near Lions Mouth Road. A large area located on the western boundary of the watershed has the highest infiltration rates with soils made up of a sand and gravel complex.

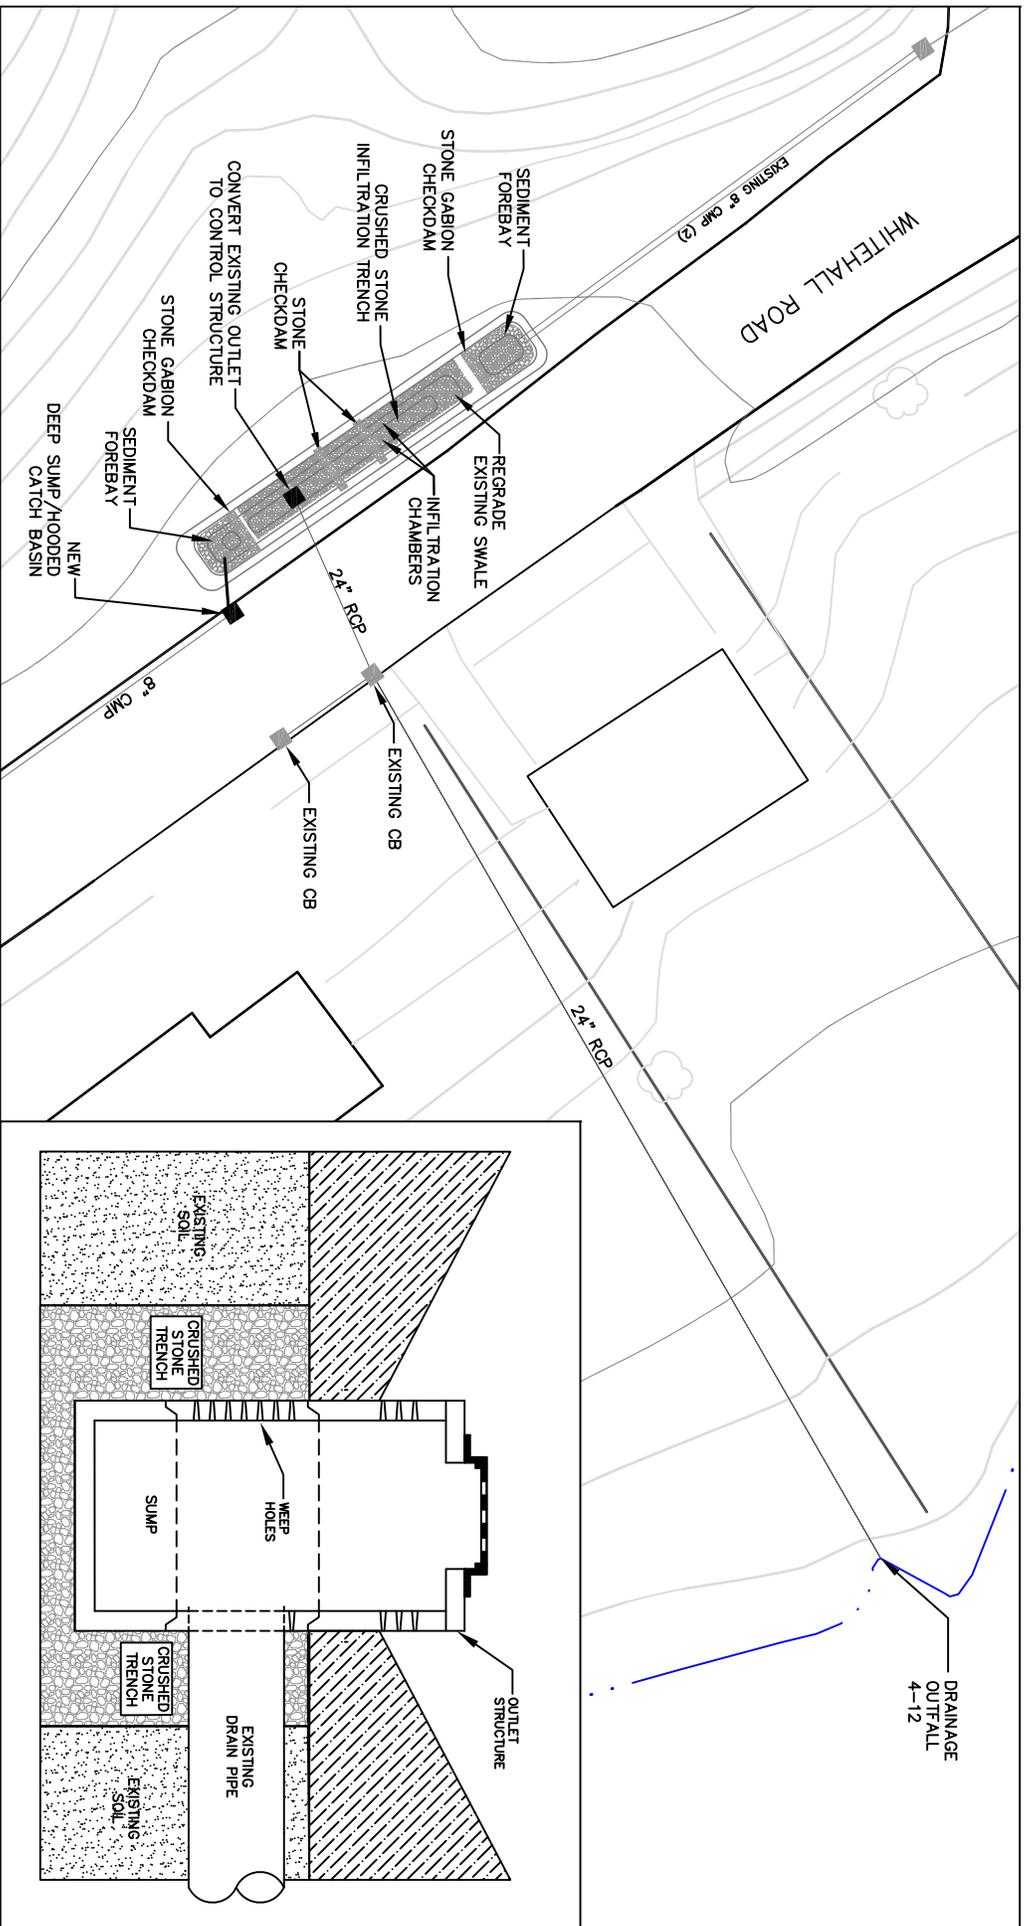
Figure 11-1

**INFILTRATION TREATMENT SWALE
WITH
OUTLET CONTROL STRUCTURE**

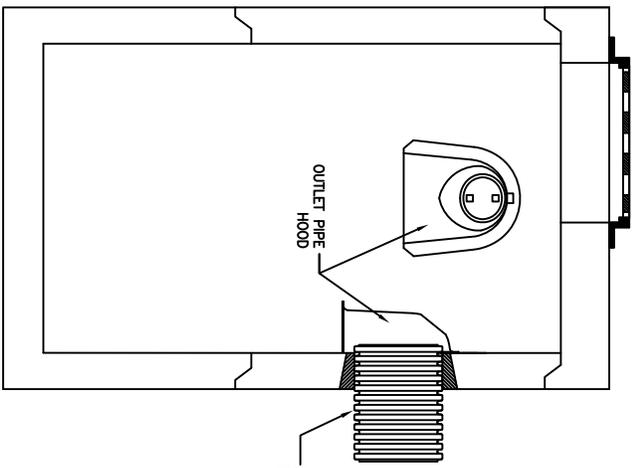
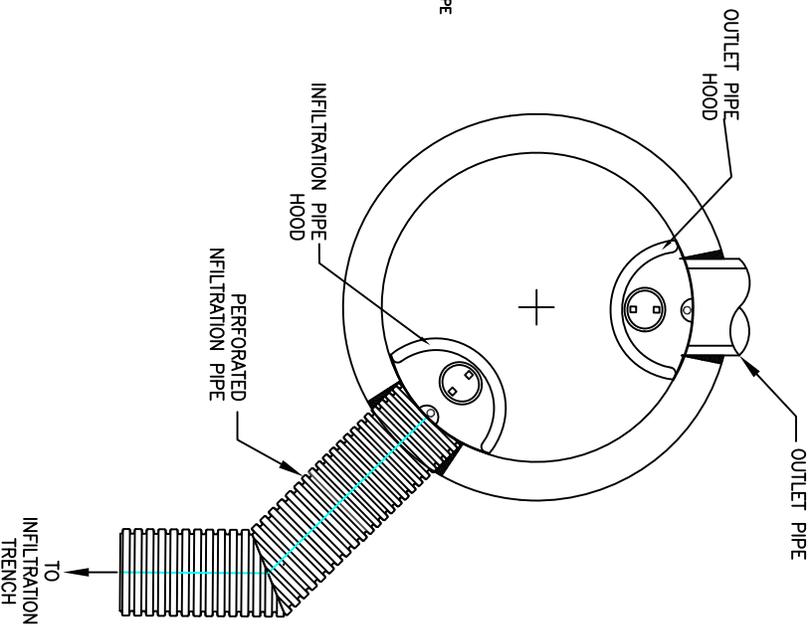
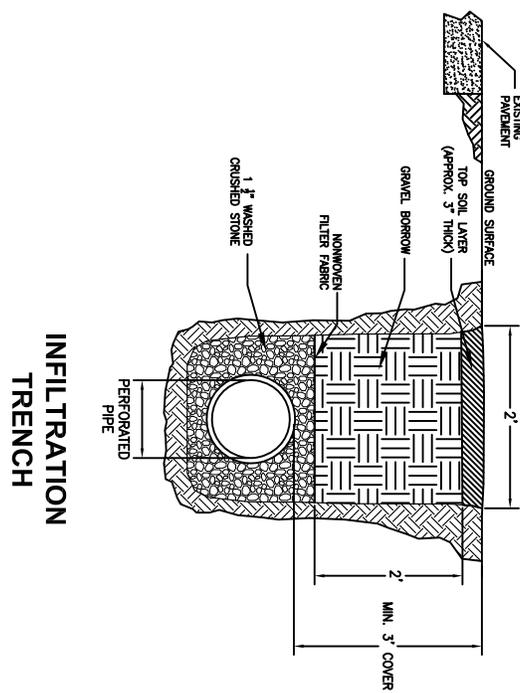
Figure 11-3

**DEEP SUMP/HOODED
CATCH BASIN**

**INFILTRATION
TRENCH**

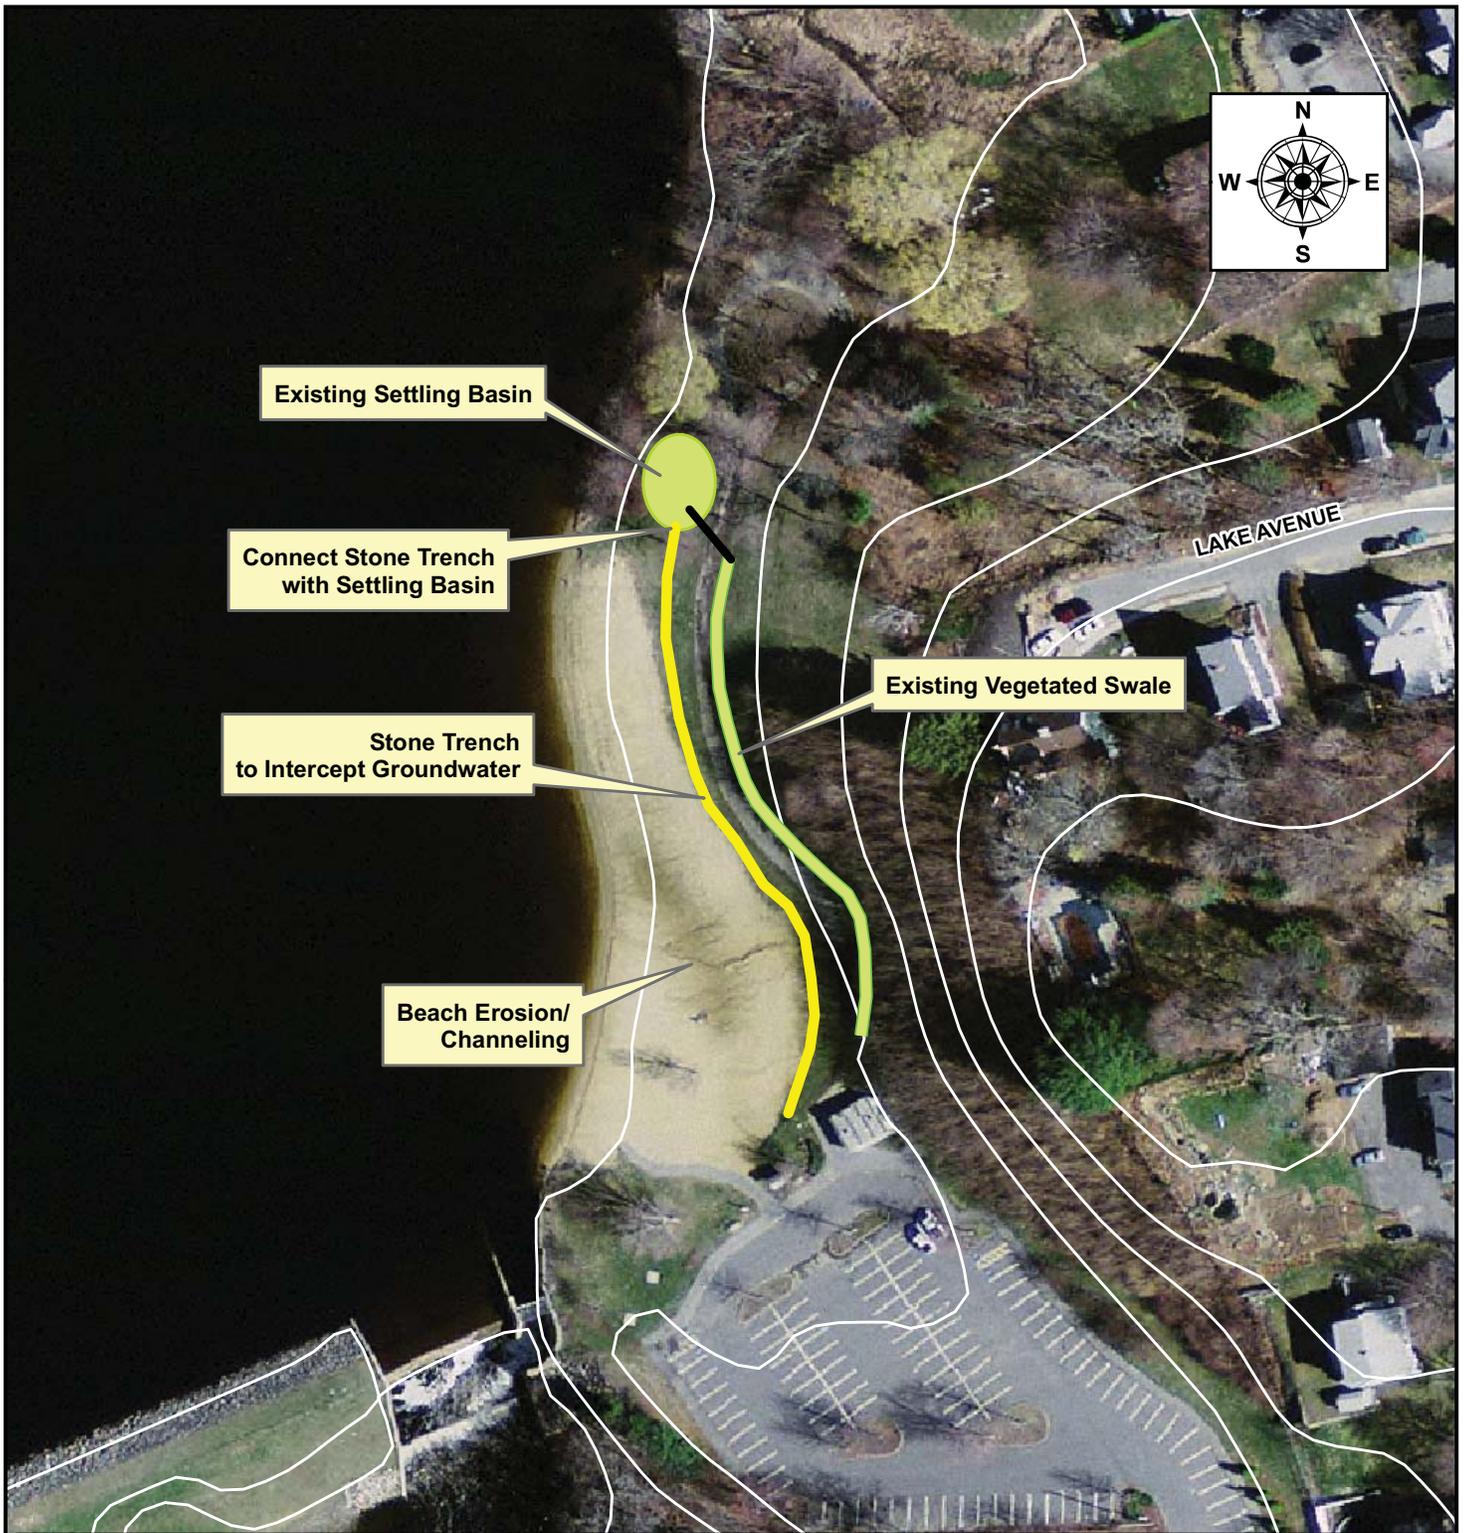
Existing Settling Basin

Connect Stone Trench with Settling Basin

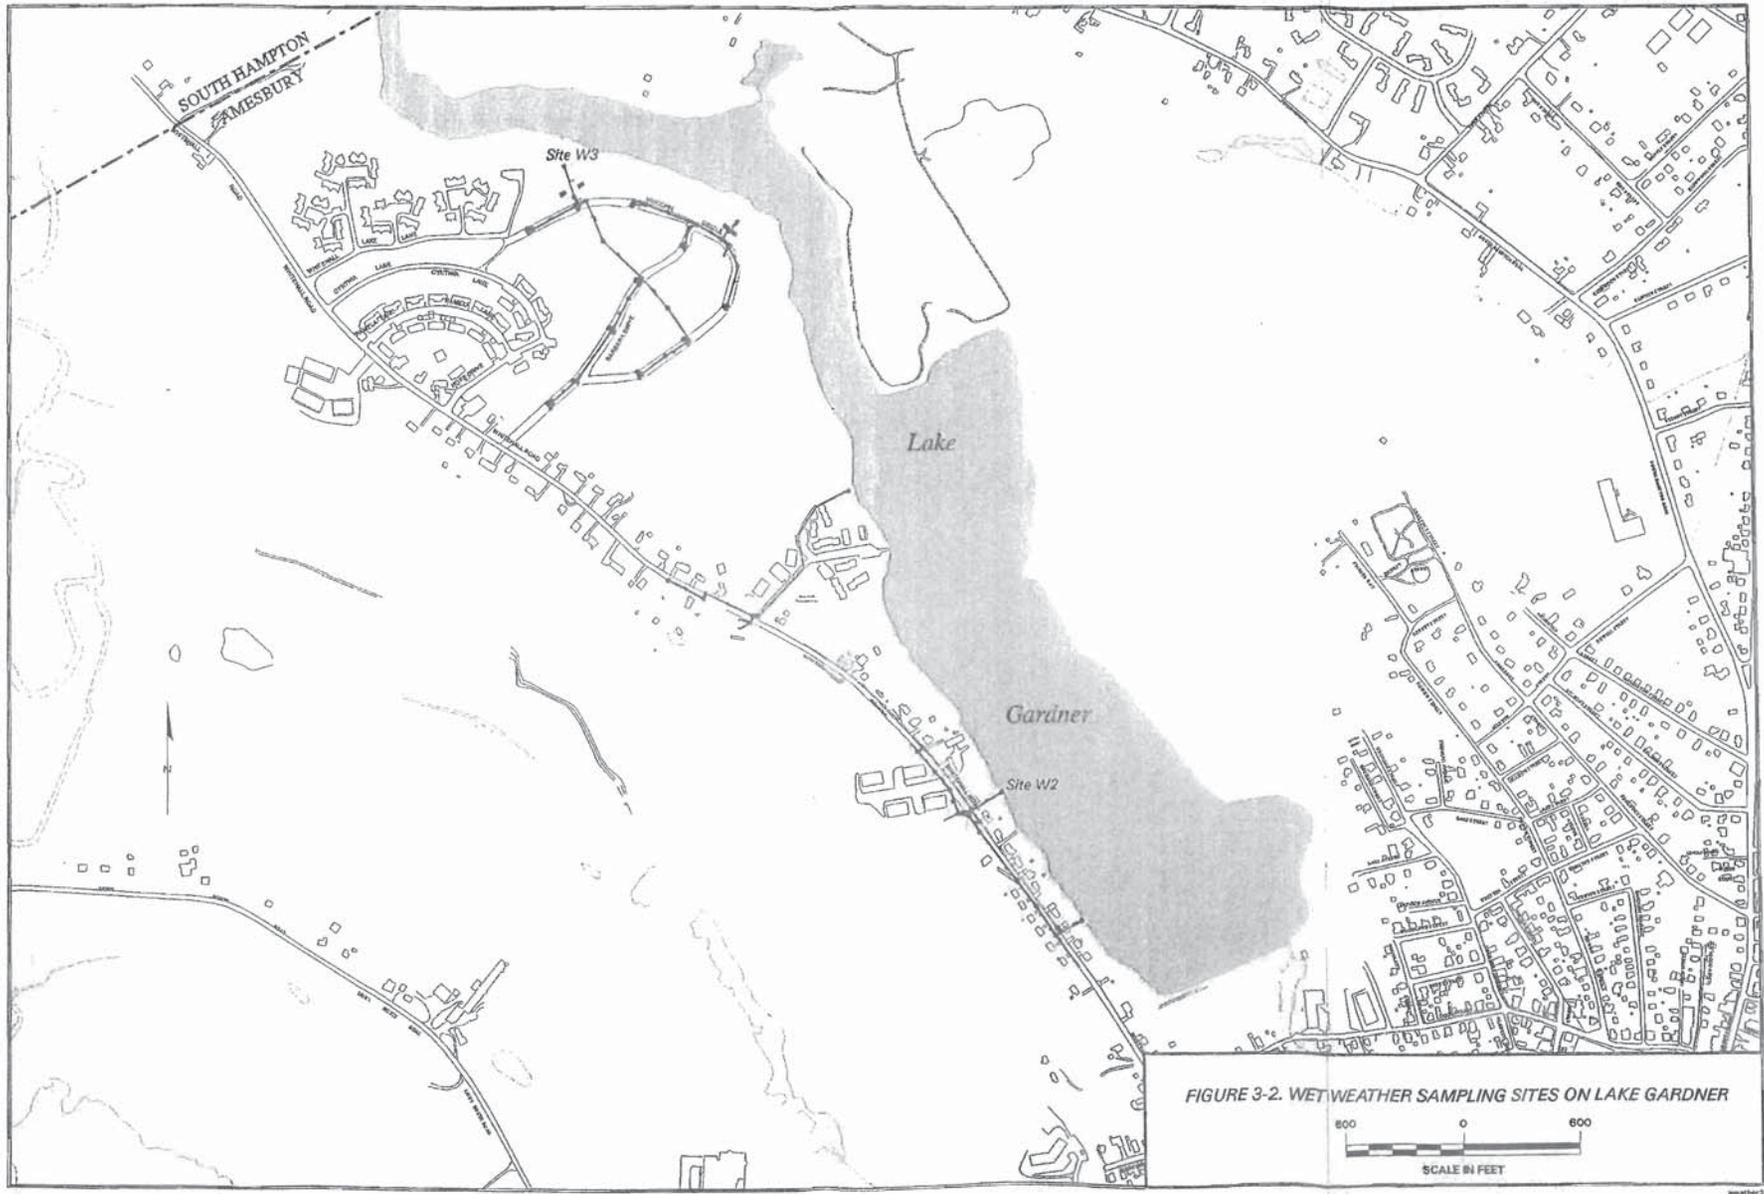
FIGURE 3-2. WET WEATHER SAMPLING SITES ON LAKE GARDNER
