Trails Assessment Report City of Amesbury

Prepared by Woodsman Inc
Site Visit Dates: 8/23/2024, 9/12/2024, & 9/13/2024

**Town Forest &
Margaret Rice Conservation Area**

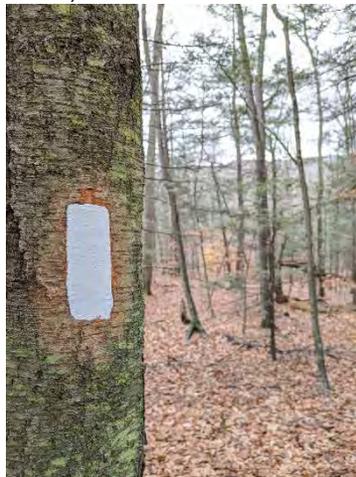
Next, the trail markings need to be consistent, accurate, and easy to understand. The standard is to mark trails with rectangular blazes, such as the one shown below.

Trail blazes should be consistent and especially visible at trail intersections to provide users with reassurance. The color of the trail blazes should match the color of the trails as shown on the trail map.

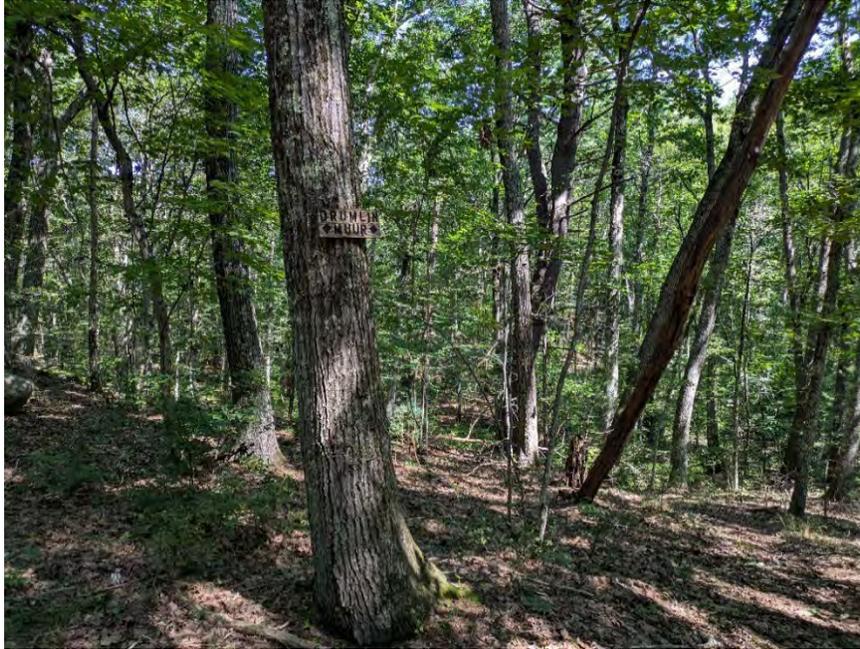
Point 7 – There is a trail sign with the name Drumlin Muur, while on the Amesbury Trails website the trail is named Big Rock, creating confusion.

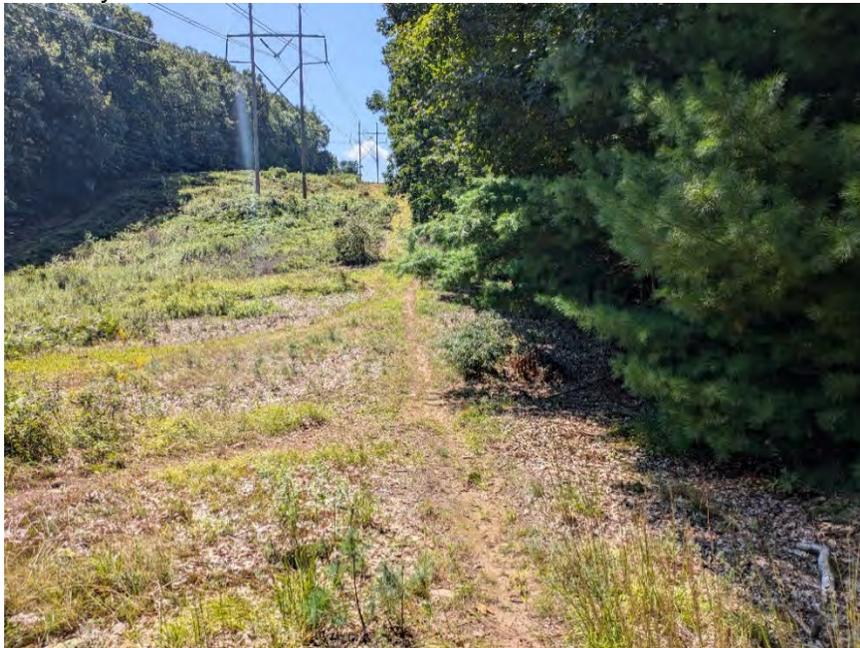
Point 10 – An unmarked intersection. A stake with a blaze could be placed into the ground to let users know where they are.

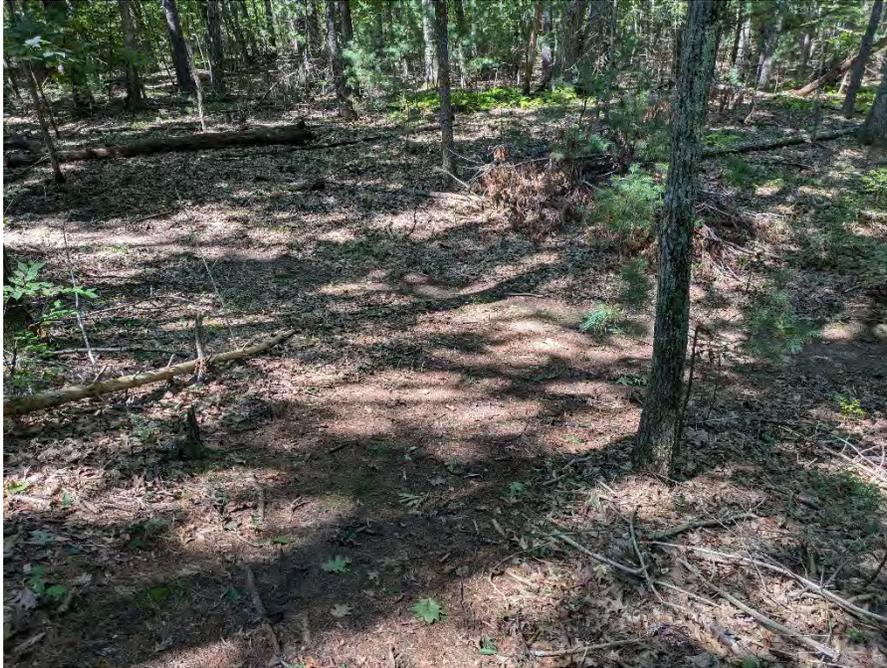
Point 11 – An unmarked intersection. Blazes will let users know which trail is which.

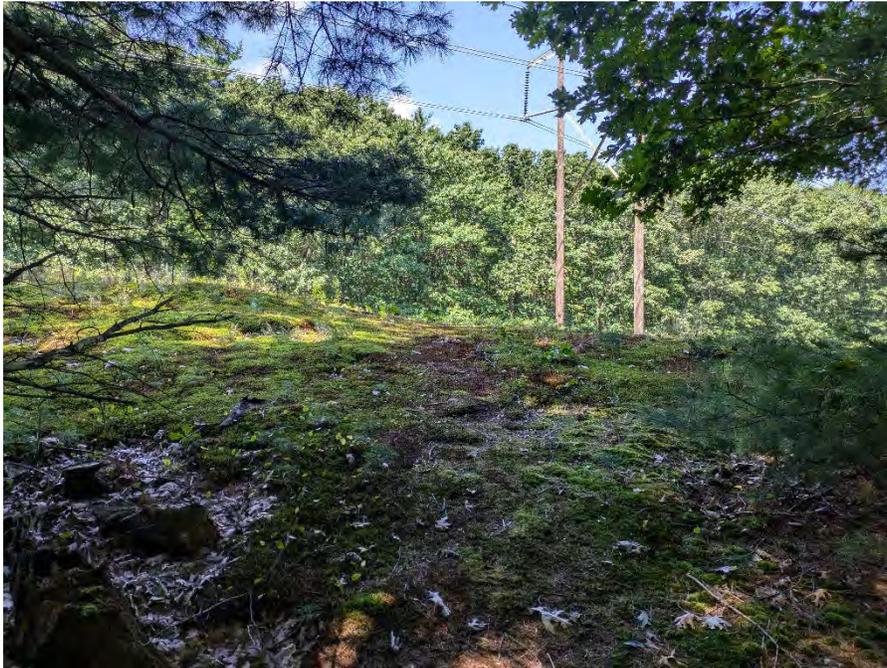
Point 12 – A trail across the powerlines near an intersection. Using blazes painted on wooded stakes will reassure users that they are on the trail in confusing areas, such as powerlines.

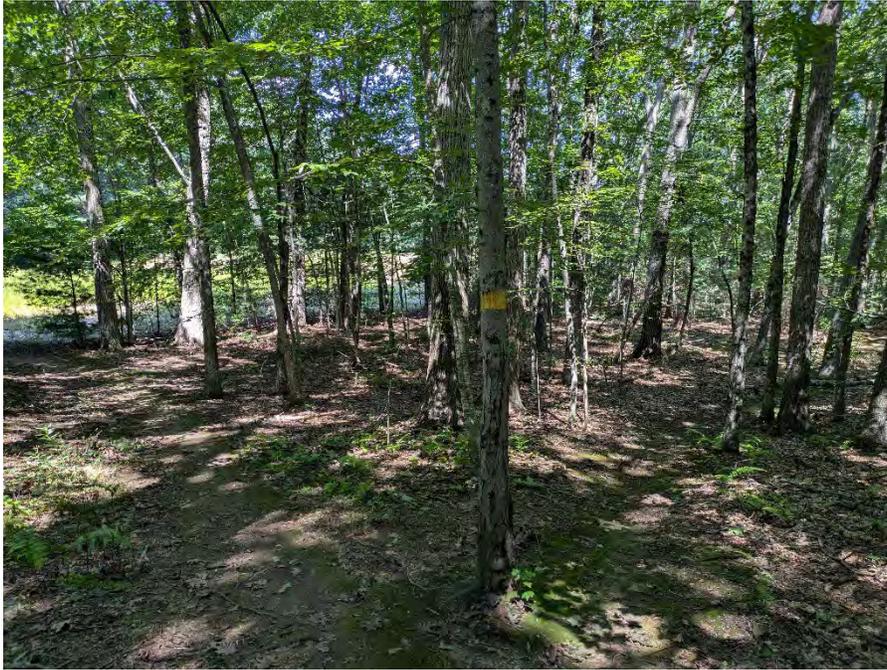
Point 13 – A confusing intersection. In this location there are yellow trail markings heading down both branches of an intersection, but according to the trail map they should only be on the right trail.

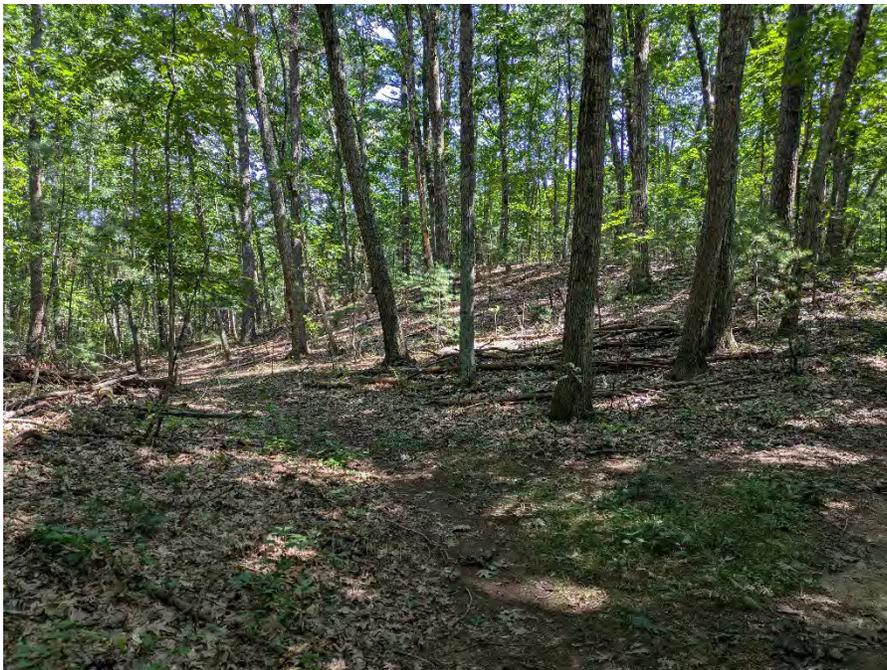
Point 14 – An intersection with no blazes or signage so the user does not know what trail they are on.

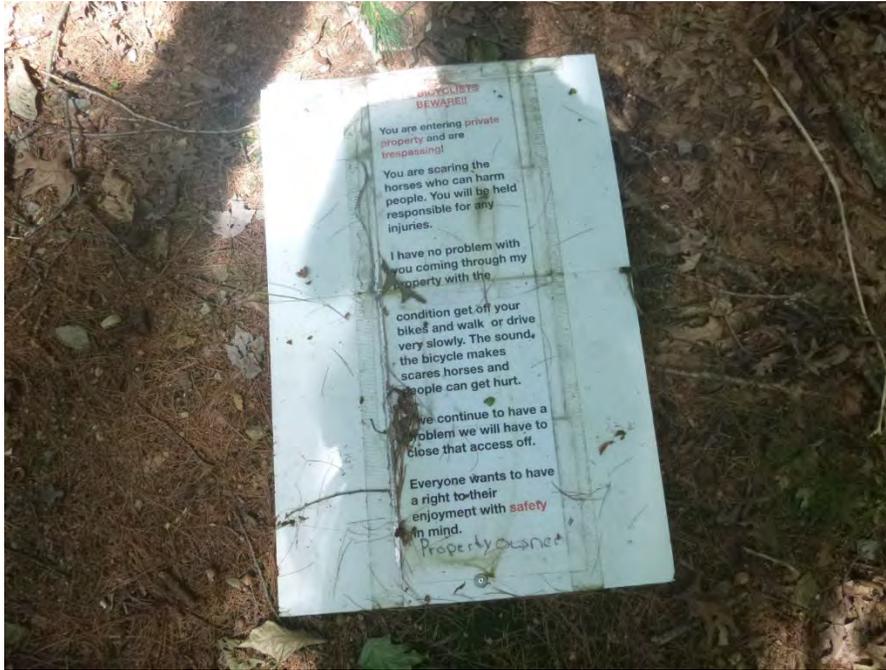
Point 27 – A spur trail leads off town land onto an adjacent horse farm. The sign below was found on the trail discussing users scaring the horses, this spur trail could be closed to avoid future conflicts.

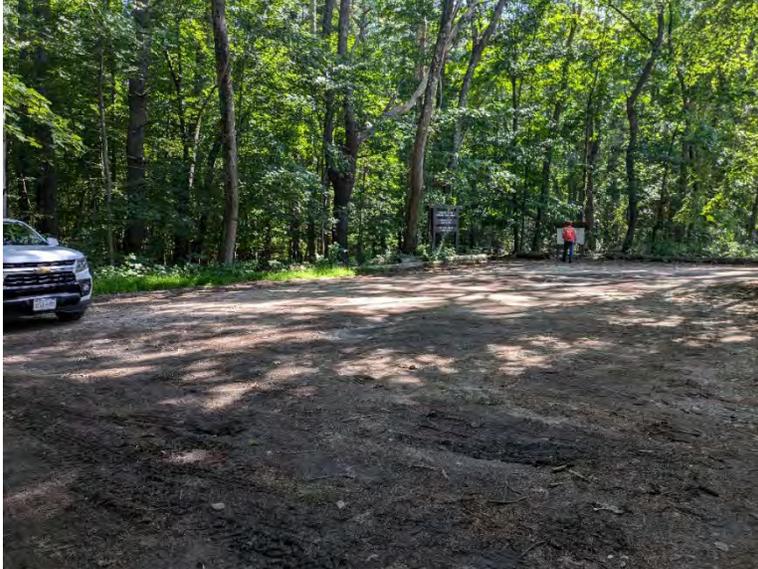
Point 1 – The current parking lot could be graded and improved with a gravel surface. This will reduce mud and puddles in the parking lot and provide a better surface for parking. The photo below shows the current surface of the parking area.

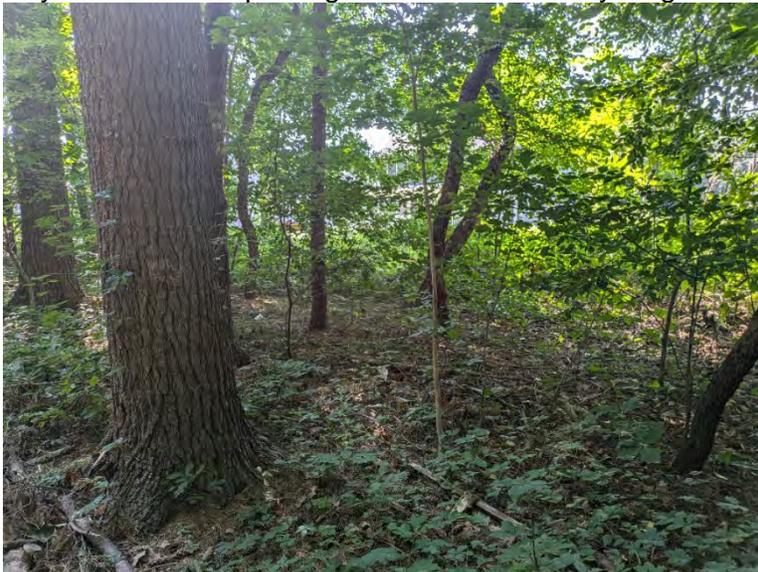
The photo below shows the vegetation currently growing between the parking area and the road. We suggest that the small trees and brush be removed from this area. This will serve two purposes, first it will allow people driving by to see that the area is there and available for public use, second, this will improve public safety. With the vegetation removed a police officer driving by on patrol can easily look in on the parking lot and ensure everything is well.

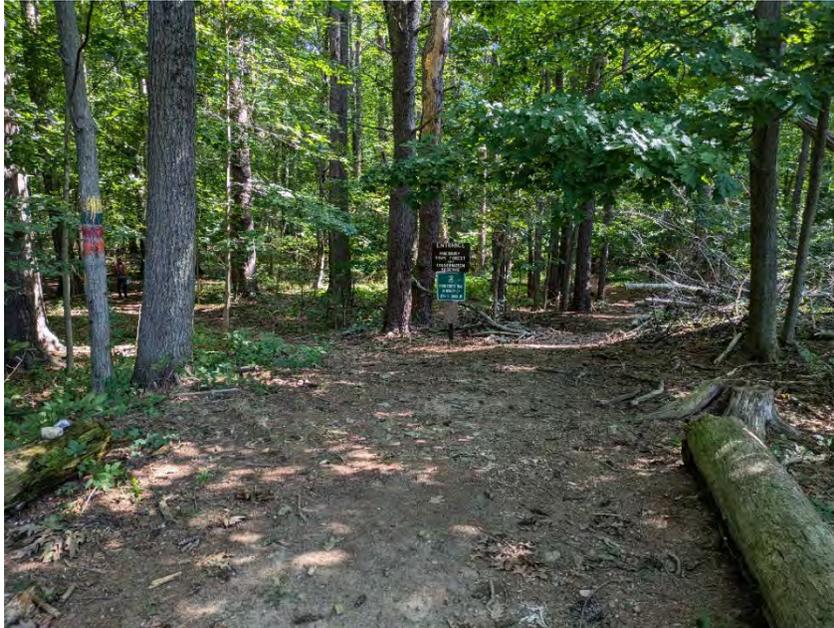
Point 2 – The photo below shows the trail head just north of the parking area. Water is flowing from the parking area down onto the trails. The parking area should be graded so that water is directed away from the trails.

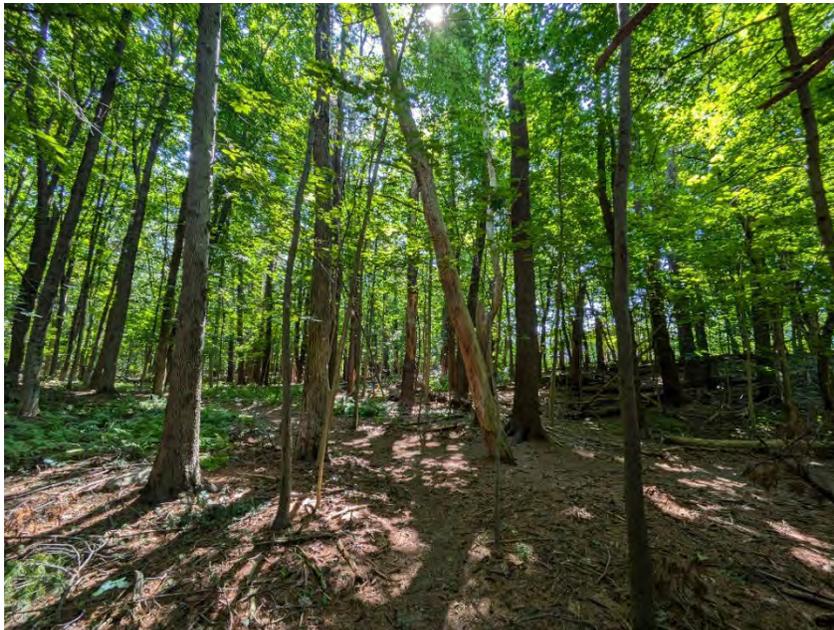
Point 3 – There is a large dead tree trunk hanging over the trail and supported by a tree adjacent to the trail. This dead tree should be removed.

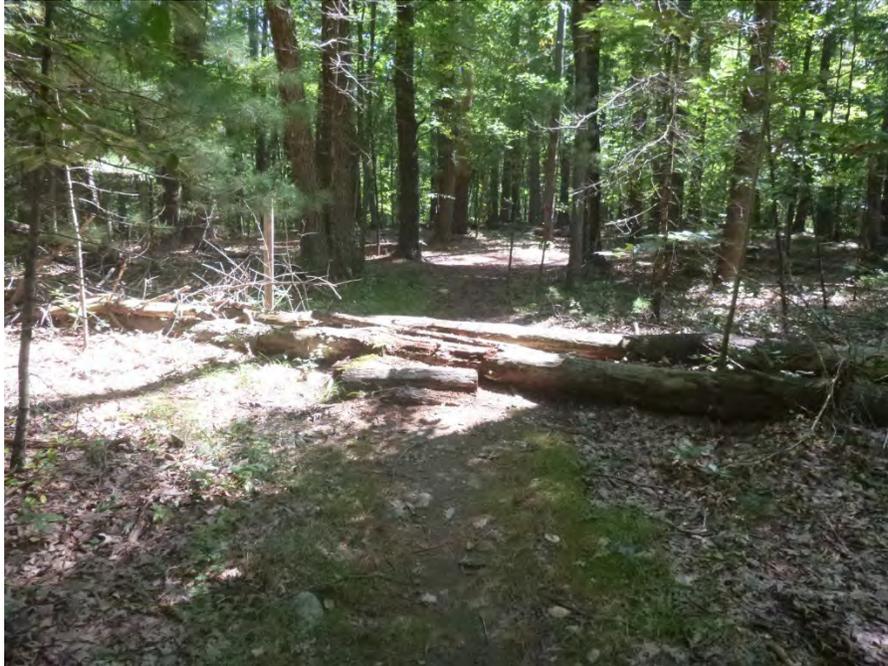
Point 54 – There is a fallen tree that has been bridged by logs with users. This creates a hazard in the trail that may not be navigable by all visitors.

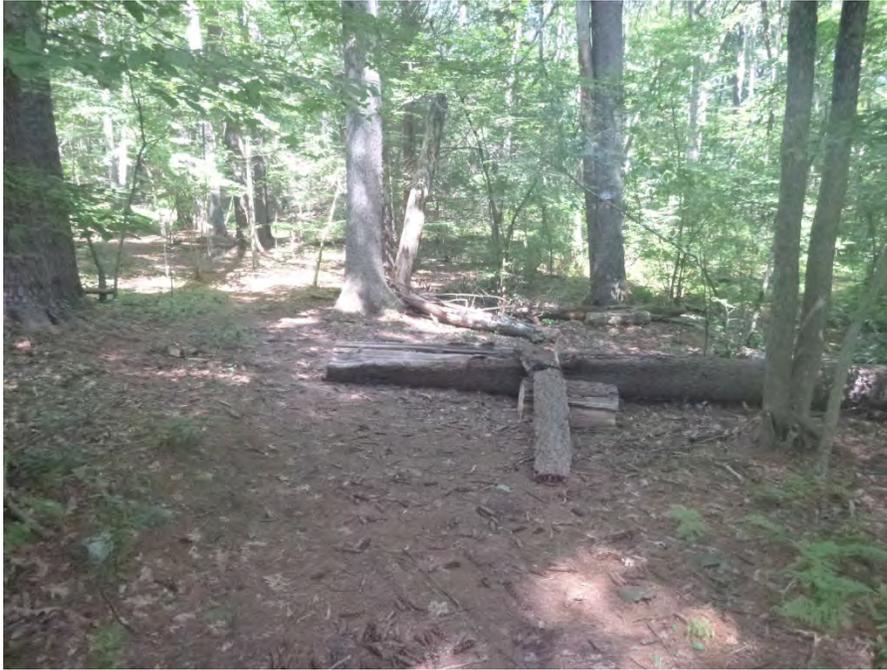
Point 50 – Improvised mountain bike jump. While these mountain bike jumps are not a hazard per se, they do present a risk to those who use them and the city should be aware that they are there.

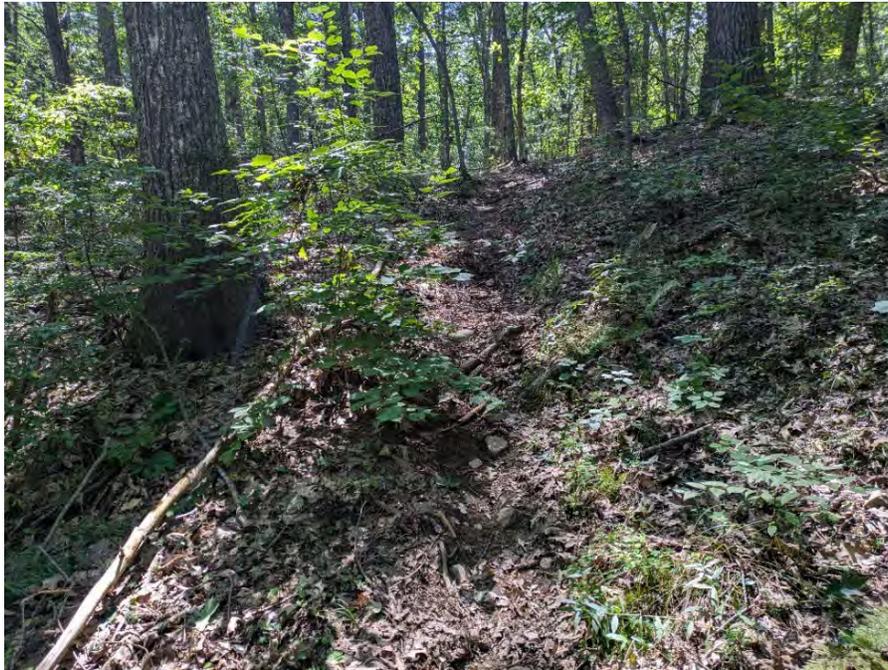
Point 15

The locations we noted that would benefit from water control on the trail surface are points, 5, 15, 17, 21, 22, 28, 36, 37, 39, and 44. Two of these points are pictured below.

Shaping a trails surface to periodically shed water at low points will help in the correction of tread erosion. Water can be controlled by contouring a trail. The edge of the trail can be cut down to allow water to drain off and the trail surface can be contoured to direct water towards the low area on the edge of the trail. These drain areas can then be periodically inspected to clear any debris which get caught in them. This is a low impact and relatively low maintenance way to control water issues on the trails. Trails that funnel water down the center of the trail rather than periodically having points designed to shed water will wash out over time. As an alternative to contouring a trail, water bars could be installed to direct water off the trail surface.

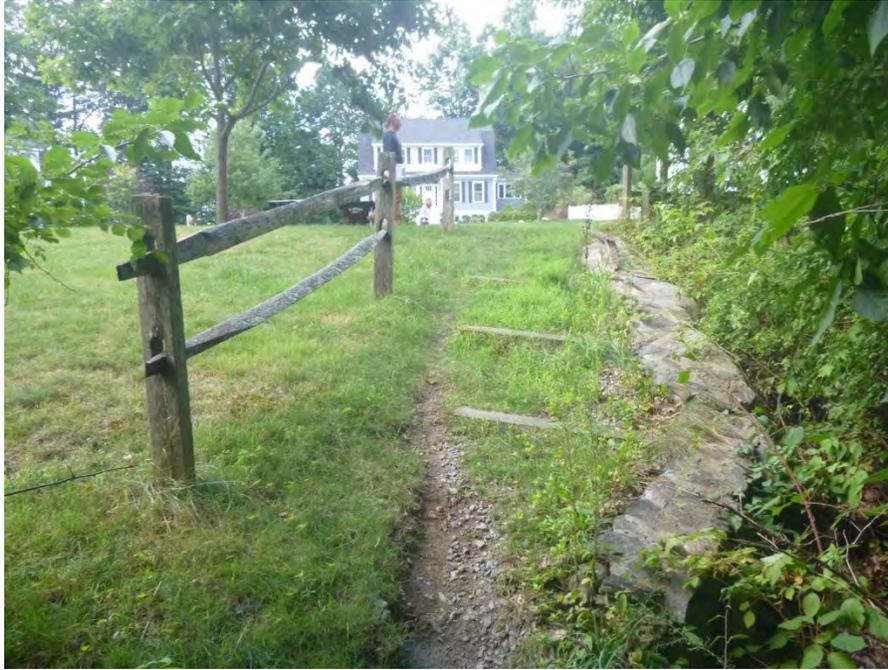
Point 55

At the beginning of the Margaret Rice Conservation Area trail there are a series of wooden water bars on a grassy slope section of the trail. As can be seen in the photo below, taken at point 55, water has found a route around the bars, causing some erosion. These water bars should, ideally, extend to the area below the fence, instead of stopping short of it.

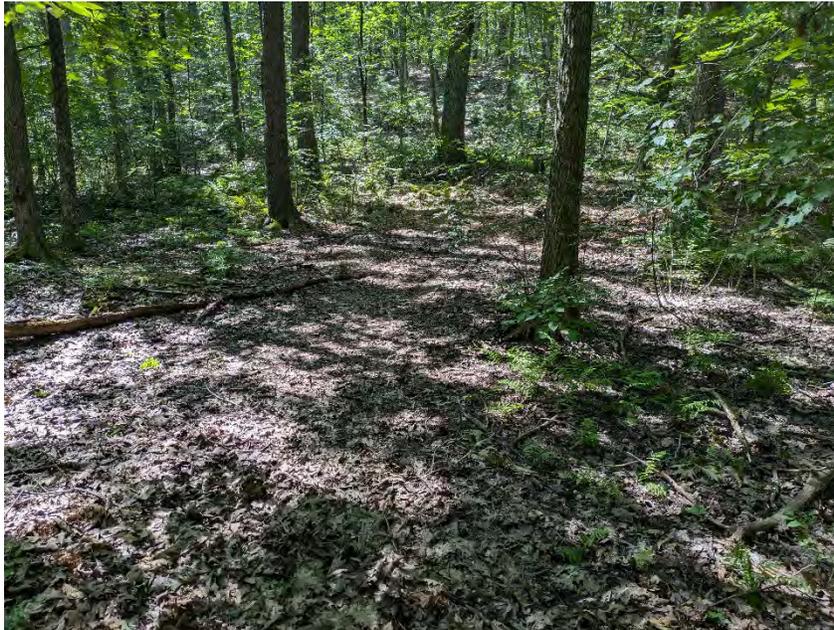
Point 8 – The trail crosses a wet depression with no improvements in place. A bog bridge could be used here to cross over the wet area.

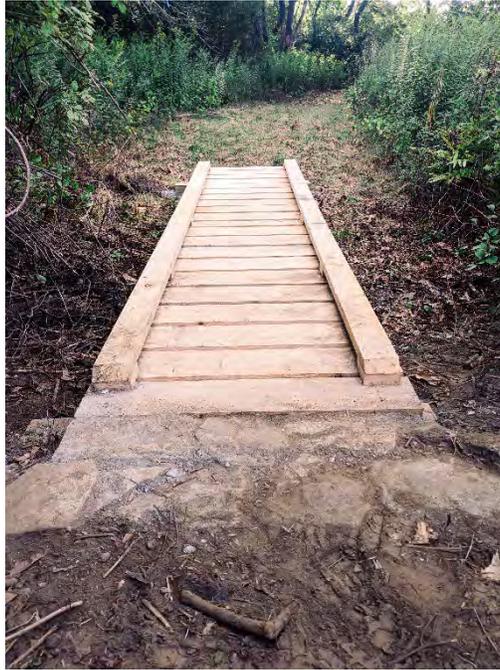
There are different ways to build bog bridging, one example of a bog bridge over a wet depression is shown here. The bridge is built using 6x6 footings on each end with two 4x6 beams providing support and a 4x4 down the center. The decking is built from white oak.

Point 30 – There is a bog bridge in this location that is in acceptable condition, but it is next to the remnants of an old bog bridge that should be removed. Additionally, a rock transition could be added to the beginning of this bog bridge to control erosion, as shown in the photo of the example bog bridge.

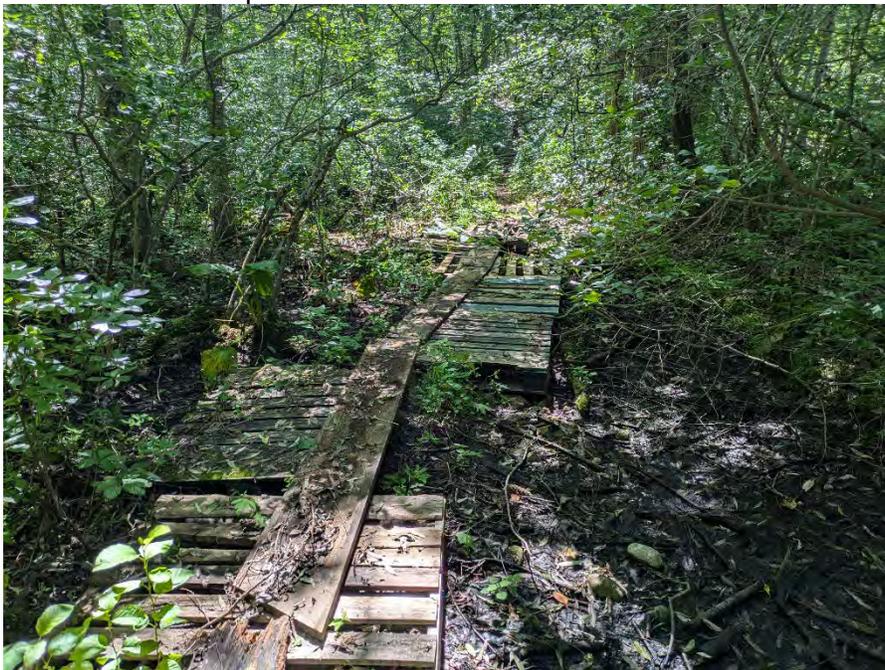
Point 9 – Old pallets and boards are used to cross a wet area. Replacing this with bog bridging would provide a safer and more permanent solution.

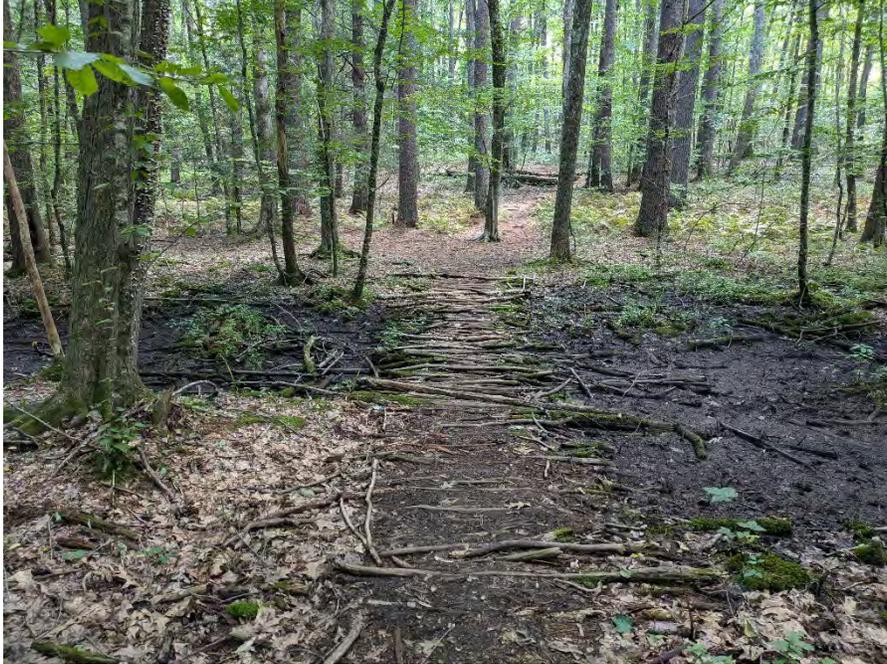
Point 19 – A wetland is crossed using a corduroy of available logs and sticks. Replacing this with a bog bridge is a more permanent solution.

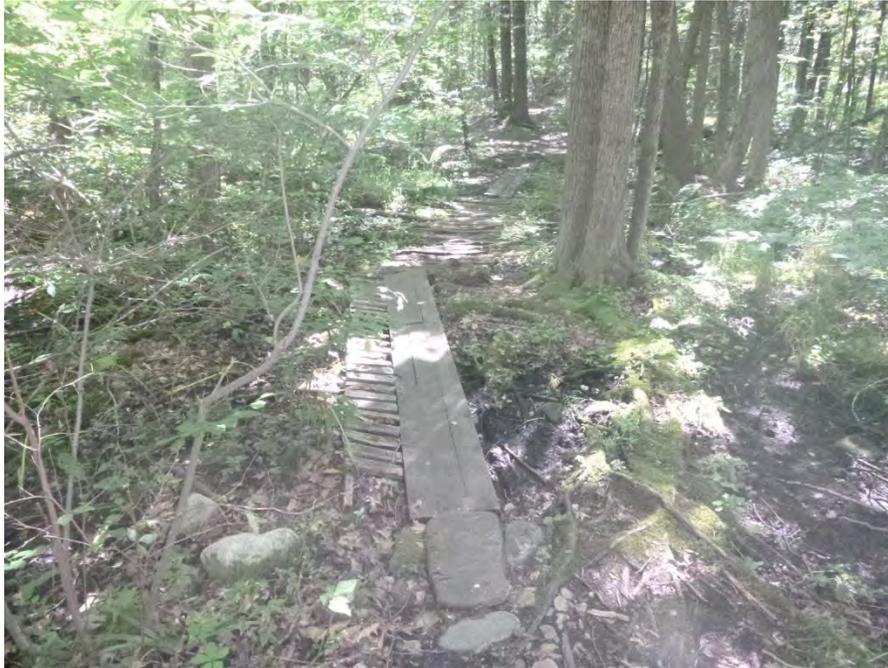
Point 31 – This section of trail crosses approximately 60 feet of wetland. The wooden planks used to cross this area are beginning to fail and the existing log corduroys could be replaced by more permanent bog bridging.

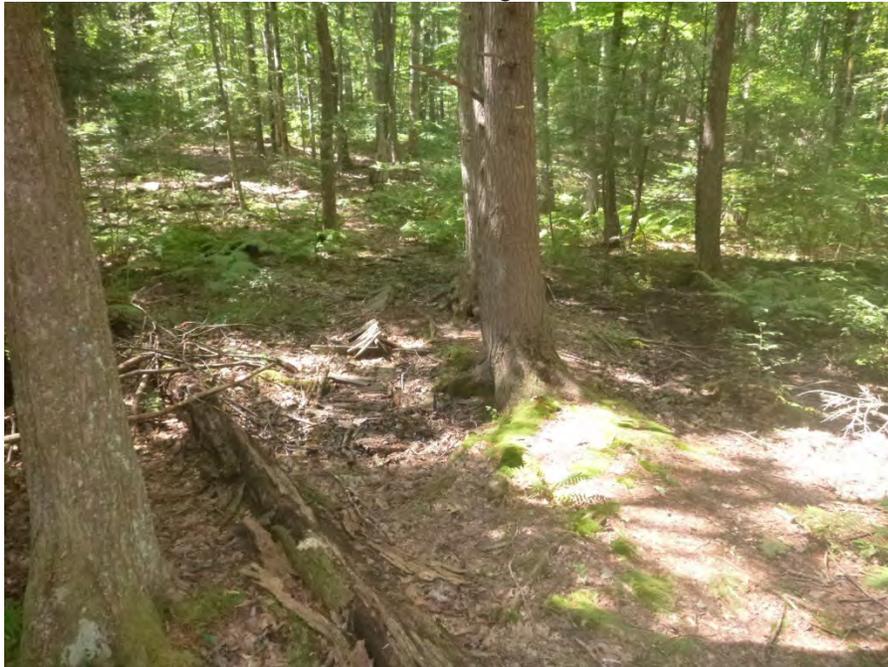
Point 45 – The existing bridge at point 45 has failed. The wooden debris and protruding nails from the old bridge are blocking the path, causing users to find their own way around the wet area. The debris should be removed and a new bridge constructed.

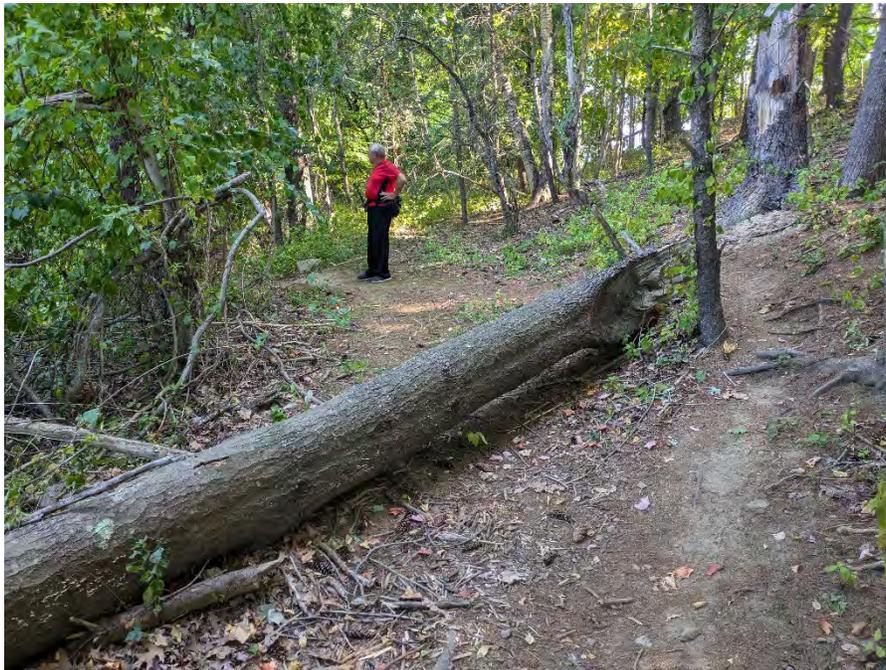
Point 3

The hazards we observed are located on the south half of Woodsom farm. The first hazard is a downed tree at point 3, which blocks most of the trail. Some users may struggle climbing over or moving around this tree. The second hazard is a dead tree hanging out over the trail at point 5. Hanging dead trees next to the trail should be removed, as eventually they will fall and block the trail, in a worst-case scenario they could fall and injure a trail user. The last hazard is at point 12. There is a drainage associated pit located here, the cover for this pit is simply a piece of metal laid over the top. The metal can be moved, which creates a fall hazard for users, additionally people could enter the pit if they wanted to. The loose piece of metal should be replaced with a top that can lock. These hazards are shown below.

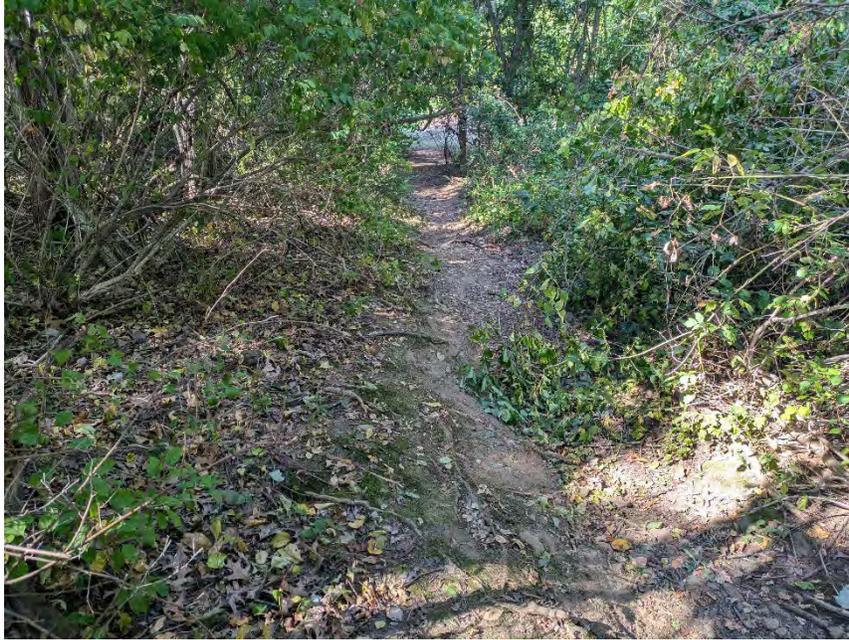
At point 4, there is a steep section of uphill trail that is suffering from some significant erosion on the lower side of the trail. There are two different options which would both work in this situation.

Point 4 – Photo 1, existing erosion on the trail and a view of the upslope side of the trail. The trail tread could be moved to the left side of the photo and the existing trail would serve as drainage.

The trail is situated, so that if looking downhill at the trail the left side is higher than the right. Vegetation along this high left side could be trimmed back and the surface of the trail moved to the higher left side, with drainage down onto the existing trail tread, which would now serve as a drainage ditch area. Alternatively, the trail could be completely re-routed to go across slope in the area between points 3 and 4, and the existing trail closed. The terrain and vegetation in this area appear well suited to the construction of a new trail here.

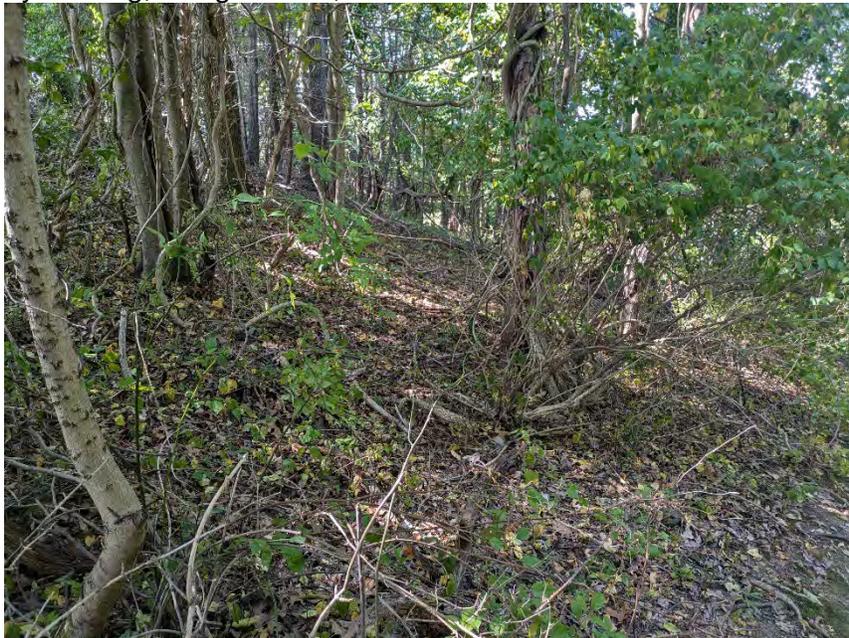
Point 4 – Photo 2, a suitable location to re-route the trail to go across the hill's slope, rather than the currently existing, straight down, trail.

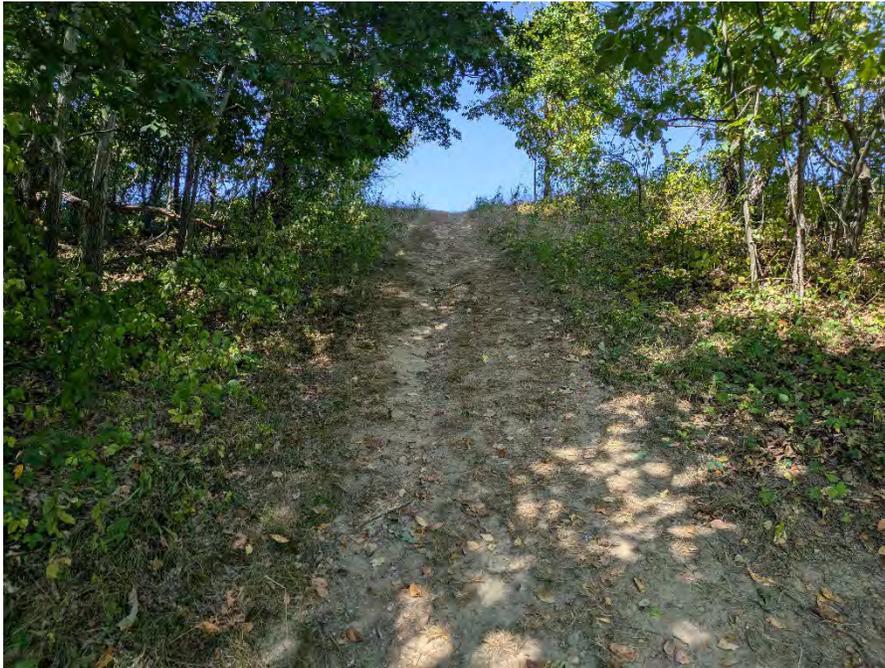
At point 11 there is a steep section of trail that heads straight down a slope. This path provides water with an easy straight down route with no resistance. Since there are no curves on this path where contouring could be easily accomplished for drainage, the best solution would be to install a couple of water bars to break the flow of water and direct it off the trail.

Point 11 – As can be seen in this photo water is starting to create a channel along the left side of the trail surface. Water bars should be installed to break the flow of water and direct it off trail.

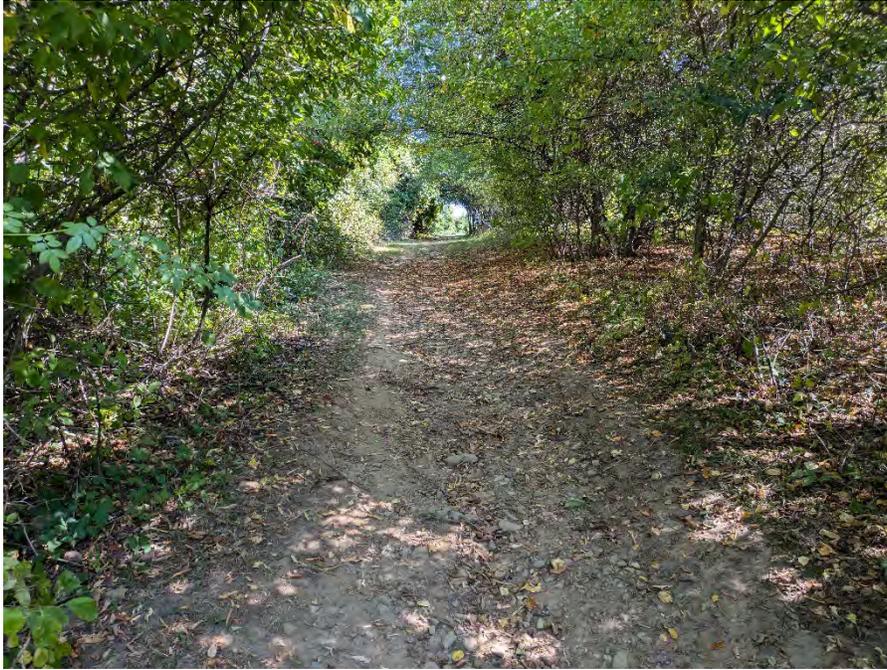
Point 7

There are two additional areas where water control is needed on the north side of Woodsom Farm. At point 7, there is another section of straight steep trail where a water bar could be installed to direct water off trail. At point 14 the farm road is starting to erode on a steeper slope. Point 14 could be fixed with contouring as it is along a gentle curve in the road. The lip of the road could be lowered and the road contoured to shed water off the side. Photos of these points are shown below.

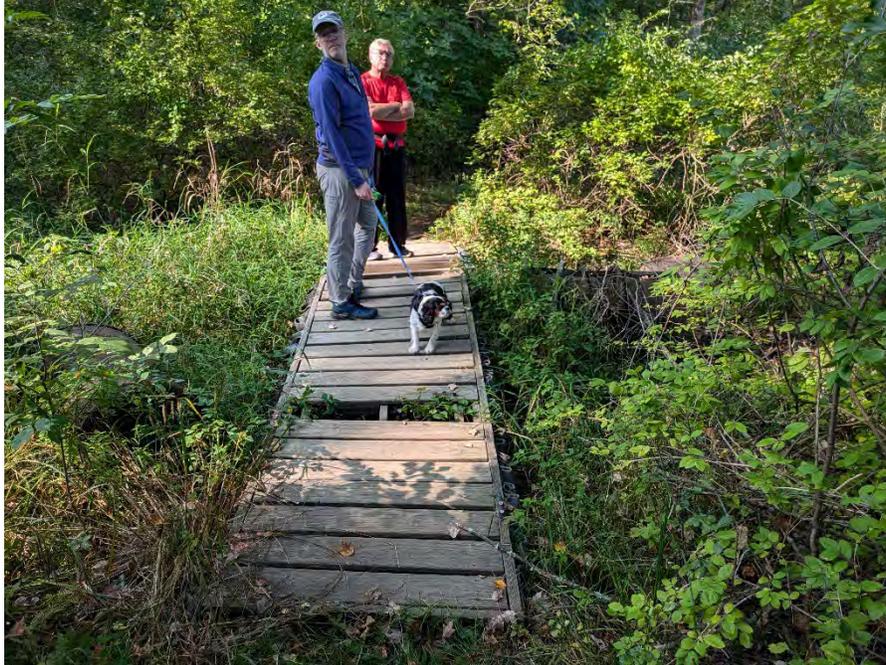
The first is an existing bridge at point 1. This bridge is simply in need of repair as there are some missing boards. In this same location there is a board used to bridge a small wet area just

Point 1 – The existing bridge in need of repairs.

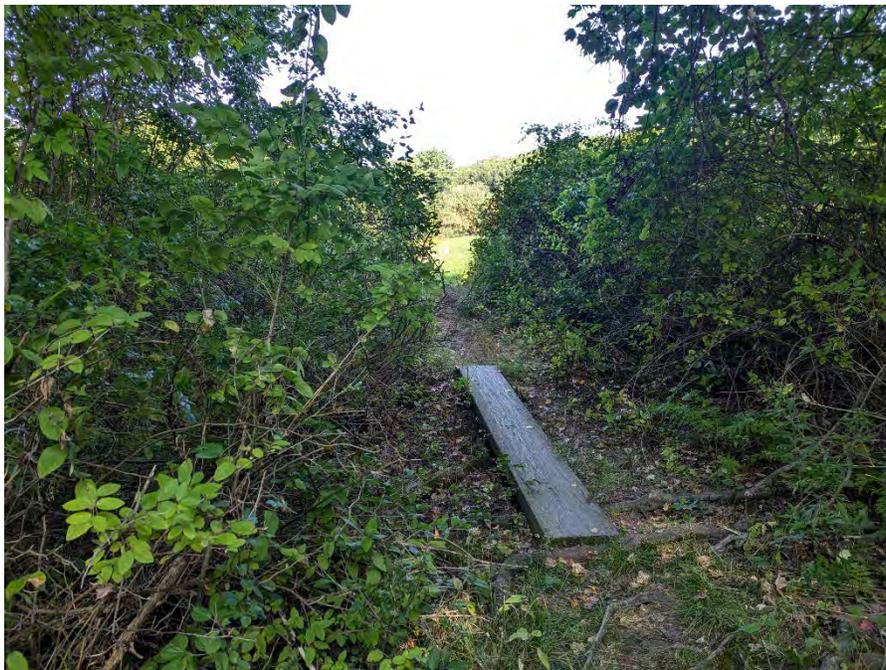
Point 1 – Board nailed into tree roots

prior to this bridge, the board is currently nailed into some tree roots. This could be improved by adding some 4x4 footers on top of crushed gravel that the board can be attached to, instead of the tree roots.

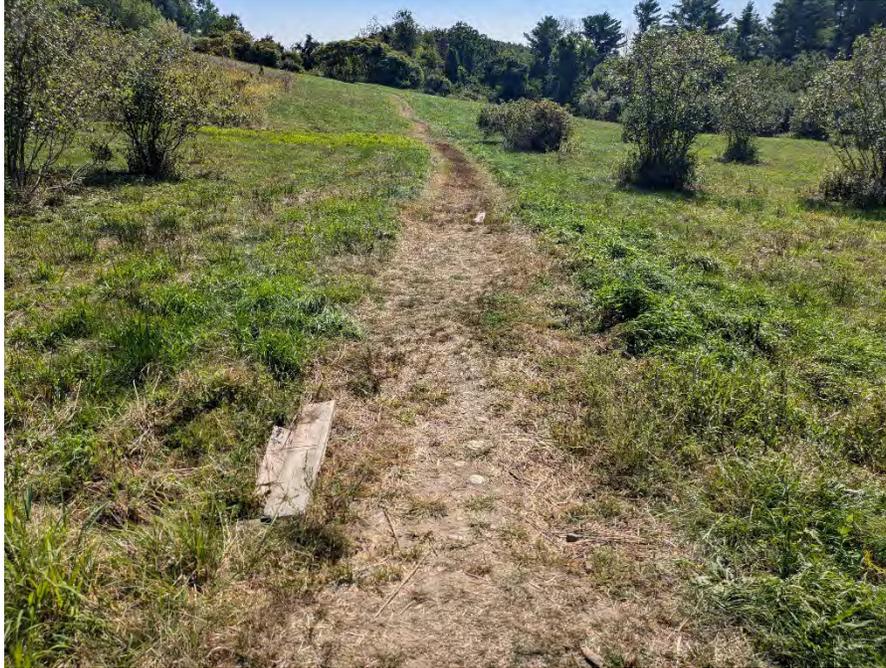
At point 9 there are a few low dips in the trail with some boards noted on the trail side, likely used by trail goers when the low dips are muddy. This area could be improved with either small bog bridges, or by rock armoring the trail. Crushed gravel could be used to fill in these low spots

Point 9 – Low dips in the trail surface

and larger stone could be set into the crushed gravel as a surface for trail users to walk on. A small bog bridge is likely quicker and easier to construct, but either solution would work.

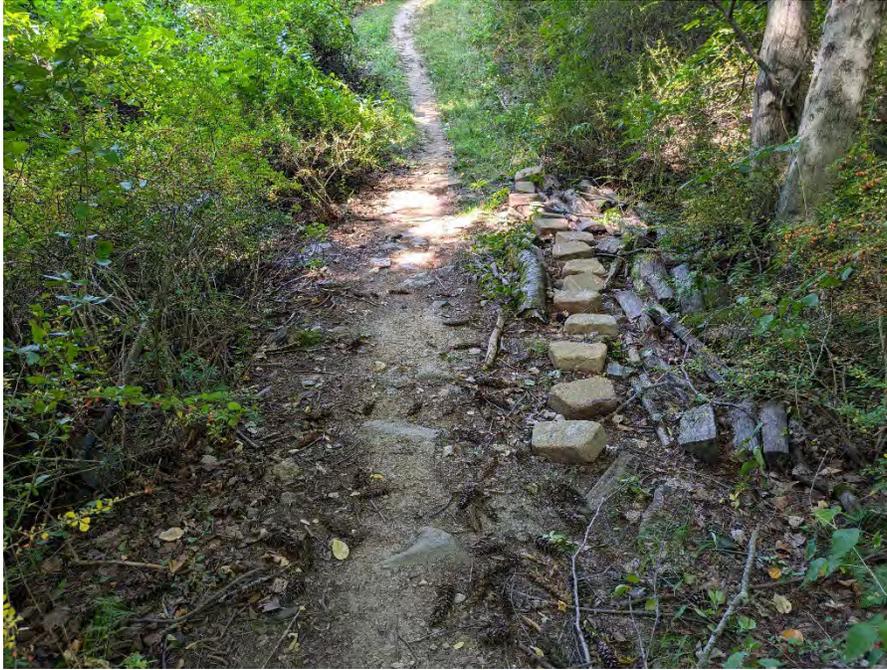
Point 13

At point 13, on the north side of Woodsom Farm, there is a spur trail that heads off the property to the east. Just before the trail leaves town property there is a low point, where it appears a seasonal stream may cross the trail. As can be seen in the photo below, trail users have created a temporary crossing by loosely placing stepping stones along the edge of the trail. A bog bridge could be built to cross this seasonally wet area. Alternatively, the stones that users have already brought in could be used to create a more permanent rock armor solution. Small gravel could be used to build up the trail surface and the stones set firmly into this gravel to create a trail surface, the gravel should allow the water to flow through and the stones should be set high enough that they are out of the water.

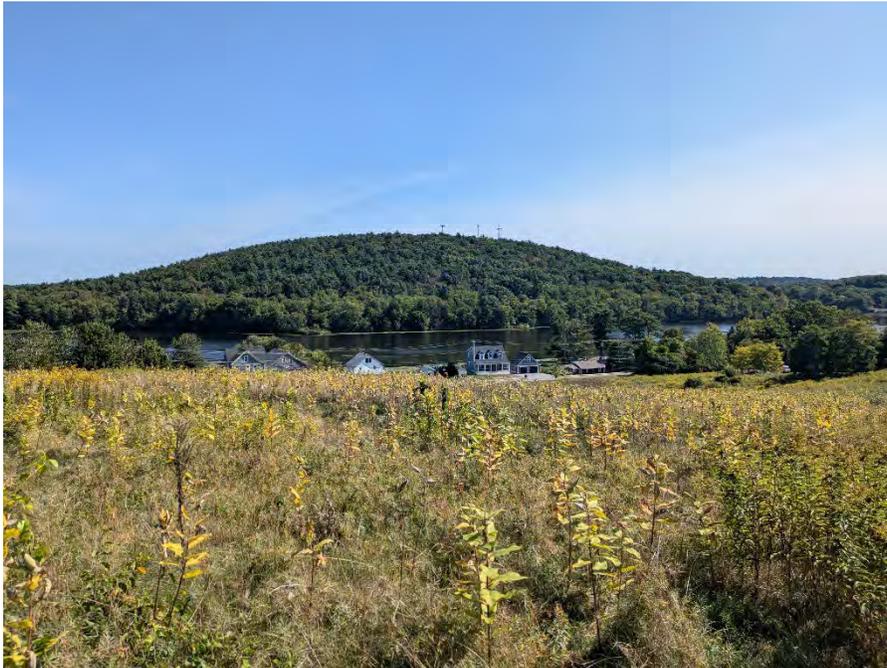
Point 6

Lastly, we had notes on two different points of interest on the property. At point 6 there is a beautiful view looking towards Powow Hill and over Lake Gardner. A bench or a picnic table could be added at this location to give users a spot to relax and enjoy the view.

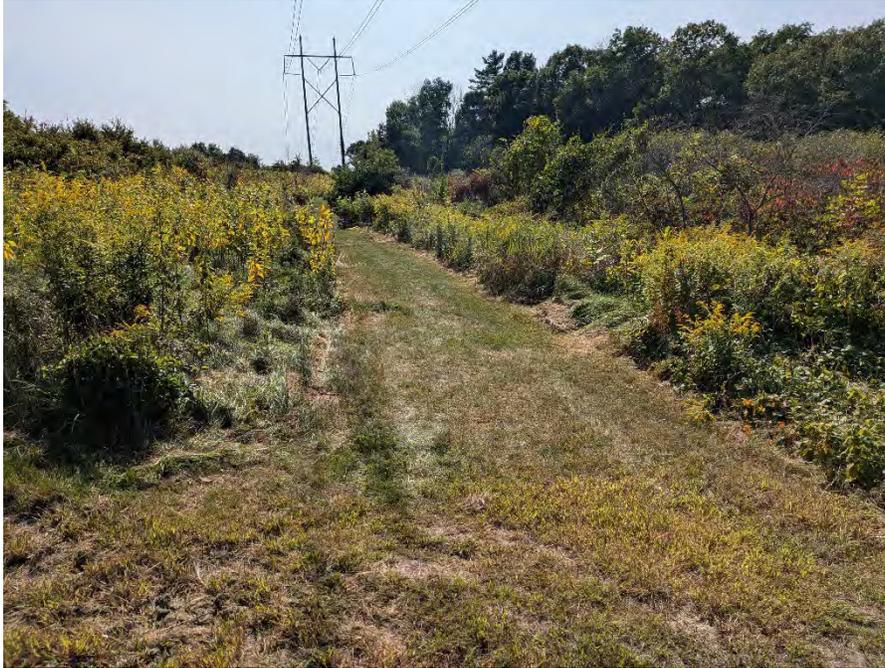
Point 15 – Good location for signage informing the public that this land is open. A trail map could be added here.

Our last recommendation is for point 15 where the trail meets Whitenall Road under the powerlines. A sign could be added here to let people know that this is land open to the public, as this part of the trail is far from the public access point on Lions Mouth Road. Eventually this would be a good area for parking for a few cars and an informational kiosk.

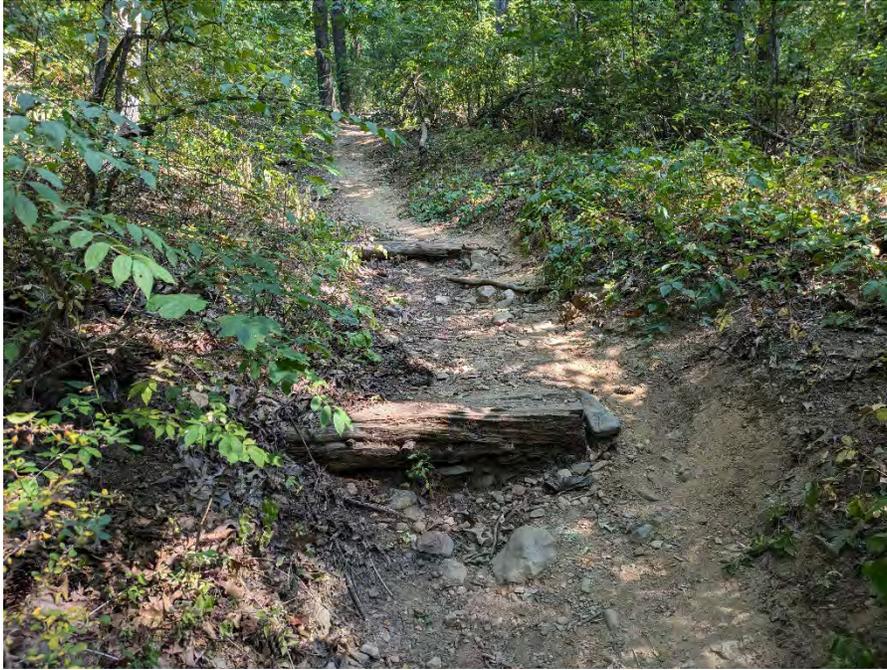
At point 13, on the Batchelder Trail, there are a series of steps installed on the tread that are helping to control erosion and direct water. The soil in front of one of these steps has washed out, creating a larger than normal drop from the top of the step to the bottom. This could be a tripping hazard to users and the bottom of the step should be filled in with soil or gravel to bring the drop back to a normal step level.

Point 13 – Soil washed out at bottom of step

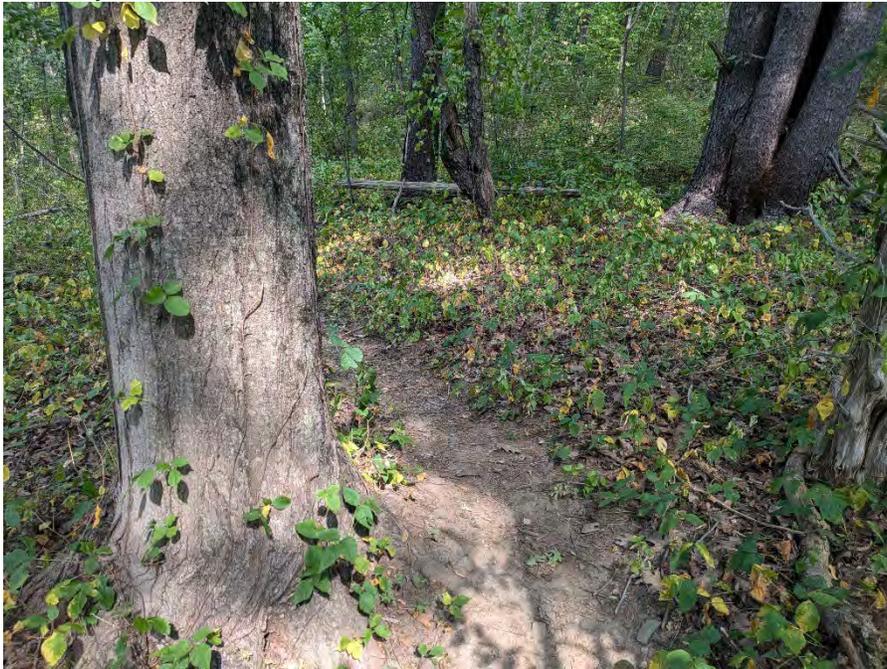
At points 15 and 24 there are large amounts of poison ivy surrounding the trail and some of this poison ivy is beginning to hang over the trail tread. The poison ivy will likely need to be continually controlled to ensure that it does not present a hazard to people on the trail.

Point 15 – Poison Ivy on the trail
