Trails Assessment Report City of Amesbury

Prepared by Woodsman Inc
Site Visit Dates: 8/23/2024, 9/12/2024, & 9/13/2024

**Town Forest &
Margaret Rice Conservation Area**

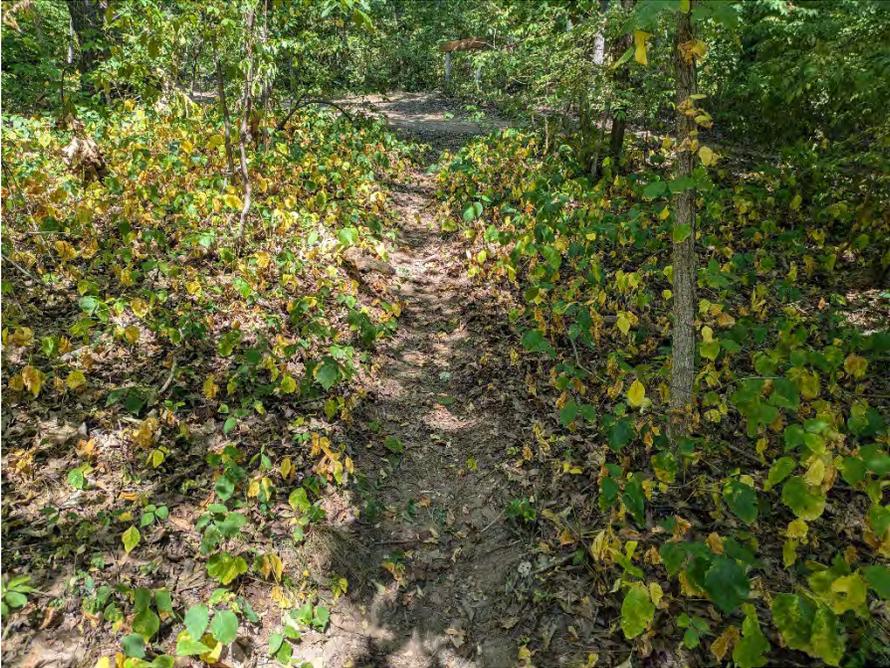
At points 15 and 24 there are large amounts of poison ivy surrounding the trail and some of this poison ivy is beginning to hang over the trail tread. The poison ivy will likely need to be continually controlled to ensure that it does not present a hazard to people on the trail.

Point 24 – Poison Ivy on the trail

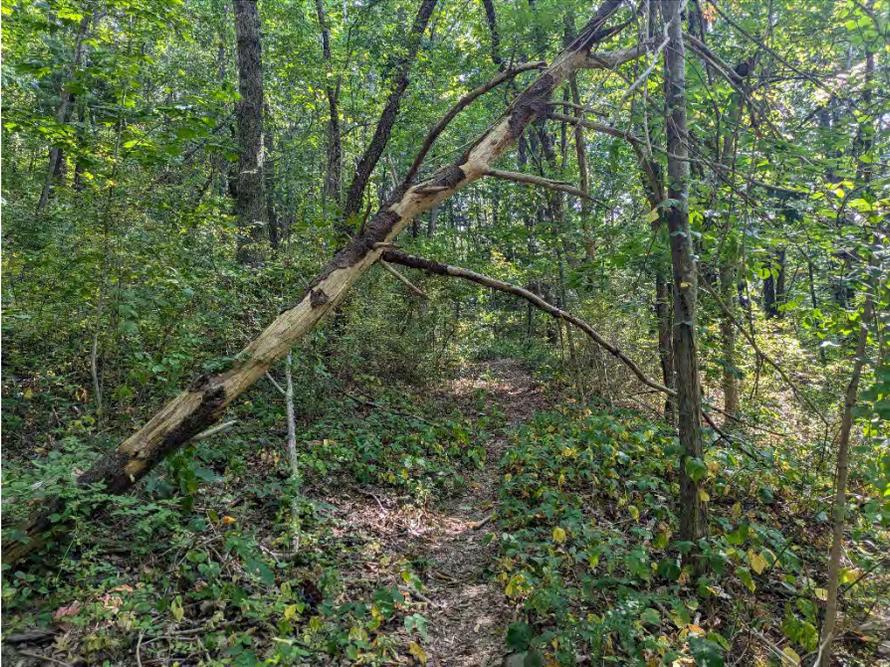
While on the property we noted two hazard trees which should be removed. One of these hazard trees is located at point 20, while the other is at point 23.

Point 20 – Dead tree hanging over trail

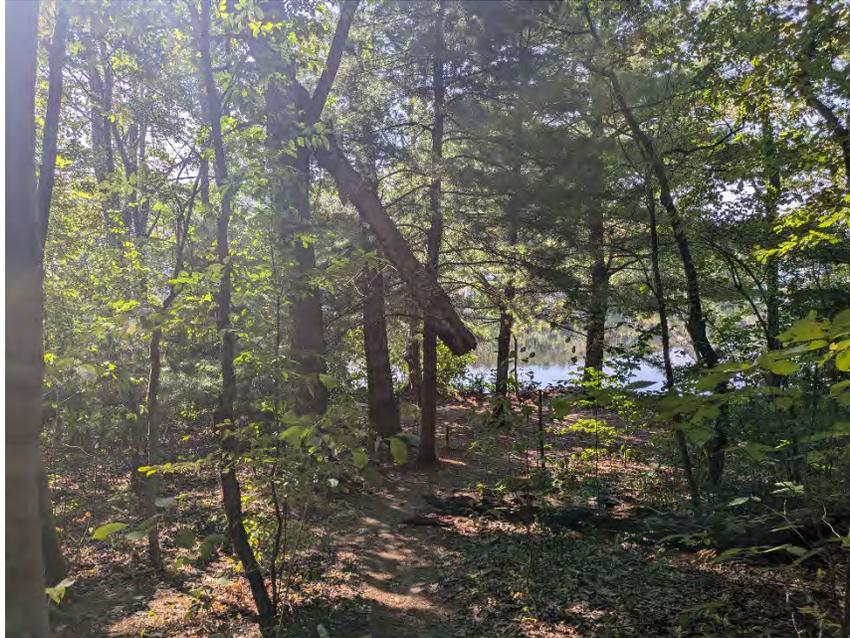
Point 23 – Snapped off tree suspended in the air above the trail. This tree should be removed to avoid the potential that it could fall on a trail user.

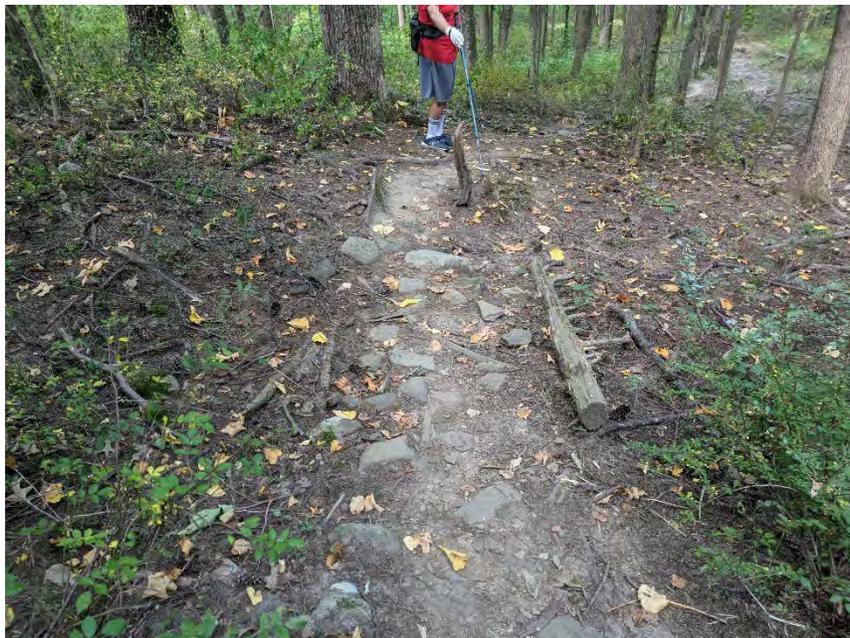
The first location is at point 9 on the Powow Trail. There is a low dip in the trail where a seasonal stream crosses over the trail and flows to a low spot on the opposite side. A bog bridge could go across this dip and raise the trail surface above the water.

Point 9 – Bog bridge needed over low area with seasonal stream.

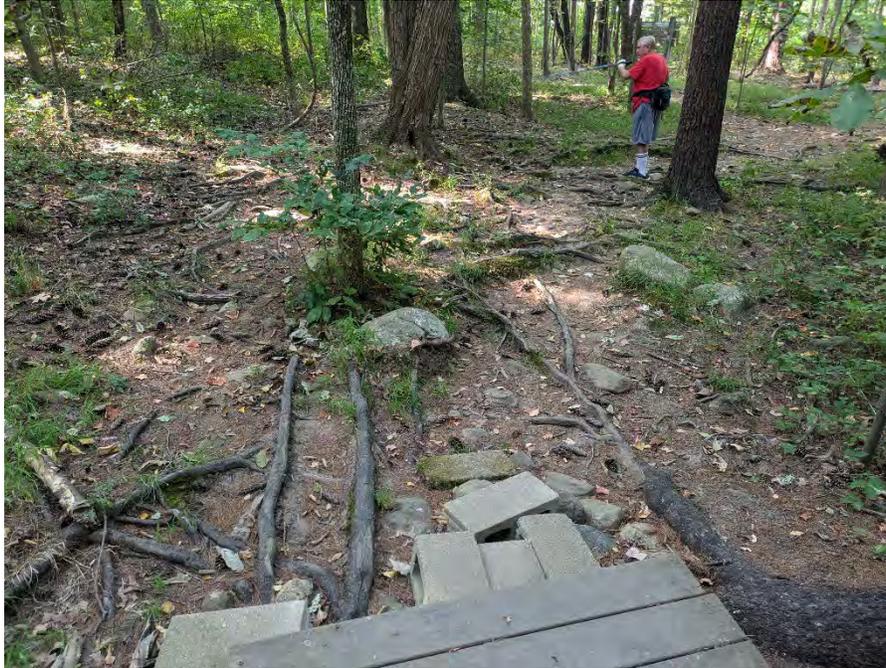
At point 11 a currently existing bog bridge stops just shy of the end of the wet area.

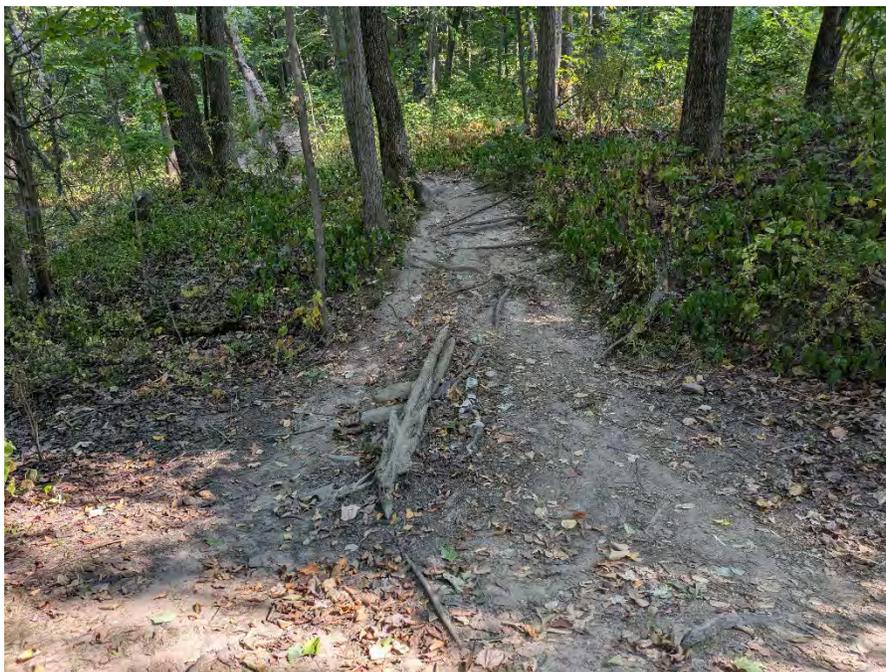
Point 12 – A small plank bog bridge is needed to cross a seasonally wet, low depression in the trail.

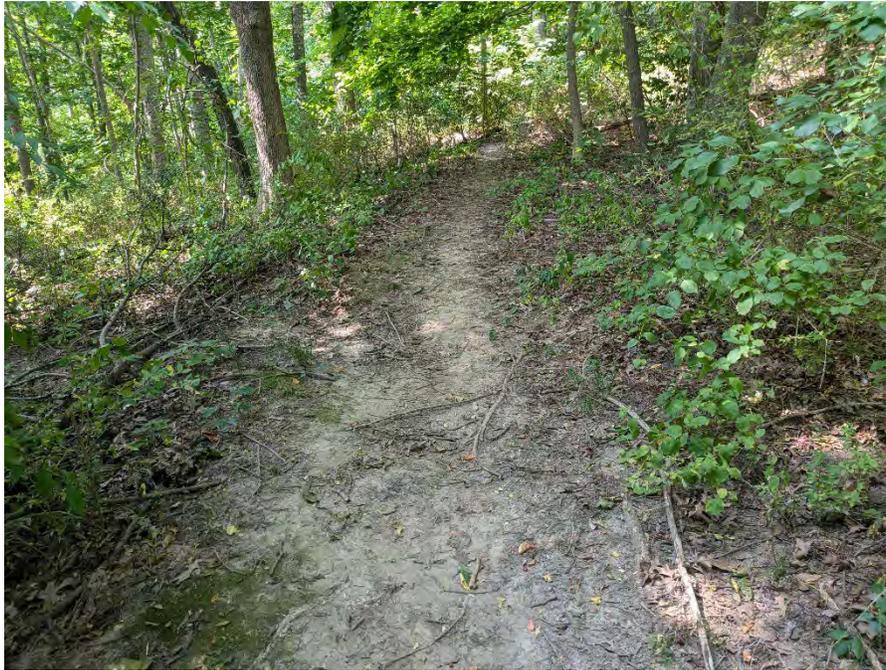
Point 17 – This point is located on a spur trail that leads off the property towards Orchard Court. There is a low point on the trail with a seasonal stream that could be crossed with a small plank bog bridge.

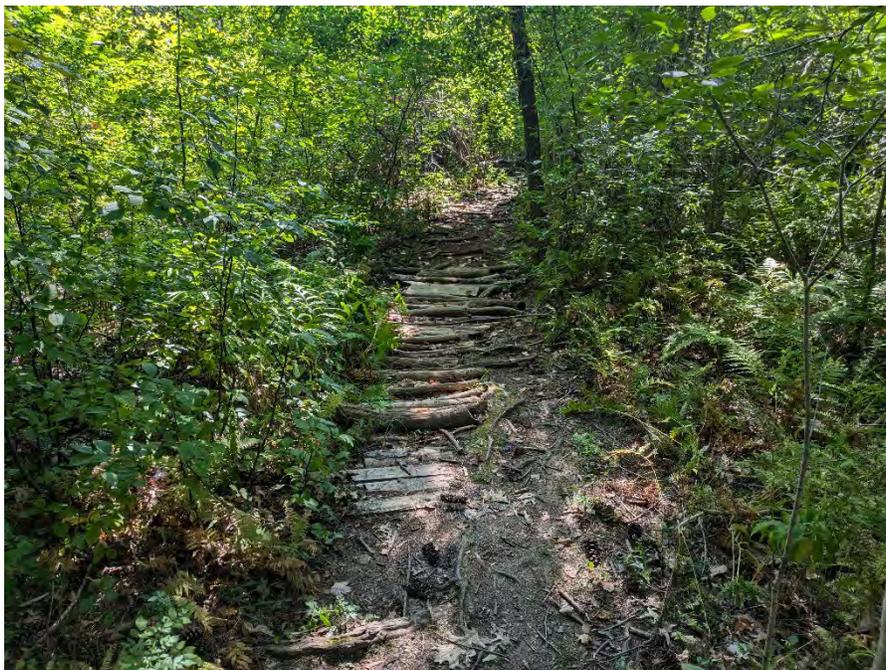
Point 22 – This area is located on Camp Kent. A wet area is crossed using a log corduroy as well as some old wooden planks. This should be removed and replaced with a more permanent bog bridge.

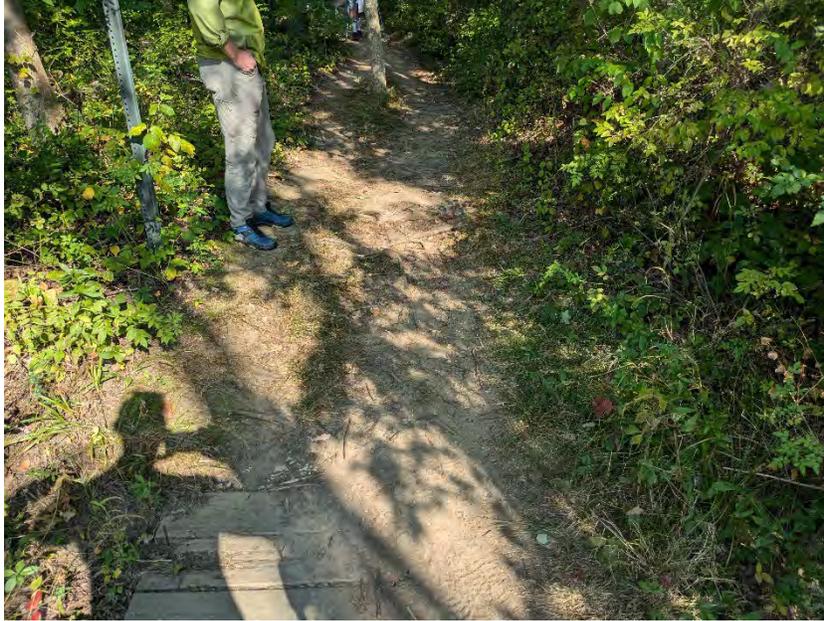
Point 1 – Water is pooling at the end of a bridge. The trail should be contoured to shed water off to the right side of the photo. The left side of the photo could be built up with some rock armoring to provide users with a dry tread to walk on. Some of the soil could be dug out, gravel could be placed down, and some large stones could be set in the gravel to provide a dry trail surface.

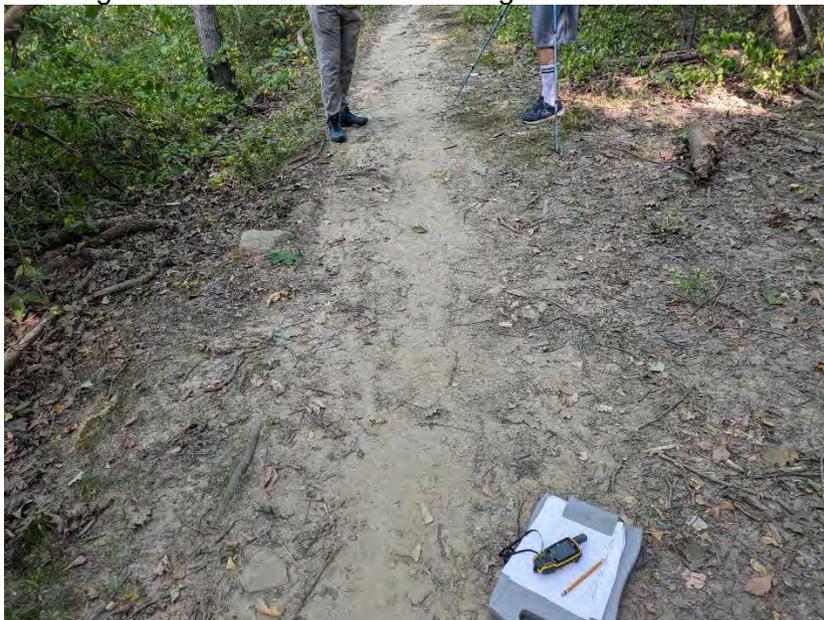
Point 2 – Point 2 is a low dip in the trail where water flows across. This could be fixed by a bog bridge, but it could alternatively be fixed with rock armoring. The dip could be filled with small diameter gravel and larger rocks could be set into this gravel as a surface for users to walk on.

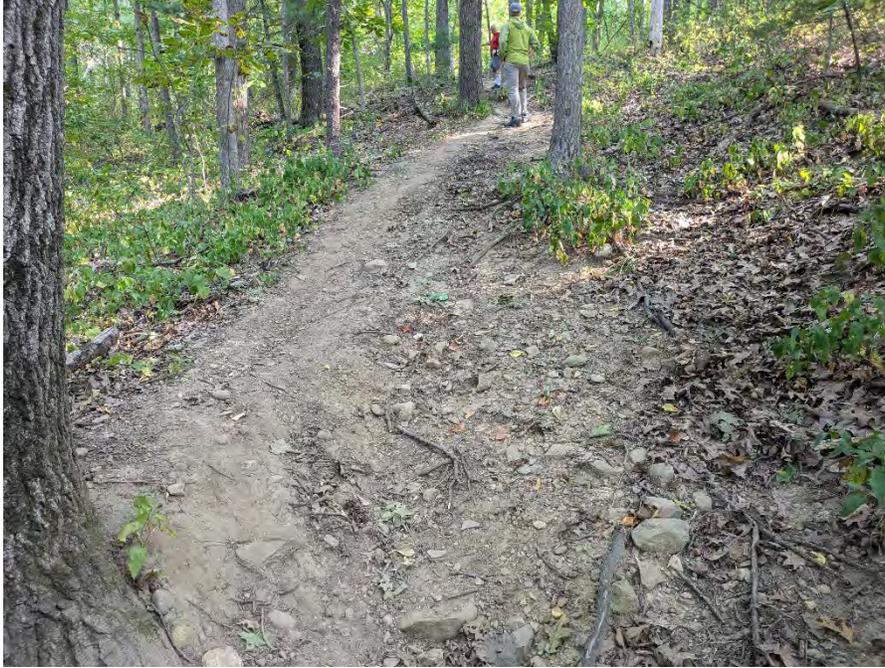
Point 3 – This area is located at the bottom of the Silvermine Trail where it connects to the Stagecoach Trail. Flowing water is beginning to wash out the trail tread. A series of water bars/steps could be installed here. This would help to hold in the soil and break the flow of water as well as provide a comfortable series of steps for users to walk down. An alternative solution would be to re-route this section of trail across the slope of the hill to the northwest, to create a more gradually sloping connection to the Stagecoach trail.

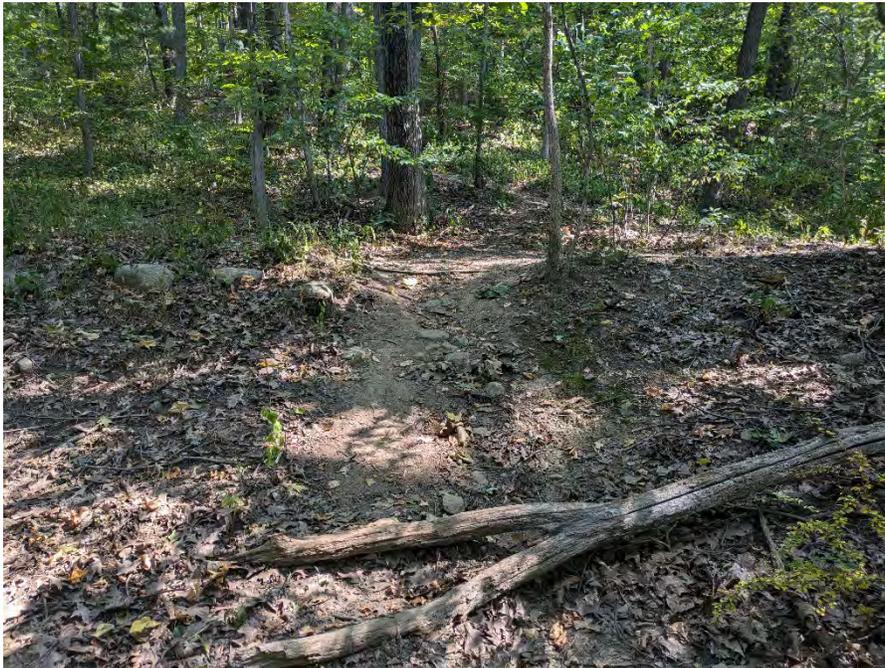
Point 19 - The spur trail heading down to the lake, directly across Stagecoach Trail from the Silvermine Trail is also suffering from the same erosion issue. If steps/water bars are added at point 3, they should also be added here.

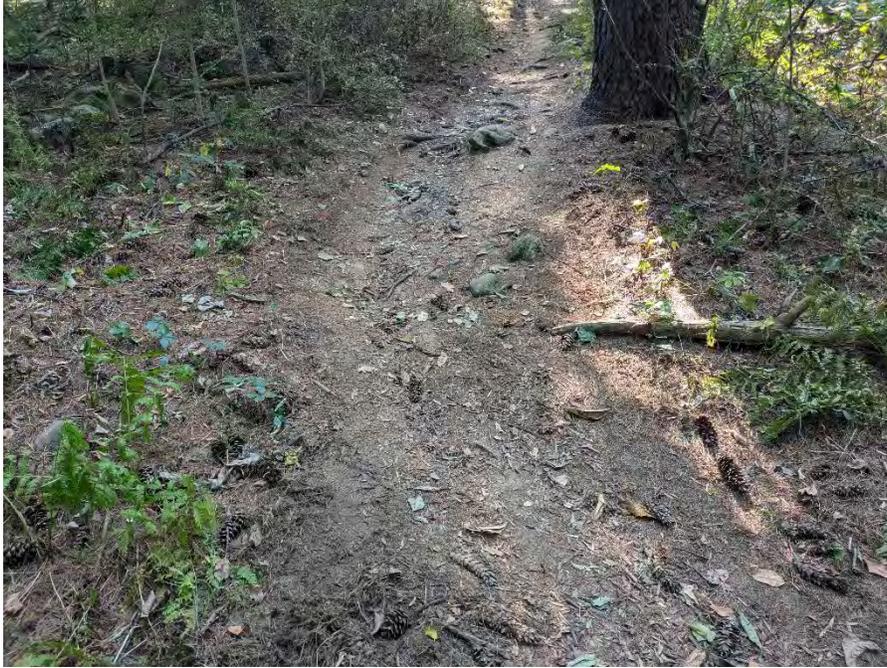
Point 6 – There is a steep section of trail, followed by a bend in the trail. This bend in the trail is a good location to contour the trail and direct water off the trail tread. By cutting down the lip of the trail at the bend and contouring the surface in this area to flow towards the low area in the lip, you can shed some of the water from the trail at this point.

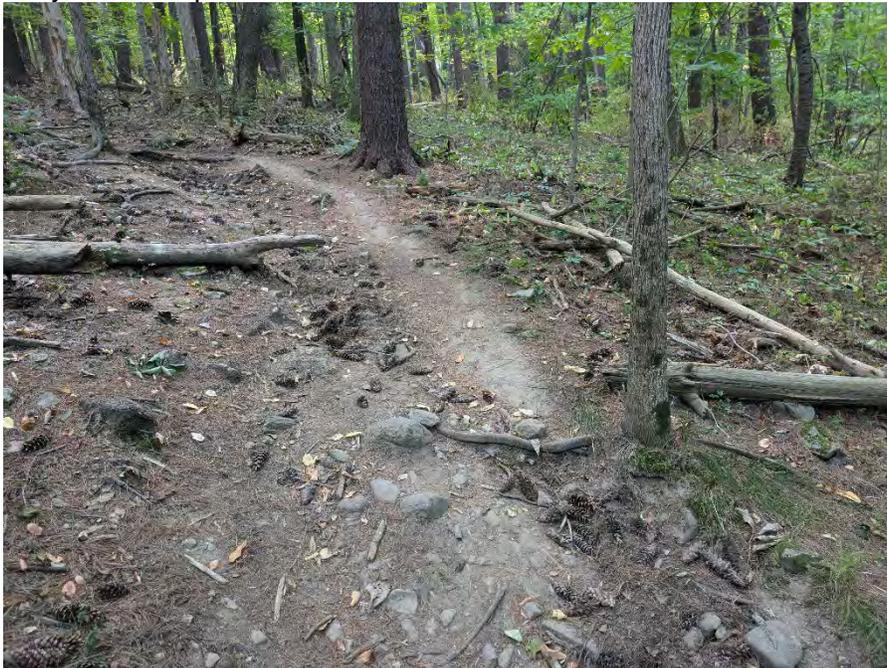
Point 7 – This is a good spot to add a water bar. As can be seen in the photo, water is flowing down a low valley in the center of the trail. By adding a water bar here and directing all this water off the trail you will help to minimize water issues and erosion further down the trail.

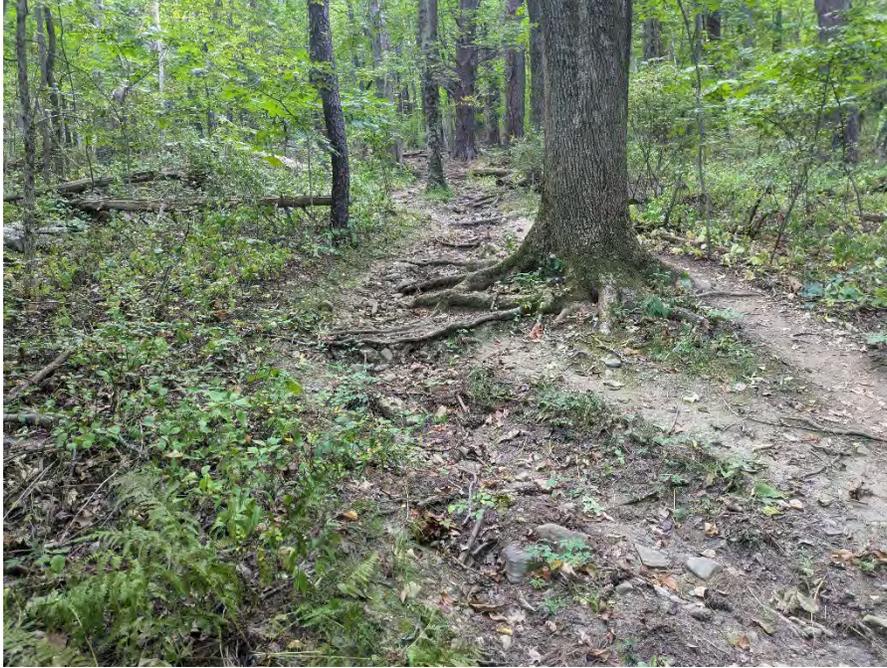
Point 8 – At point 8 there is heavy water flow following the trail tread. As can be seen in the photo the water is flowing down the left side of the trail, while the right side of the trail is higher. Users should be directed to the higher right side of the trail and the lower left side of the trail should be dedicated to the flow of the stream. In some areas this may take a bit of work to remove obstacles and high points that are blocking the flow of water to keep water flowing in the low areas and to keep the trail tread on the higher ground.

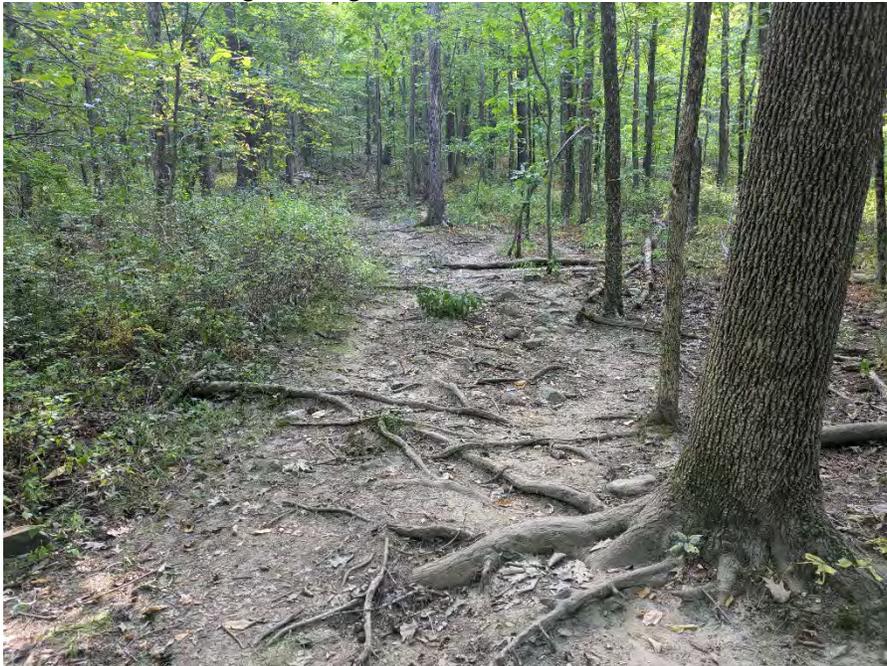
Point 10 – This is a low point on the trail where water is flowing over it during the wet season. During our visit we noted that there are many large, loose rocks scattered throughout this trail. These rocks can be used for rock armoring to cross wet areas. This section of trail would be a good candidate for rock armoring to bring the trail surface above the wetness.

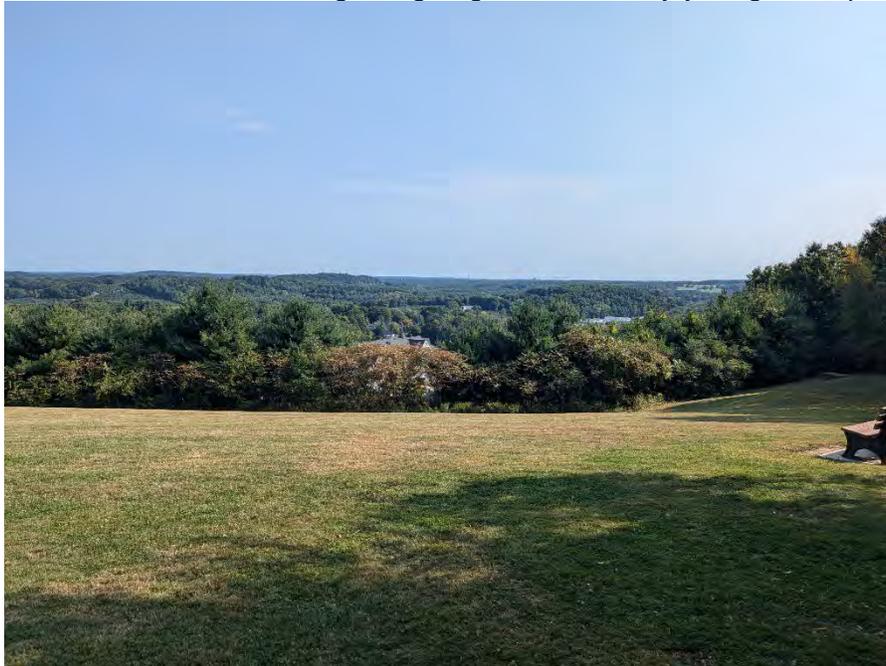
Point 5 – The view from Powow Hill beginning to get obscured by young white pines.

The last thing of note in this area is the view from the top of Powow Hill at Point 5. Unfortunately, some young white pine trees are beginning to get tall enough to obscure these views. We recommend that these white pines be removed while they are still small to prevent the view from being obscured any further. Once the pines are removed the area can be planted with native low-growing wildflowers and shrubs so that the area can remain naturally vegetated and the view can be preserved. It is important that this view be preserved as it is the main attraction of this area. Benches are currently set up for users to be able to sit and enjoy the view and the Silvermine Trail, Batchelder Trail, Powow Trail, and the new trail all lead to this point.
